ORCHARD LANE, EAST MOLESEY

**PRELIMINARY BAT ROOST
ASSESSMENT**

Report No: RT-MME-153535-02

RevB: May 2023

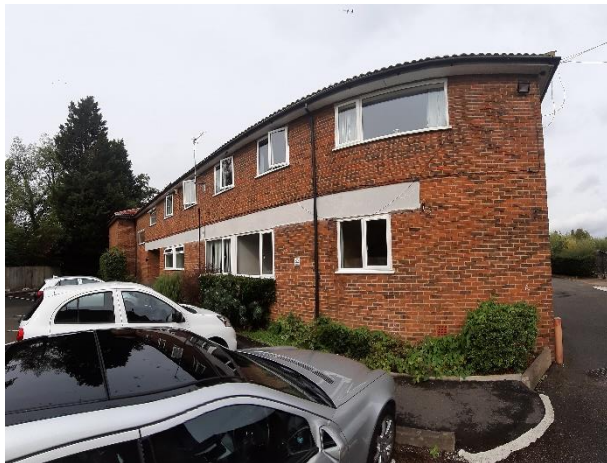
Building B1 was a U-shaped modern building with brick walls and a pitched clay tile roof (Plate 4.1). The end roof tiles were inspected using a torch and did not have gaps extending into crevices nor into the loft space. No lifted, slipped, or missing roof tiles were recorded (Plate 4.2). The building had a wooden soffit throughout. This soffit was in good condition with small holes in places associated with pipe vents (Plate 4.3). No cracks or holes were recorded in the brickwork and no gaps were recorded around the window and door-frames. No evidence of bats was recorded although not all features could be inspected fully due to the height and location on the building.

Plate 4.1: South-facing Aspect, B1

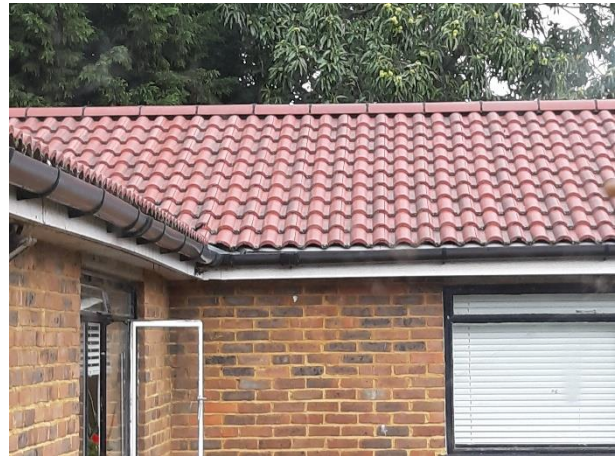
Plate 4.2: Clay Roof Tiles, B1

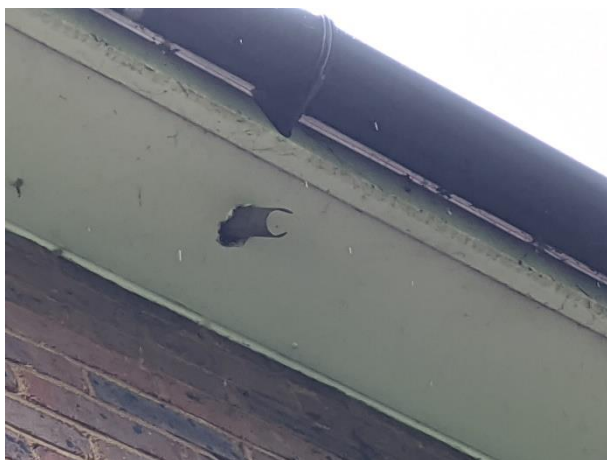
Plate 4.3: Gap Around Piping, Soffit Box, B1

Building B1 had several access points in its wooden soffit that potentially provide direct access to the loft space. It was not possible to fully inspect the loft space due to its low height and due to water tanks obscuring views of the whole space. As such the building is assessed as having high potential to support roosting bats.

These buildings, alternatively known as Molesey Venture, Newstead House and Sundial House, have been assessed as having high potential to support roosting bats. Bat Surveys: Good Practice Guidelines published by the Bat Conservation Trust (Collins, 2016) recommends that for structures with high bat roosting potential at least three dusk emergence and/or dawn re-entry surveys be undertaken during the bat emergence/re-entry survey season to determine the presence/absence of roosting bats within the structures. The bat emergence/re-entry survey season extends from May to September. At least two of the surveys should be undertaken during the peak season for emergence/re-entry surveys between May and August and one of the three surveys should be a dawn re-entry survey. If a roost is discovered during these surveys, a Natural England licence application may be required.

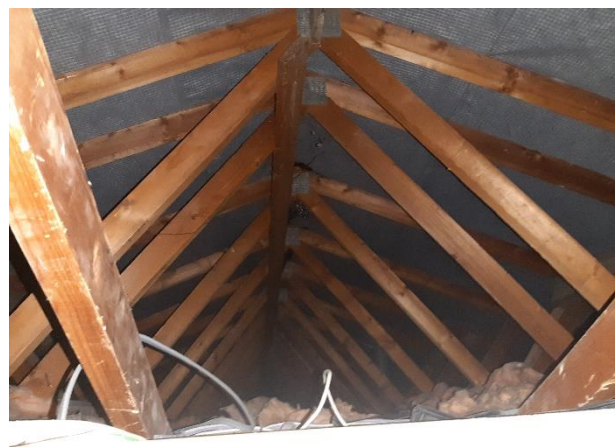
The internal rooms and corridors of the building were in constant residential use and in good condition with no suitable features for roosting bats. The loft space of the building was approximately 1 m tall, 6 m wide, and followed the U-shape of the building making it approximately 70 m long. It had breathable membrane sarking and a wooden ridge beam was present (Plate 4.4). The loft space was well insulated and water tanks were present. No evidence of bats such as droppings or foraging remains was recorded within the loft space.

Plate 4.4: Loft Space, B1

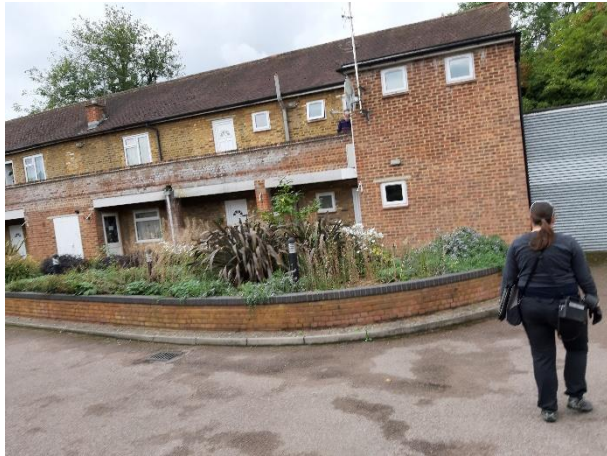
Building B2 was an early-mid 20th century terrace of apartments. It was brick-built, two storeys tall, and had a pedestrian walkway on its east-facing aspect that created a canopy over the entrances to the ground floor apartments (Plate 4.5). No cracks or crevices were recorded under this canopy. On the west-facing aspect the building overlooked the River Ember (Plate 4.6). The roof was constructed from clay tiles, many of which were lifted. Gaps under the ridge tiles were also recorded. On the building's north-facing gable end there was a substantial amount of missing brickwork and mortar (Plate 4.7). Gaps were present between the roofbeams and the brickwork at the roof's eaves (Plate 4.8). No evidence of bats was recorded although not all features could be inspected fully due to the height and locations on the building. The chimneys were in good condition with no cracks or lifted lead flashing observed. Elsewhere there was no further potential bat roost features. An extension structure was present at the north of the building, built from sheet metal. This extension did not have any features which might be utilised by roosting bats.

Plate 4.5: East-facing Aspect, B2

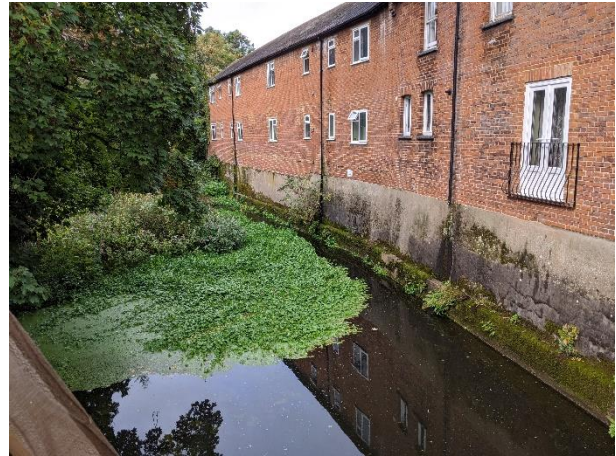
Plate 4.6: West-facing Aspect, B2

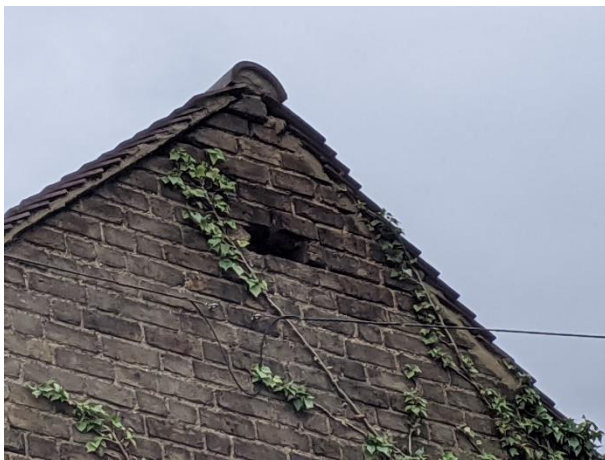
Plate 4.7: North-facing Gable End, B2

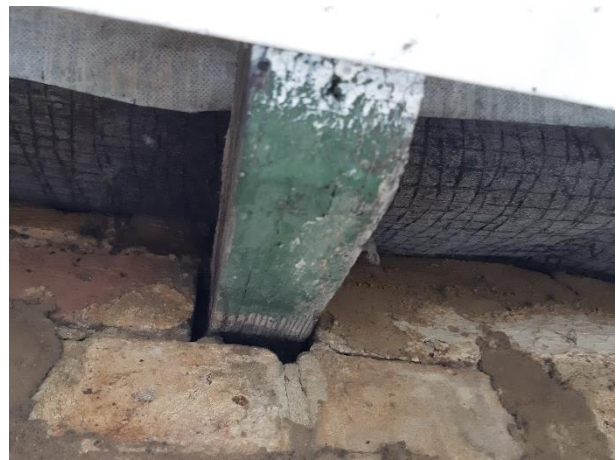
Plate 4.8: Gaps at Eaves, B2

Buildings B2, B4 and B5 were similar in their structure and design. They were of early-mid 20th century design and were characterised by pitched clay tile roofs and unrendered brick walls. On each of these buildings, gaps were recorded at the eaves leading directly into loft spaces. Lifted roof tiles were also recorded on the roofs of these three buildings, creating the possibility for bats to roost in the gap between roof tiles and felt sarking. Features unique to building B4 included a hanging tile feature on the south-facing aspect and gaps surrounding a plastic soffit. Gaps under ridge tiles were recorded on buildings B2 and B5. Building B2 was immediately bordered at its west-facing aspect by the River Ember. This stretch of the river was highly suitable for bats due to an absence of lighting and high levels of vegetation and tree cover. As such building B2 directly connects to a suspected commuting corridor for bats. With these considerations the buildings B2, B4 and B5 are assessed as having high potential to support roosting bats.

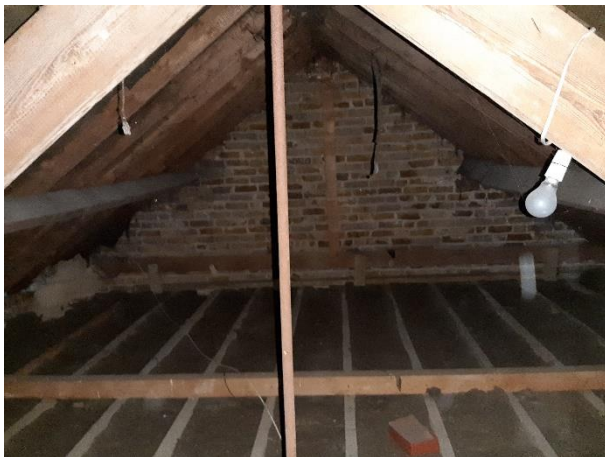
The roof contained a loft space approximately 30 m in length that was divided by brick walls (Plate 4.9). Two of these divided sections were inspected, accessed via loft hatches in individual apartments. The internal rooms of these apartments were considered unsuitable for roosting bats. The loft spaces were approximately 2 m tall by 6 m wide. They had wooden ridge beams and felt sarking. The sarking was torn and missing in places, exposing the roof tiles (Plate 4.10). Wasp nests, mouse droppings and rat droppings were prevalent. No evidence of bats, such as droppings or foraging remains, was however recorded.

Plate 4.9: Loft Space, B2

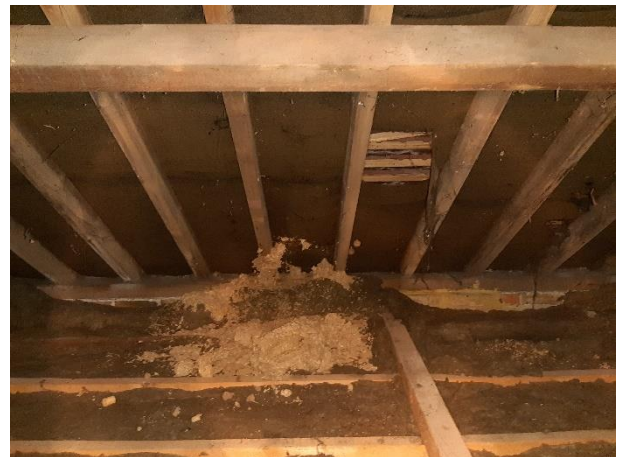
Plate 4.10: Torn Felt Sarking & Wasp Nest

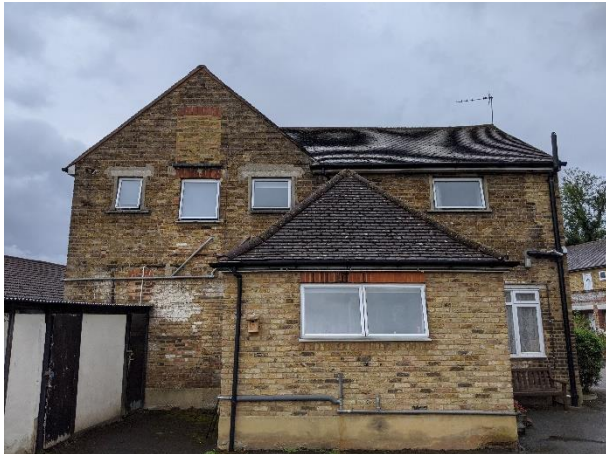
Plate 4.11: North-facing Aspect, B4

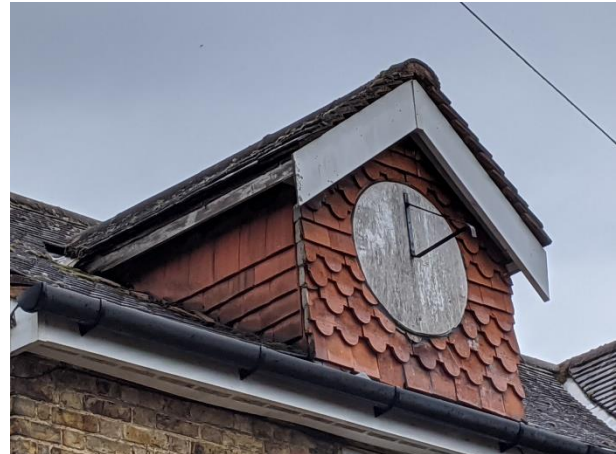
Plate 4.12: Hanging Tile Feature, B4

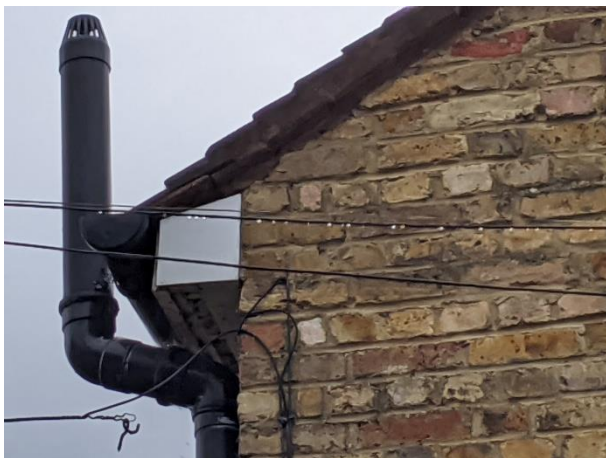
state of repair. Lifted tiles were however recorded in places. A plastic soffit box was present beneath sections of the roof, and where this soffit met the gable end there were large gaps potentially leading into the loft space (Plate 4.13). Missing mortar was also recorded in these locations underneath bottom roof tiles. No evidence of bats was recorded although not all features could be inspected fully due to the height and locations on the building. Elsewhere the structure had no suitable bat roosting features.

Plate 4.13: Gaps Around Soffit, B4

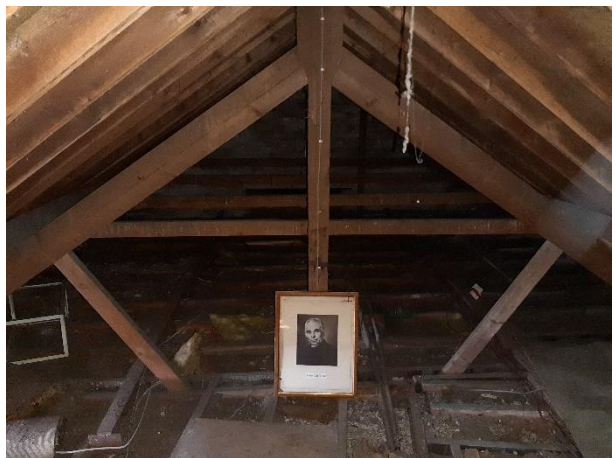
The main roof contained a loft space that was roughly T-shaped, approximately 2 m tall by 10 m wide and long. The loft space contained a water tower and had a window that illuminated approximately a third of the space. Wooden ridge beams and felt sarking were present. Light was observed entering the loft space through gaps at the eaves. No evidence of roosting bats was found during the loft inspection.

Plate 4.14: Loft Space, B4

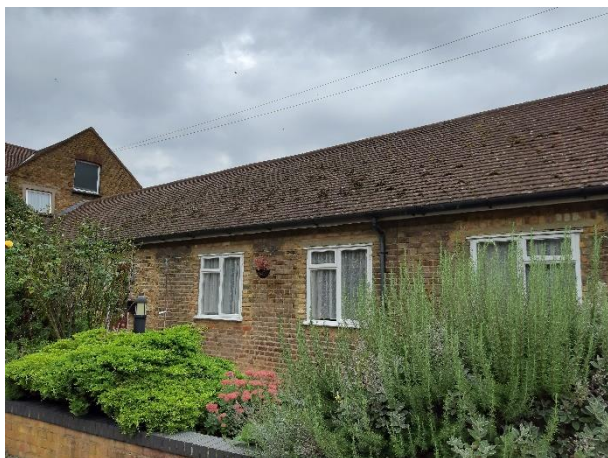
Building B5 adjoined Building B6 at its north and was a very long single-storey building (Plate 4.15). As with buildings B2 and B4 its walls were made from unrendered brickwork and its roof from clay tiles. The roof had lifted tiles and gaps under ridge tiles. The building had no soffit or fascia, and gaps leading directly into the loft space were recorded at the eaves. No evidence of bats was recorded although not all features could be inspected fully due to the height and locations on the building. Elsewhere the structure had no suitable bat roosting features.

Plate 4.15: West-facing Aspect, B5

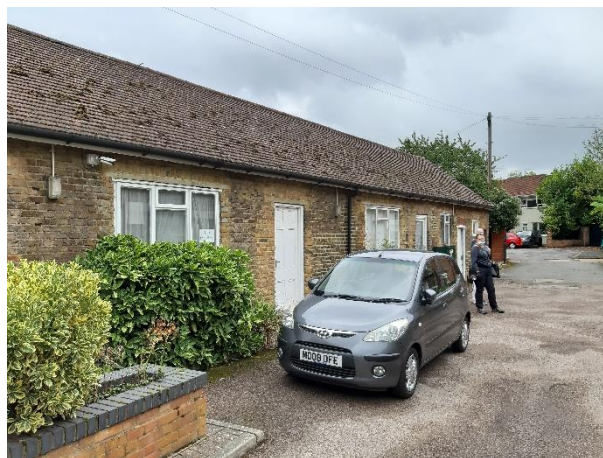
Plate 4.16: West-facing Aspect, B6

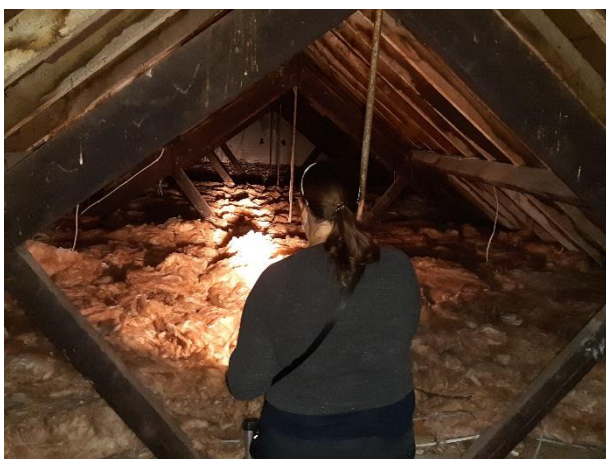
The building's internal rooms were considered both unsuitable for and inaccessible to roosting bats. The loft space was approximately 2 m tall, 6 m wide, and 40 m in length with few dividing brick walls (Plate 4.17). It

Plate 4.17: Loft Space, B6

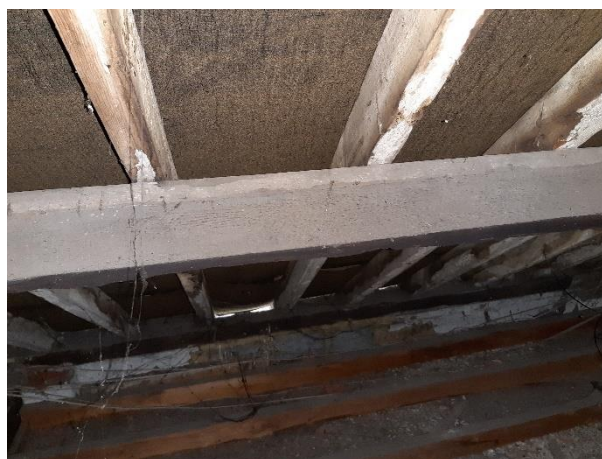
was heavily insulated and had felt sarking that appeared to be in good condition. Wooden ridge beams were present and the space was not cobwebbed. Gaps at the eaves were clearly visible (Plate 4.18).

Plate 4.18: Gaps at Eaves, Light Entering

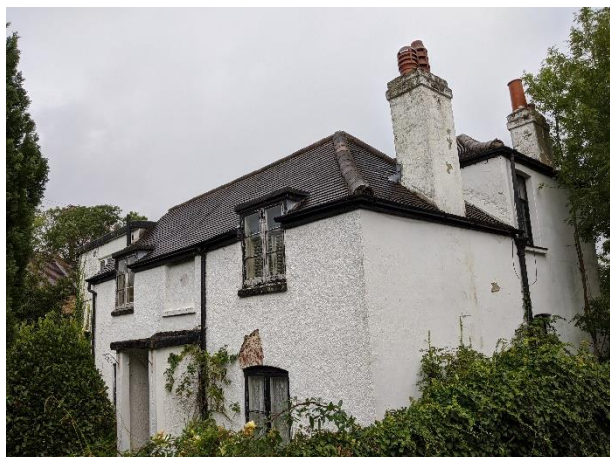
The residential cottage situated in the southeast corner of the site was of early-mid twentieth century design and had rendered brick walls (Plate 4.19). It had a pitched clay tile roof over the main section of the building, with smaller sections of flat roof to its west and north. No lifted roof tiles were recorded, and moss was observed growing around the ridge tiles, blocking any potential gaps there. Missing mortar was recorded at the lowermost ridge tiles, while lifted lead flashing at the base of the chimneys potentially concealed access points to the loft space or crevice features that might be used by roosting bats (Plate 4.20). The buildings wooden fascia boards were flush and no holes or cracks were recorded on the external walls. No evidence of bats was recorded although not all features could be inspected fully due to the height and locations on the building. Elsewhere the structure had no suitable bat roosting features.

Plate 4.19: Southeast-facing Aspect, B6

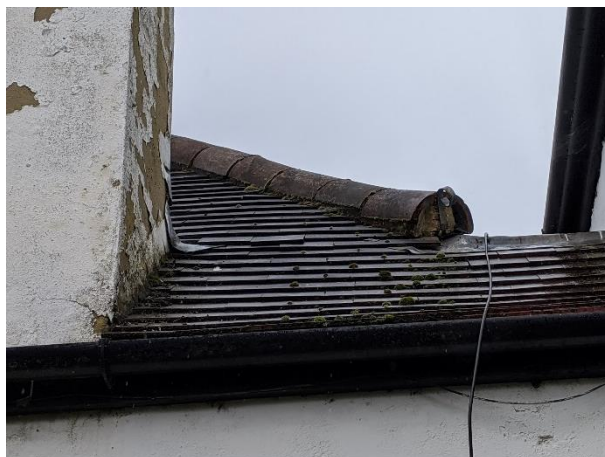
Plate 4.20: Lifted Lead Flashing & Missing Mortar, B6

Building B6 had missing mortar associated with ridge tiles and lifted lead flashing associated with its chimneys. Its loft spaces appeared to be accessible to roosting bats and therefore the building is assessed as having high potential to support roosting bats. Building B7 was in a good state of repair with the exception of a small amount of missing mortar below the roof tiles at its north-facing gable end. In consideration of this single potential roosting feature, the building is assessed as having low potential to support roosting bats.

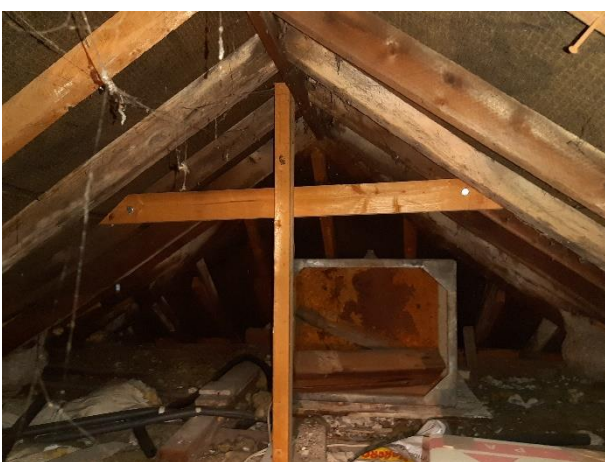
The internal rooms of the building were unsuitable for and inaccessible to roosting bats. Two loft spaces were inspected, both of which were approximately 1 m in height (Plate 4.21). Light was recorded entering the smaller loft space at the edge of the gable end where the brickwork met the tilework (Plate 4.22). Both loft spaces were very damp and wasp nests, disused bird nests, mouse droppings and rat droppings were recorded in both. Wooden ridge beams were present and the spaces were well insulated.

Plate 4.21: Larger Loft Space, B6

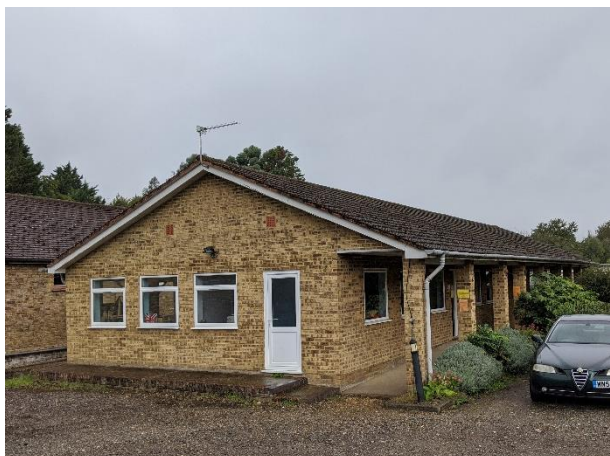
This building was a single-storey rectangular building with a pitched clay tile roof (Plate 4.23). It had unrendered brick walls and was currently in use as a horticultural and arts centre. The building appeared to be in good condition with no gaps in the brickwork nor any lifted or slipped roof tiles. Missing mortar was recorded below tiles at the north-facing gable end of the building (Plate 4.24). The building was not internally inspected due to covid-19 restrictions.

Plate 4.23: Southeast-facing Aspect, B7

The horticultural centre has been assessed as having low potential to support roosting bats. Bat Surveys: Good Practice Guidelines, published by the Bat Conservation Trust (Collins, 2016), recommends for structures with low bat roosting potential that at least one survey (consisting of either a dusk emergence survey or a dawn re-entry survey) be undertaken during the peak season for emergence/re-entry surveys (May to August) to determine the presence/absence of roosting bats within the structure. Should this survey confirm the presence of roosting bats, it will be necessary to undertake additional surveys in order to inform a Natural England licence application. In addition, should the survey identify the presence of significant levels of bat activity at the site, it may be necessary to undertake further survey visits to comprehensively assess the value of the site to bats.

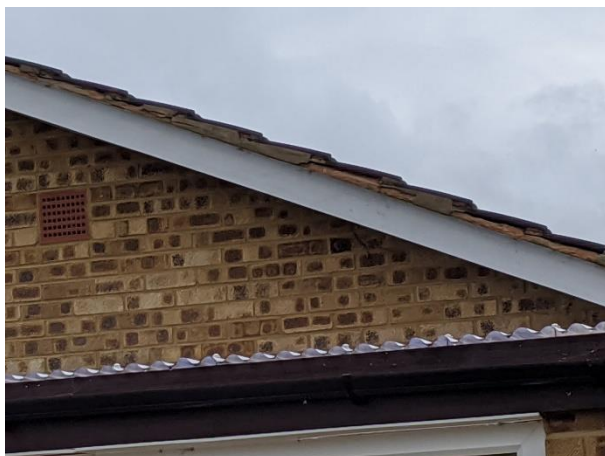
Plate 4.24: Missing Mortar, B7

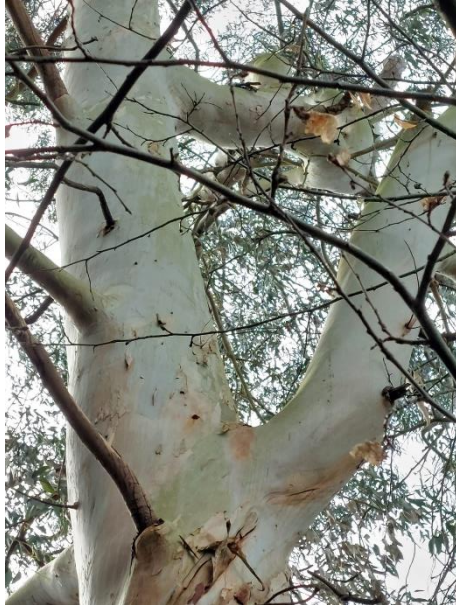
None of the trees within the development site boundary exhibited potential crevice or cavity features that might be utilised by roosting bats, such as knotholes or significant standing dead wood. The trees were therefore assessed as having low and negligible potential to support roosting bats and no further survey effort was recommended. Trees were further assessed on 14th April 2023 and not found to have developed potential roosting features.

Plate 4.29: A mature eucalyptus tree trunk devoid of potential roosting features for bats

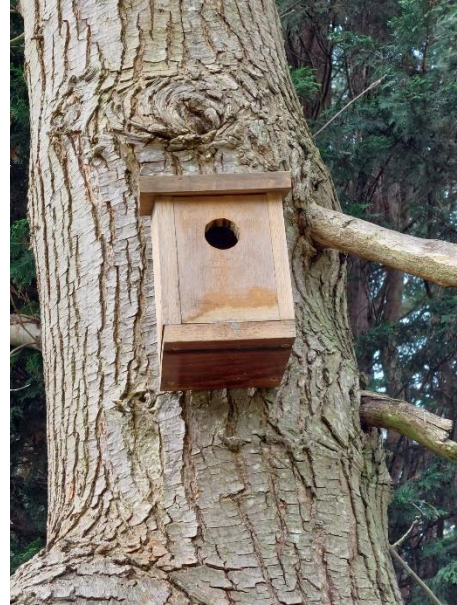
One tree at the northern boundary (approximate location <https://what3words.com/flows.foam.dart>) had a wooden bird box affixed to its trunk. This bird box was thoroughly inspected on 14th April 2023 using an endoscope and no evidence of roosting bats, such as droppings or foraging remains, was recorded within the bird box.

Plate 4.30: Bird box affixed to a tree
