Bat Survey Report

Land at 12 Claygate Lane

**12 Claygate Lane
Hinchley Wood
Esher
KT10 0AQ**

23-005
September 2023

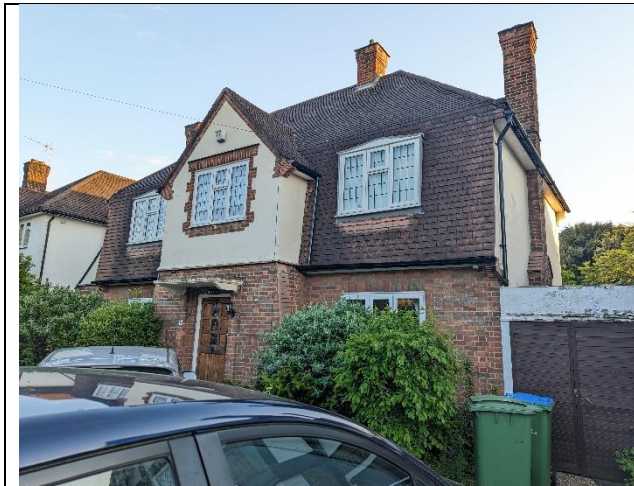
- 4.1 The building is a two-storey house of brick construction with hanging tiles cladding the upper north-eastern elevation. The tiled roof is hipped, with gabled intersecting roofs to the north-east and south-west elevations and a cat slide to the south-eastern hip.

Photograph 1: *North-east and north-west elevations*

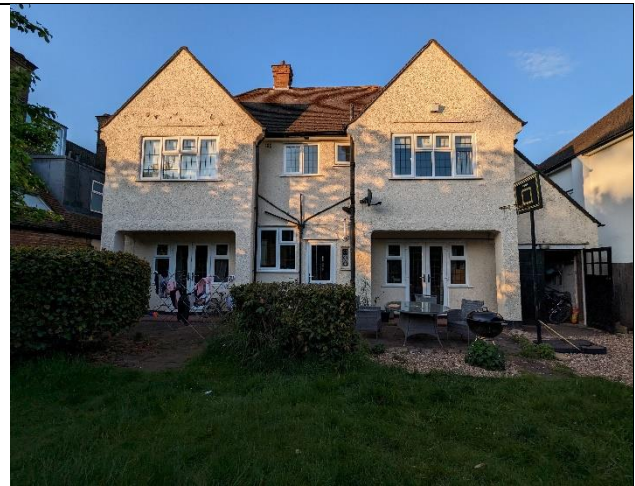
Photograph 2: *South-west elevation*

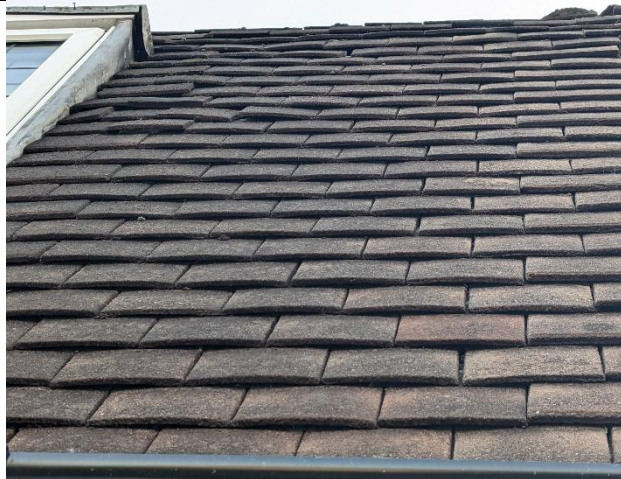
- 4.2 Numerous gaps were noted beneath lifted roof tiles on all elevations, particularly on upper courses below the ridge and alongside the hips. Gaps were also noted beneath upper courses of hanging tiles and beneath lifted lead flashing at the dormer windows. No evidence of bats was identified anywhere around the exterior of the property.

Photograph 3: *Gaps beneath hanging tiles*

- 5.2 The daytime assessment identified high potential for bats in the house on site due to numerous gaps beneath lifted roof and hanging tiles and lifted lead flashing. A small gap in timber sarking along the length of the ridge provided potential access from the ridge cavity through into the loft void, however the level of cobwebbing and lack of evidence of bats indicates that the void has not been used by void-dwelling bat species for some time, if ever.

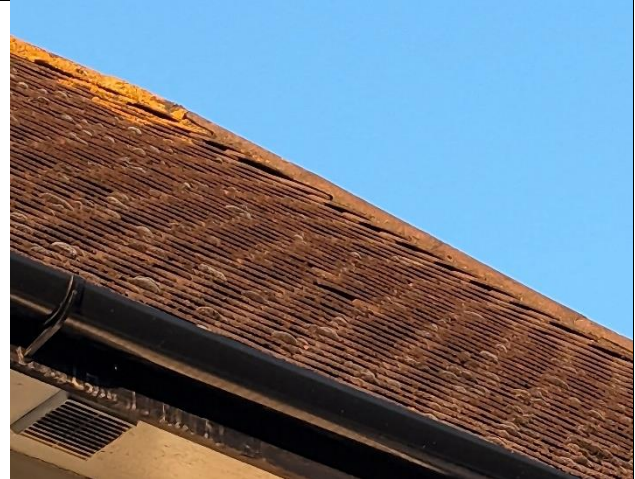
Photograph 4: *Gaps beneath roof tiles*

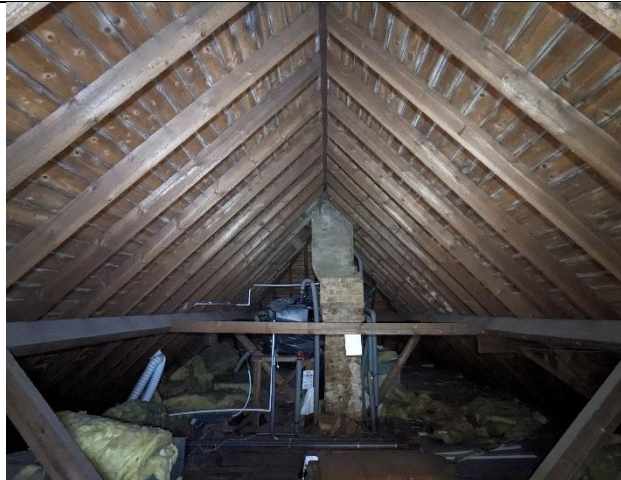
- 4.3 Internally a single large loft void is present spanning the entire property. The roof is lined internally with timber sarking and insulated at floor level with fibreglass wool. The ridge cavity was visible due to a narrow gap in the sarking, with cobwebbing noted along the majority of the ridge. The loft void was found to be largely dusty with no visible light ingress and no evidence of bats identified present.

Photograph 5: *Large loft void*

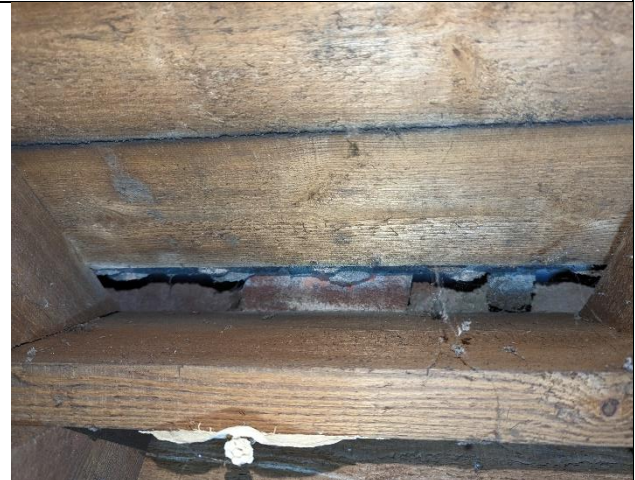
Photograph 6: *Visible ridge cavity with cobwebbing*
