**TREE SURVEY AND ARBORICULTURAL
IMPACT ASSESSMENT IN RELATION TO
PROPOSED DEVELOPMENT AT
HEATH BUILDINGS,
HIGH STREET,
OXSHOTT,
SURREY.**

Revised January 2024.

Heath Buildings Tree Root Mapping Report

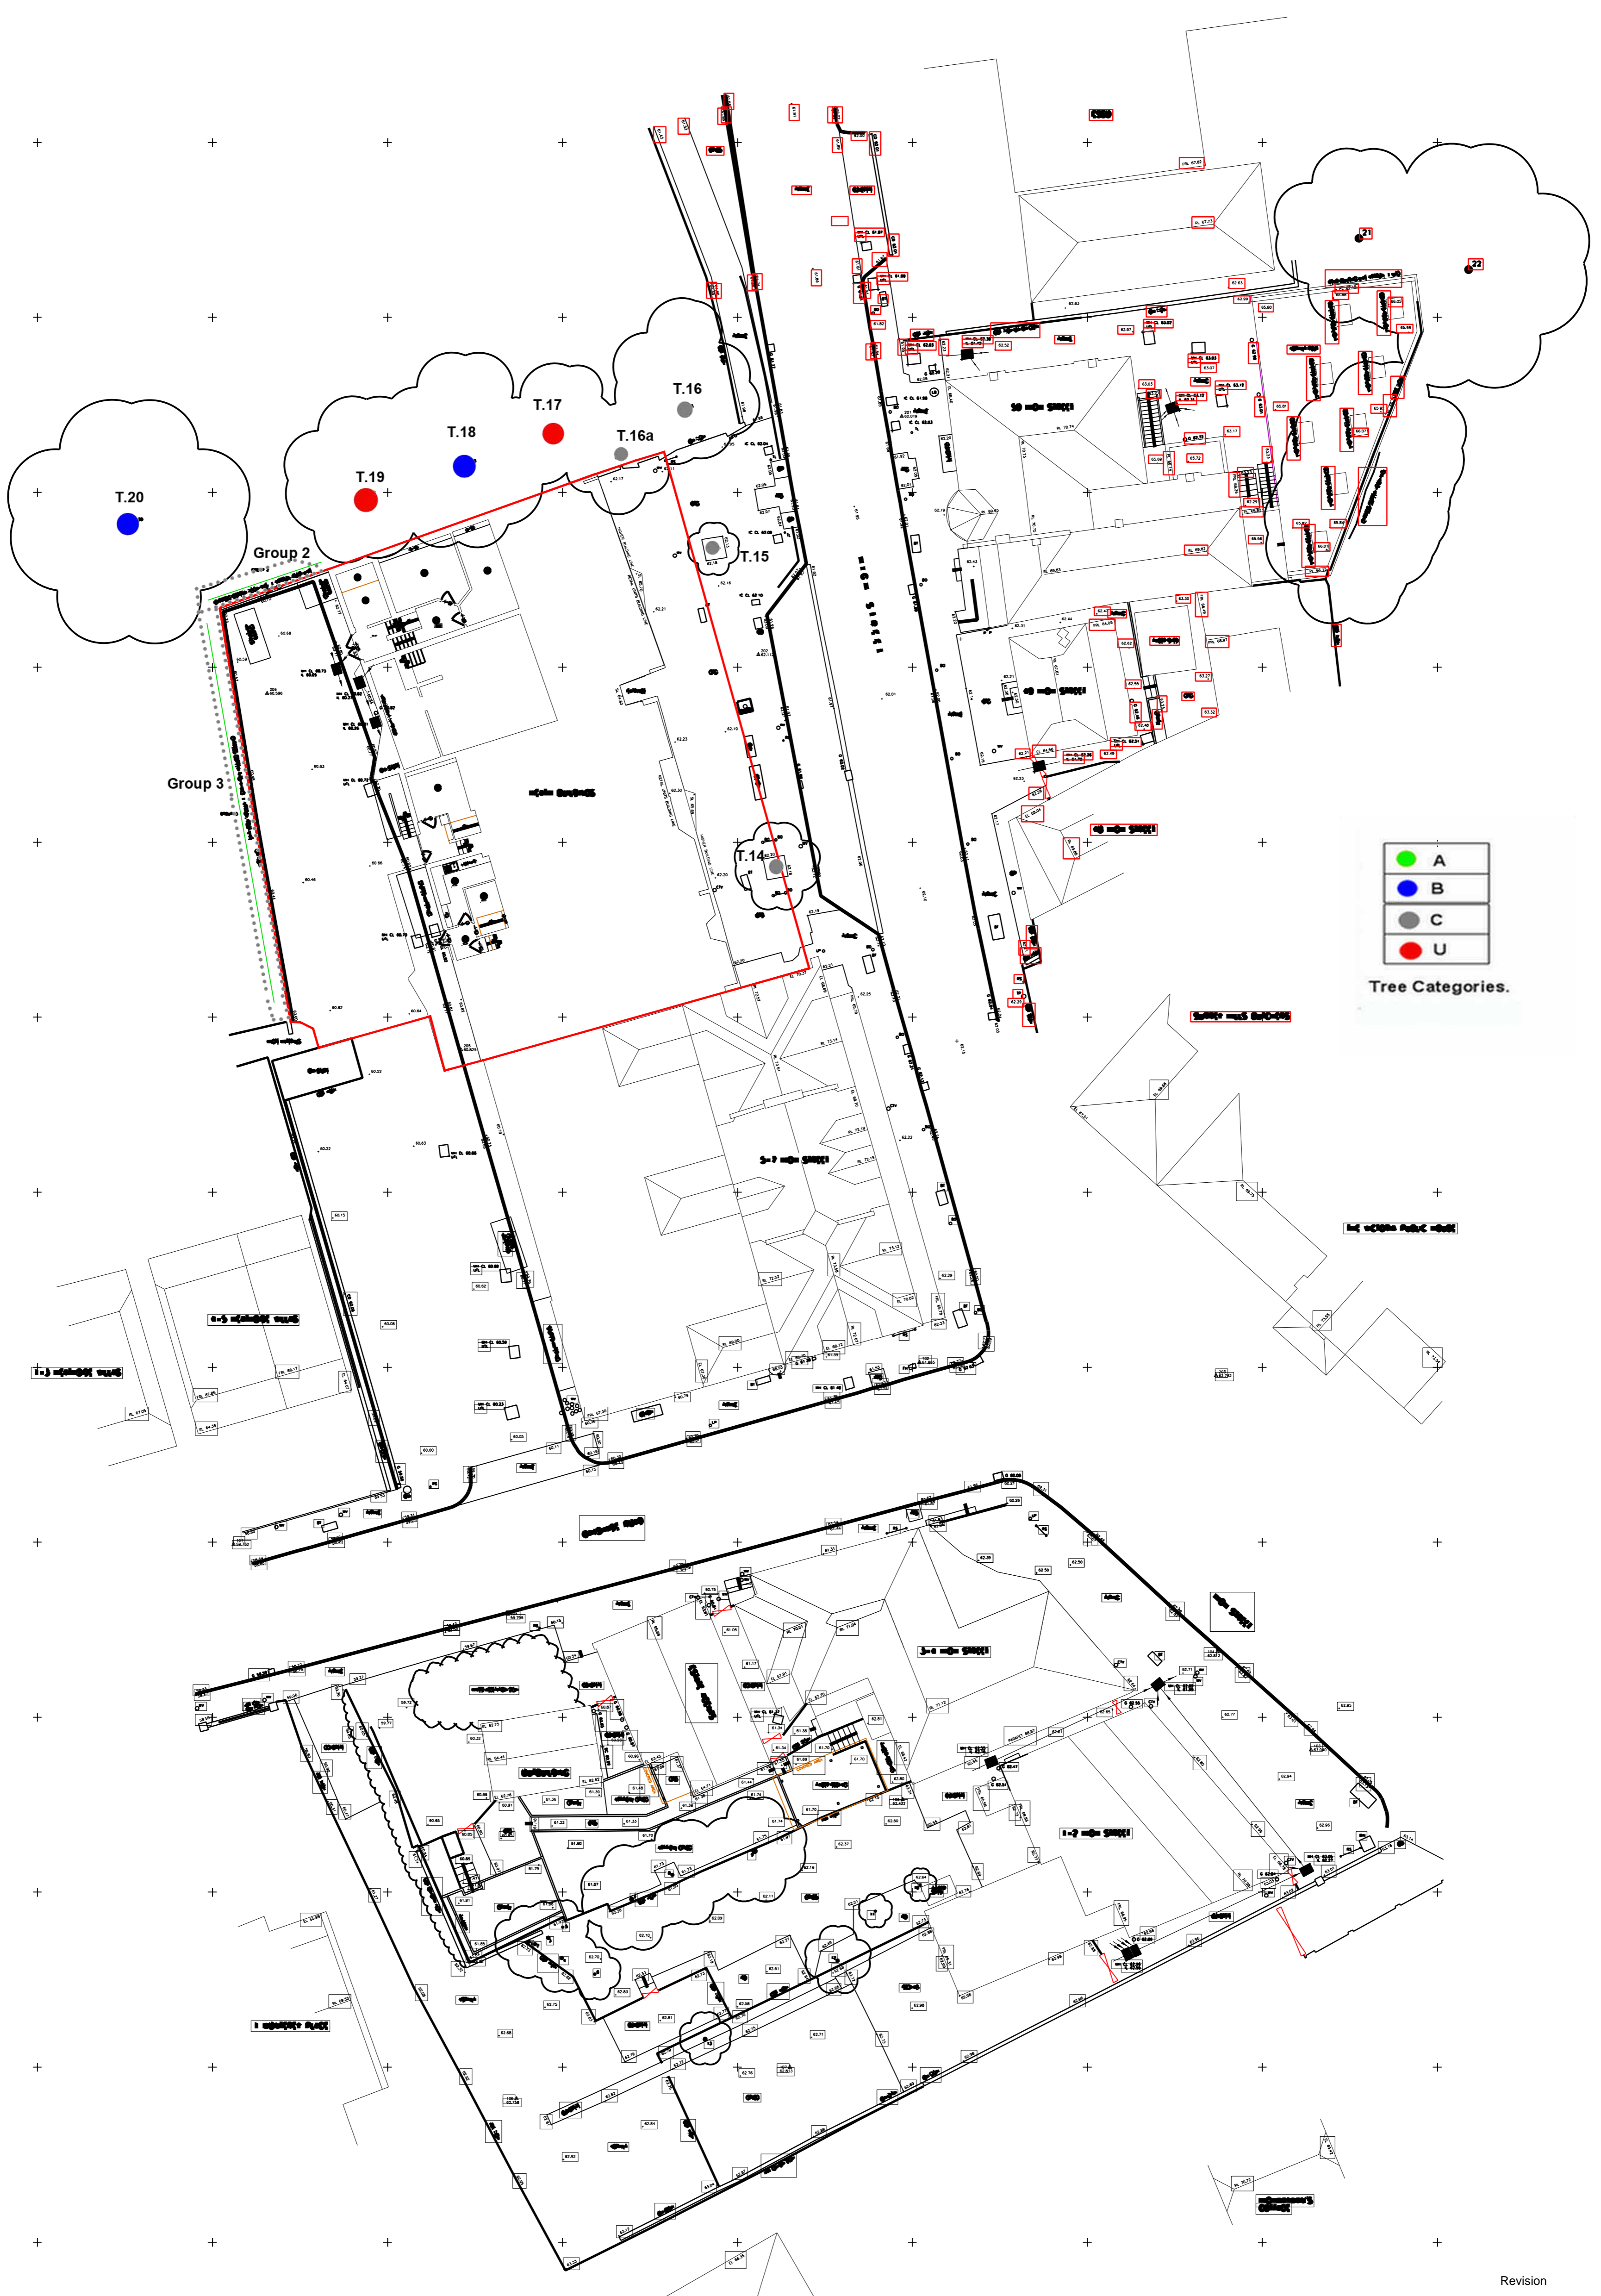
Appendix 'b'
Tree Locations.

3. I have been supplied with a copy of the existing site survey and enclose a copy of this drawing as appendix 'b' to this report which indicates the position of the trees with their respective identification numbers.

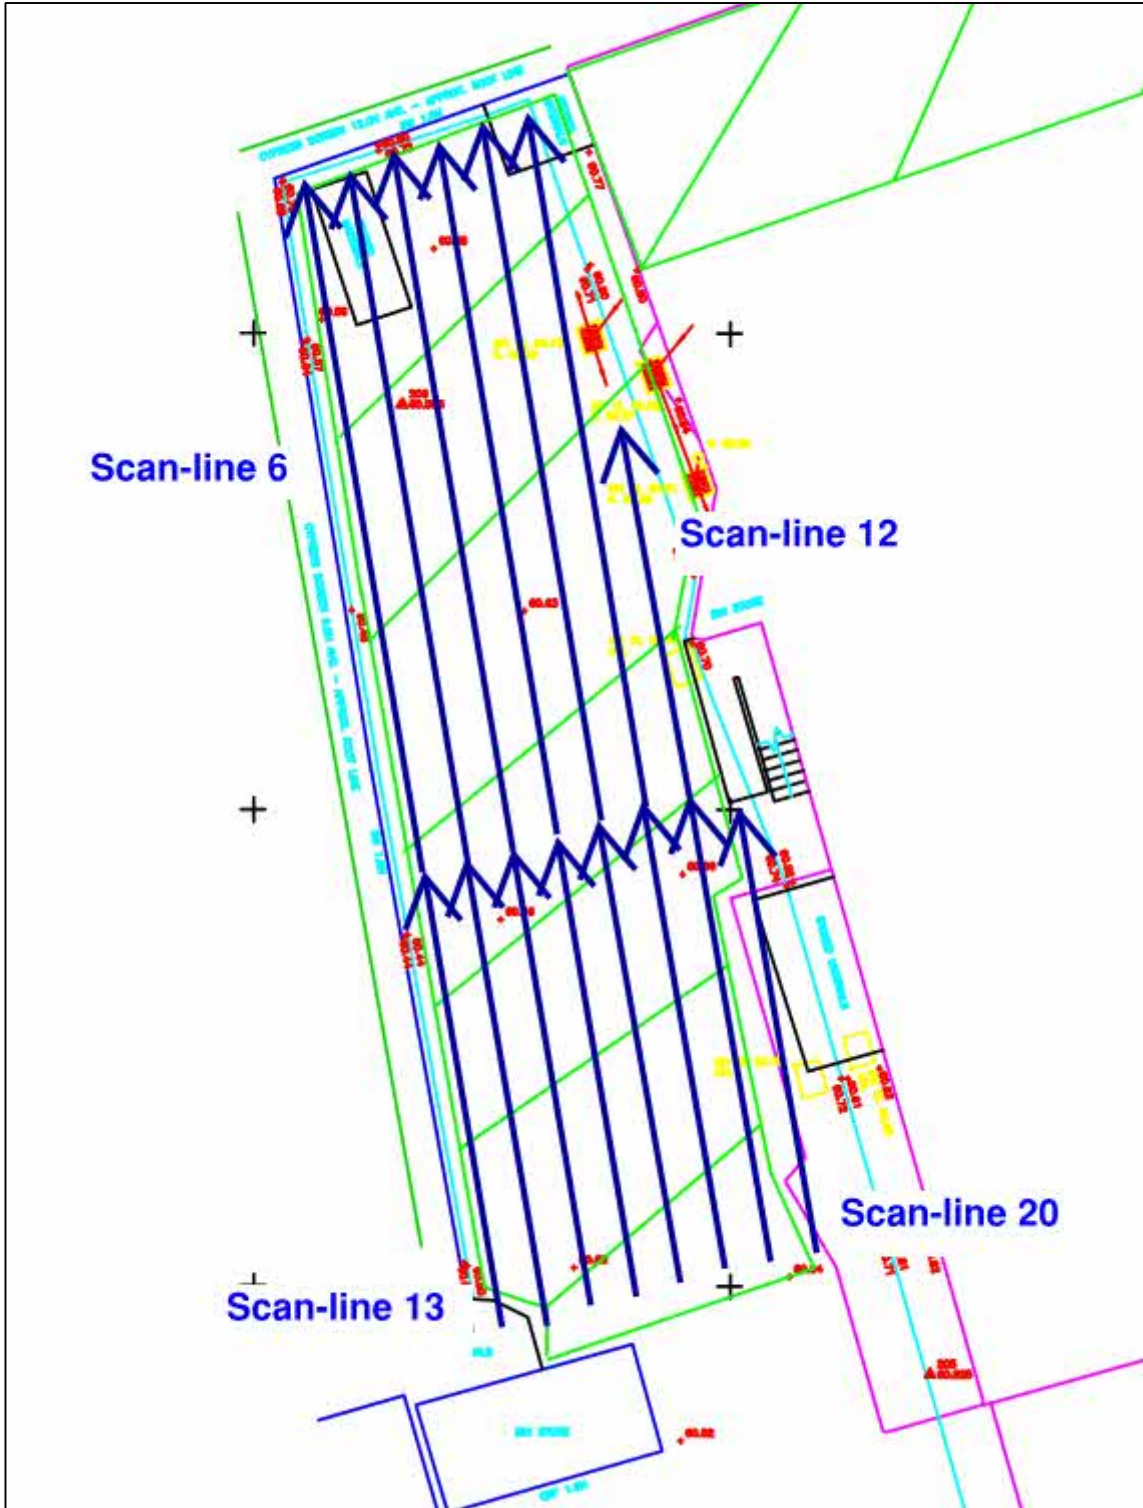
Scan-Line Layout Schematics – Section 2

Scan-lines 6-20 are located in the parking area behind Clay Hair salon (See Appendix A1). The ground conditions over the scanned area consisted of tarmac. 4 root reflectors ranging from 79-150cm depth on scan-lines 6 and 13 (500mm from boundary). These are likely attributed to the conifer hedge on the adjacent property.

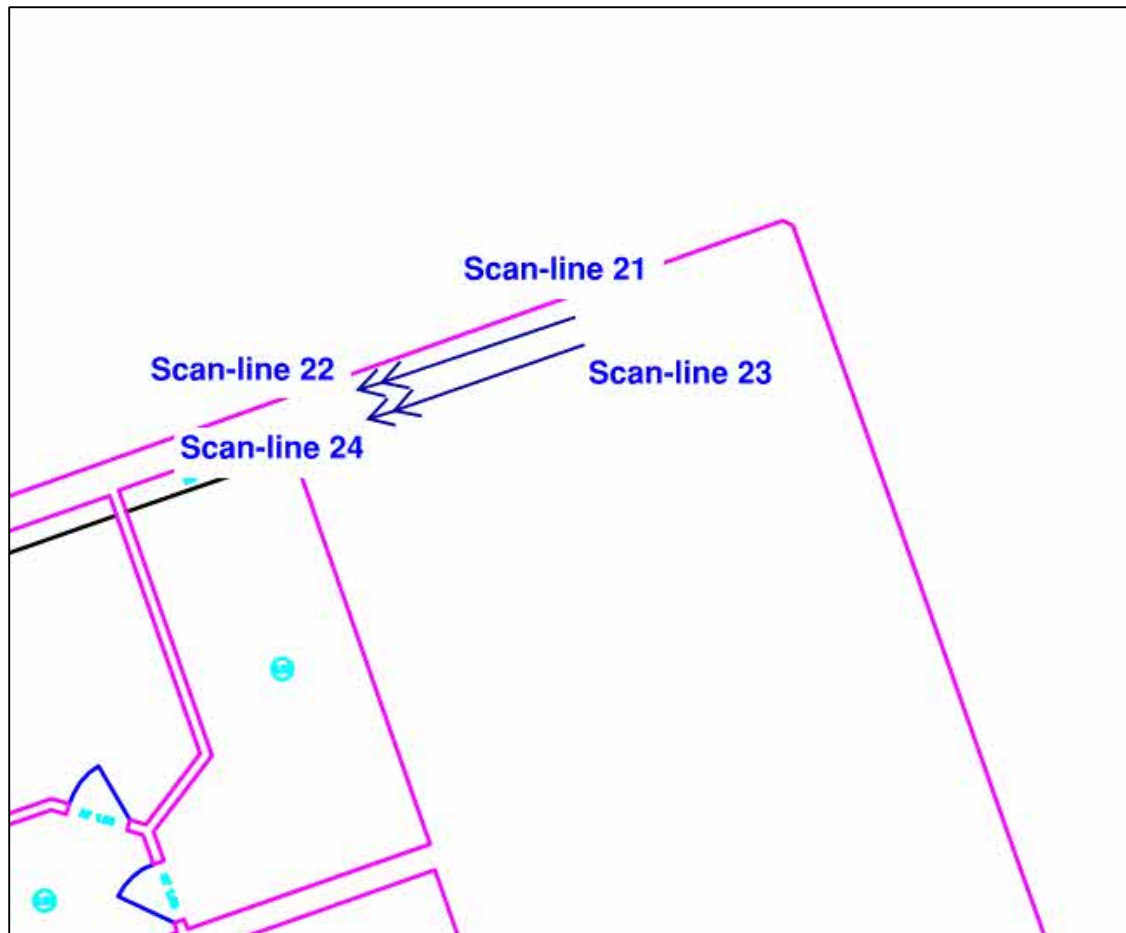
Scan-Line Layout Schematics – Section 3

Scan-lines 21-24 are located within the basement on the North side of the building (see Appendix A1). Ground conditions consist of heavily compacted desiccated soil and building rubble. No positive root reflections were detected in this area.

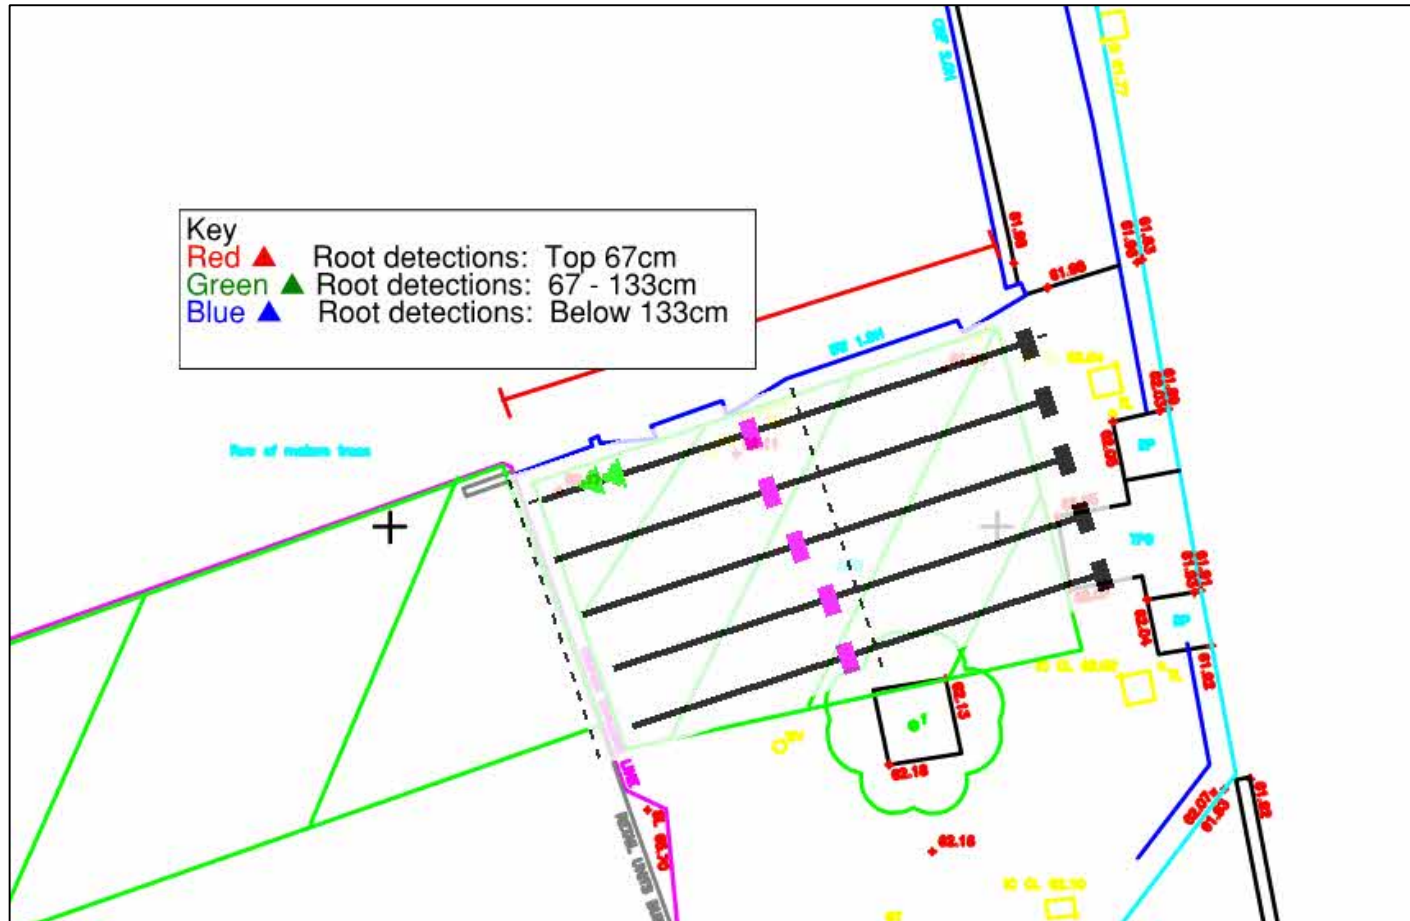
Top-Down View Root Locations – Section 1

Scan-line 1-5 are located between Clay Hair Salon and the pelican crossing (see Appendix A1). The ground conditions of the scanned area consist of paving. Two positive root reflections were detected at around 100-120cm depth on scan-line 1 (600mm from the boundary wall). These are likely attributed to the Laurel hedge adjacent to the reflection positions.
