# Orchard Lane / East Molesey

# Phase 2 land quality assessment: The Molesey Venture, East Molesey, Surrey

**Report reference:** 4224R1rev1

**Date of reporting:** 12<sup>th</sup> October 2022

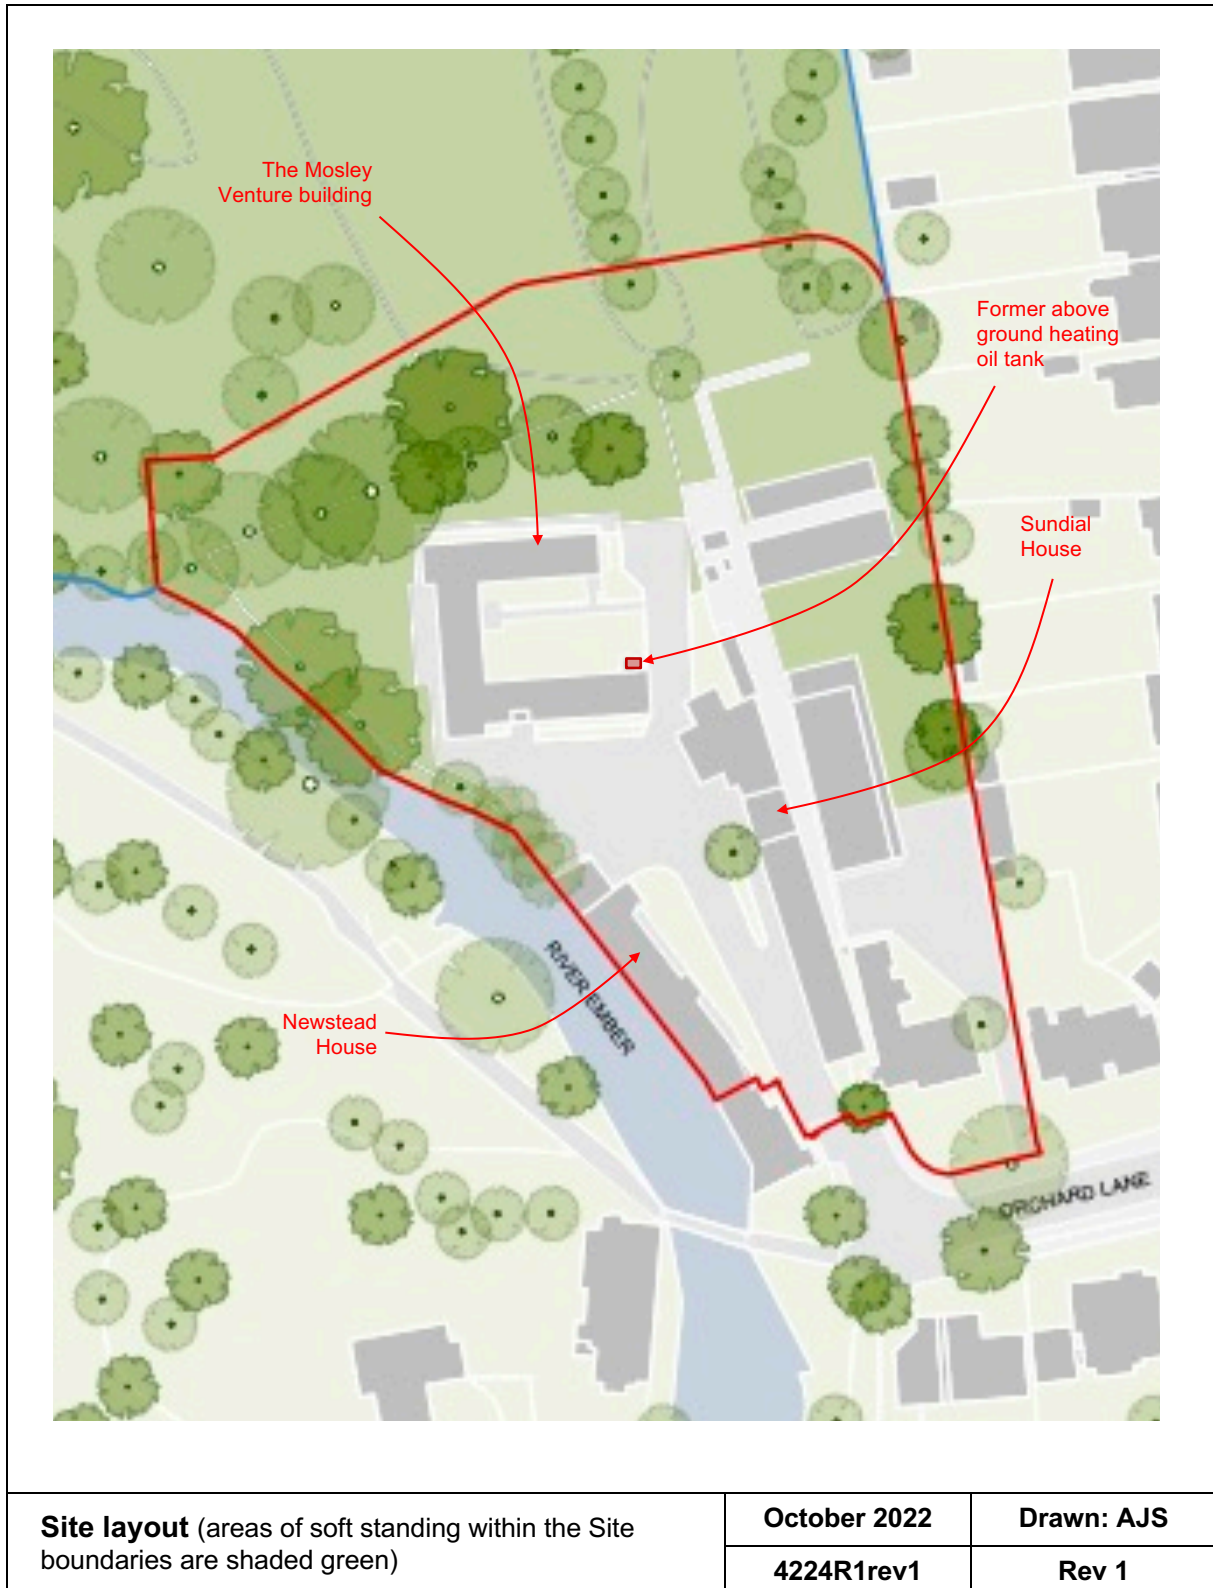
**Figure 1.2 Current Site layout**

The Site is currently occupied by a series of one and two-storey residential buildings which are used for sheltered housing / supported living accommodation. The buildings are largely surrounded by tarmac hard standing across the southern half of the Site, including access roads and parking areas. Several soft landscaped areas are present in the northern third of the Site including a vegetable garden in the north-east of the Site. The current configuration of on-Site buildings and areas of soft standing is shown on Figure 1.2.

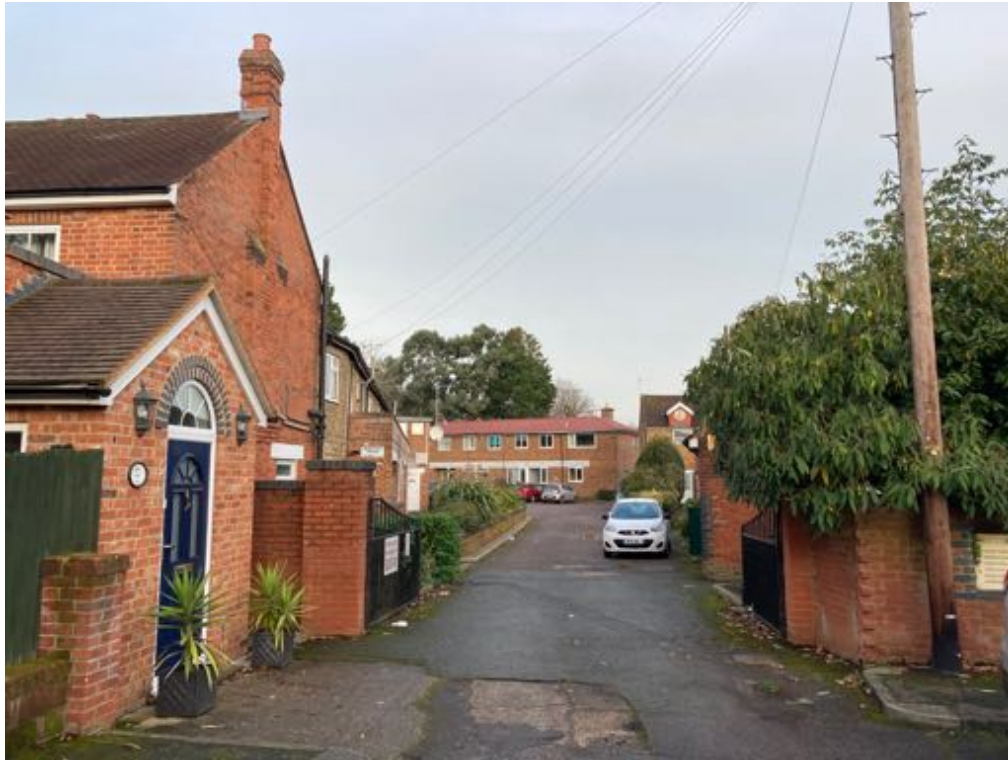
**Photograph 1**

**Description:** Main Site entrance / access road

**Location:** View from Orchard Lane; looking to the north

- The on-Site structures were of brick construction with tiled roofs (see Photographs 1 to 5, 7, 11, 12, 18, 19, 22 and 25 in Appendix C).
- The residential buildings were partly occupied at the time of the site investigation (as sheltered accommodation / assisted living).

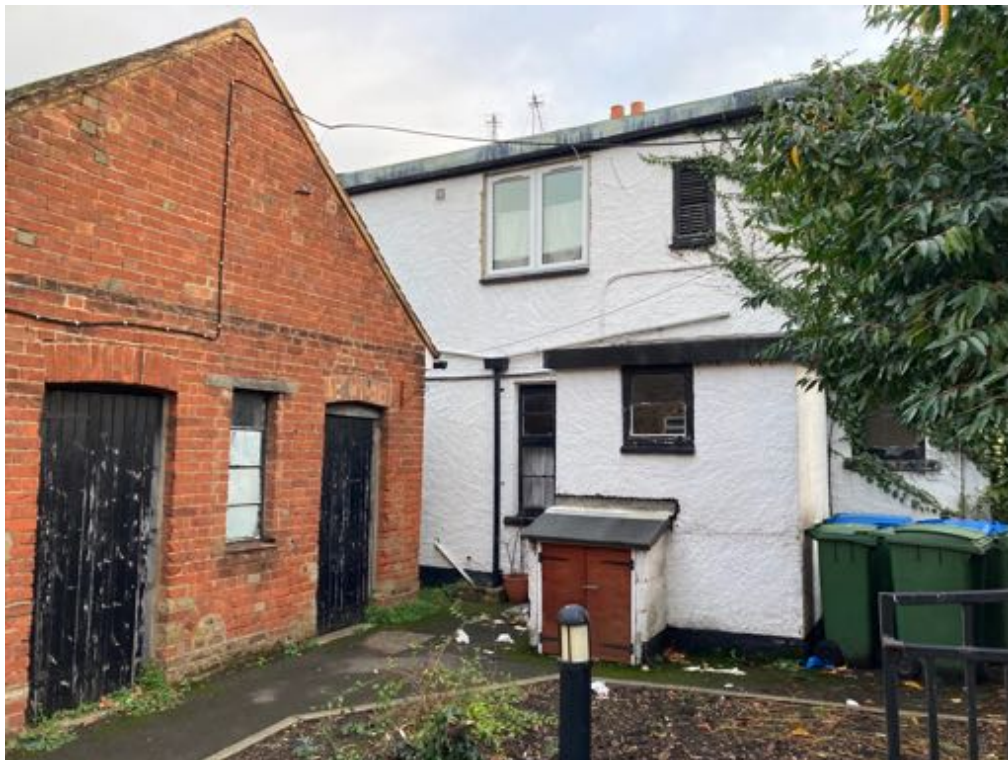
**Photograph 2**

**Description:** Lower Rivercroft property and Sundial House

**Location:** Southern end of the Site; looking to the north-east

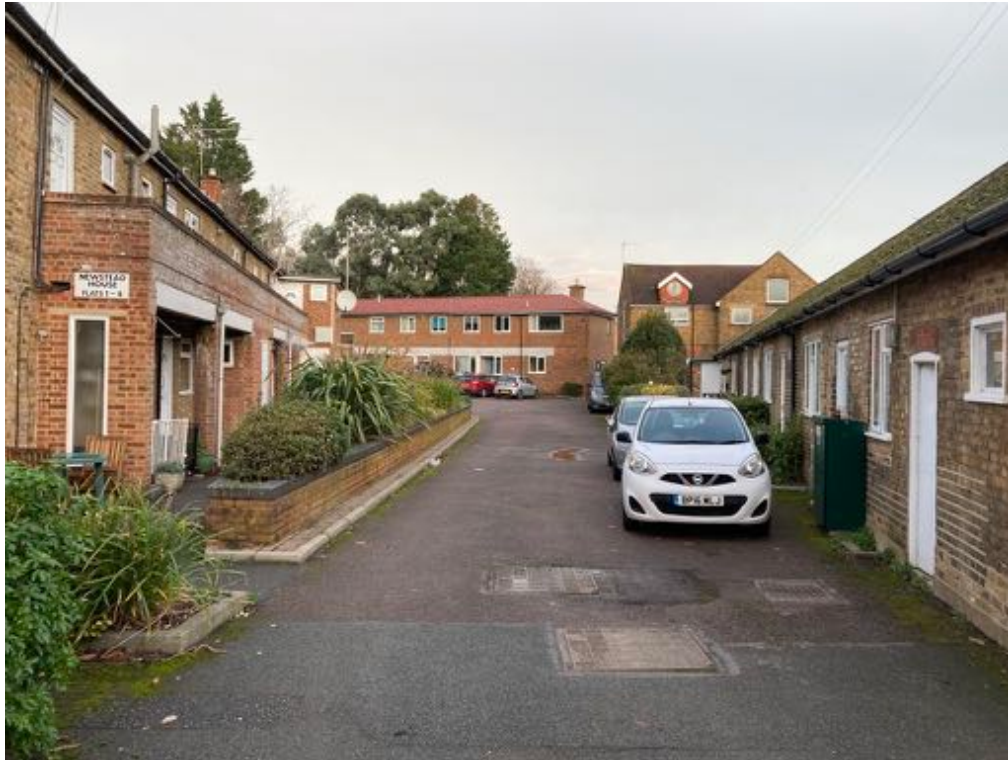
**Photograph 3**

**Description:** Site access route

**Location:** South-western part of the Site; looking to the north

- Numerous buried services were evident along the Site access route in the south-western part of the Site (see Photograph 3 in Appendix C).
- The route of a 36-inch water main (operated by Thames Water) was marked close to the northern edge of the Site.

- The southern half of the Site was largely covered by hard standing, comprising building footprints and tarmac driveways and parking areas. Raised planters were present either side of the main access route (see Photograph 3 in Appendix C) and a small grassed garden was evident in the south-east corner of the Site (see Photographs 16 and 17 in Appendix C).

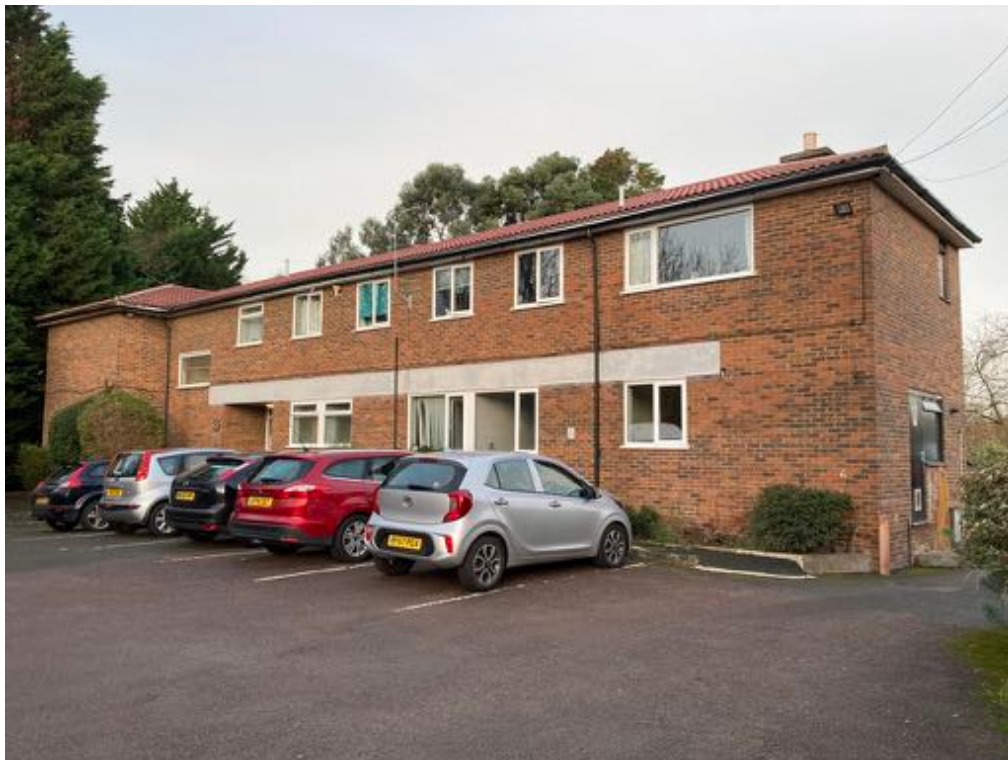
**Photograph 4**

**Description:** The Molesey Venture residential accommodation

**Location:** North-western part of the Site; looking to the north-west

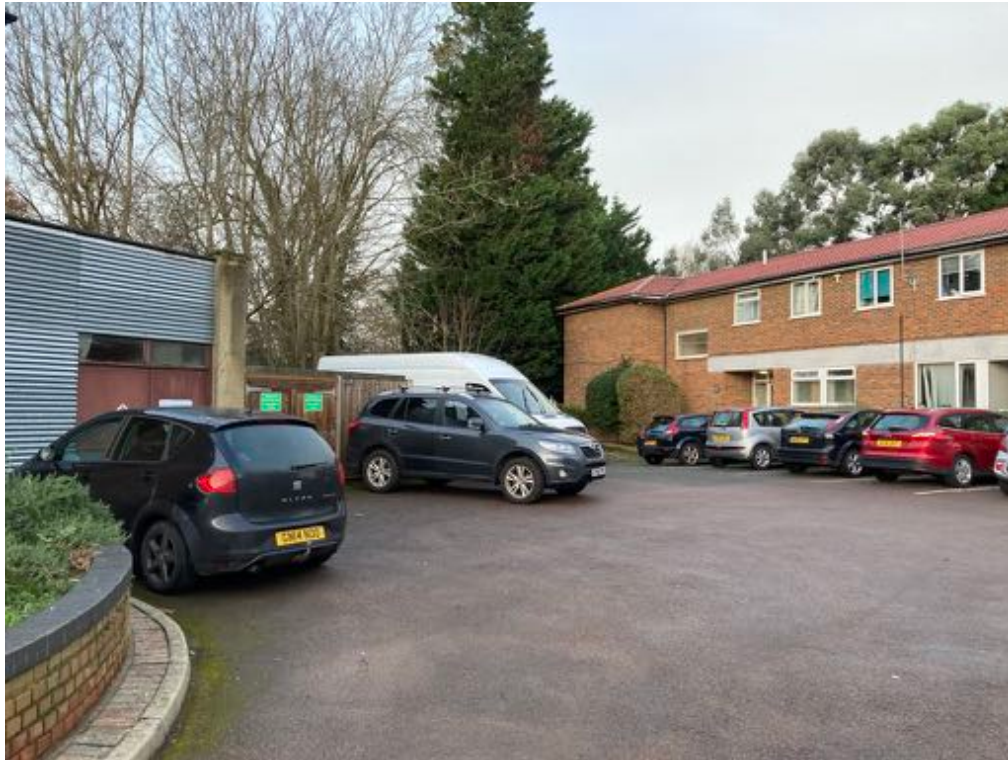
**Photograph 5**

**Description:** Car parking area in front of The Molesey Venture accommodation

**Location:** Central-western part of the Site; looking to the north-west

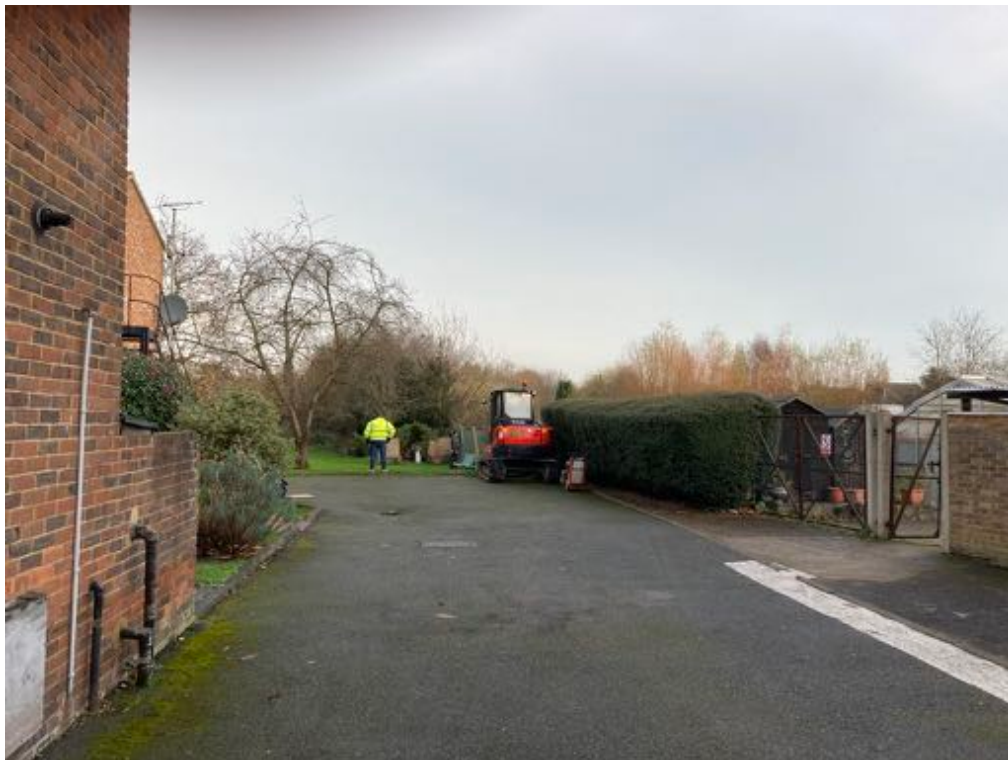
**Photograph 6**

**Description:** Northern end of Site access road

**Location:** North-central part of the Site; looking to the north

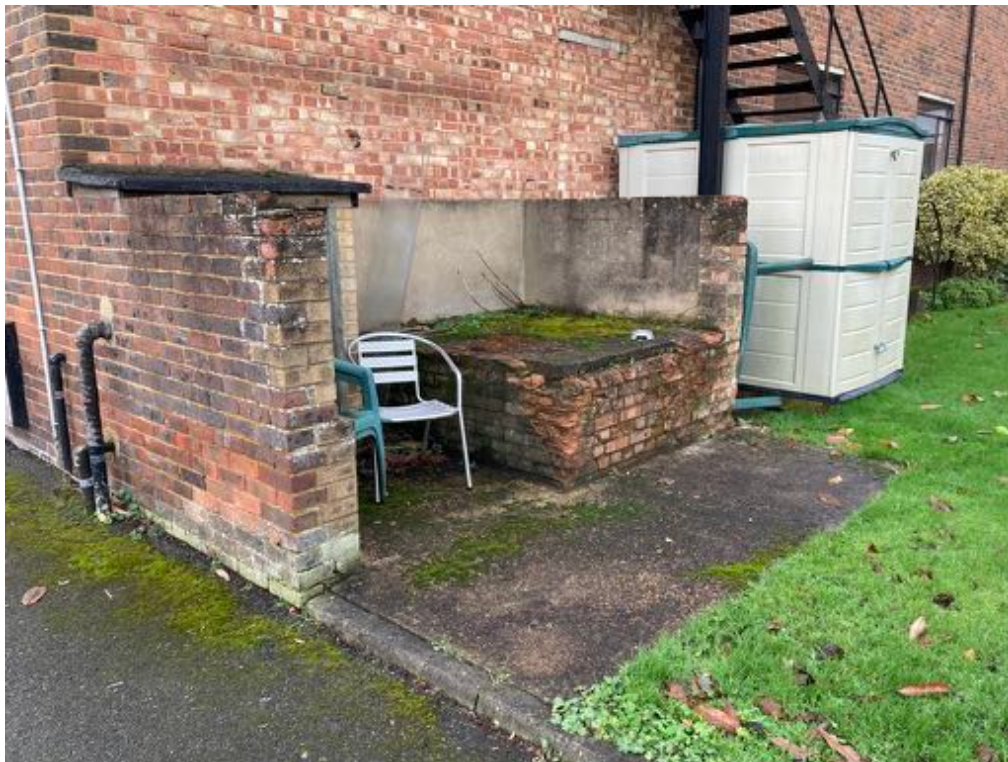
**Photograph 8**

- The location of a former heating oil tank was confirmed in the central-northern part of the Site (see Figure 3.1). Although the tank is understood to have been removed many years ago, the brick tank stand remains in situ (see Photograph 8 in Appendix C). A former transmission line was evident on the western edge of the stand (see Photograph 9 in Appendix C). The tank stand was positioned on a concrete slab of c. 0.09 m thickness. Note: trial pit TP01 identified a further concrete surface directly beneath the slab (see Photograph 31 in Appendix C). No obvious staining was observed on the concrete slab underlying the former tank position.

**Description:** Location of former above ground heating oil storage tank

**Location:** South-eastern corner of The Molesey Venture courtyard area

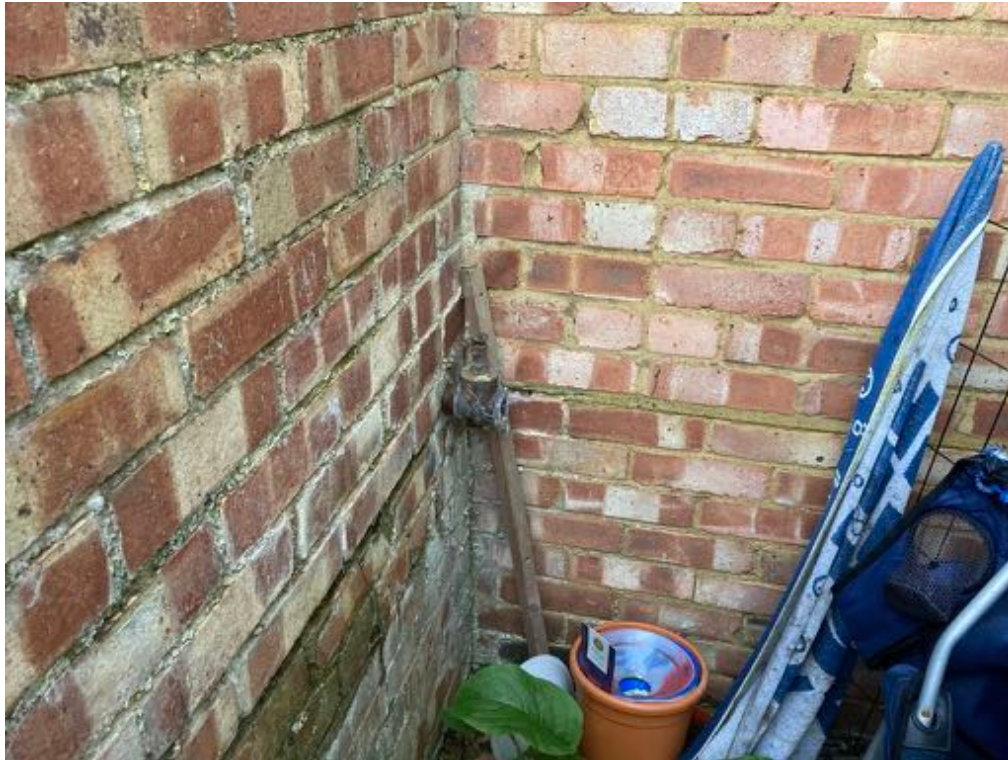
**Photograph 9**

**Description:** Fuel transmission line – former heating oil storage area

**Location:** South-eastern corner of The Molesey Venture courtyard area

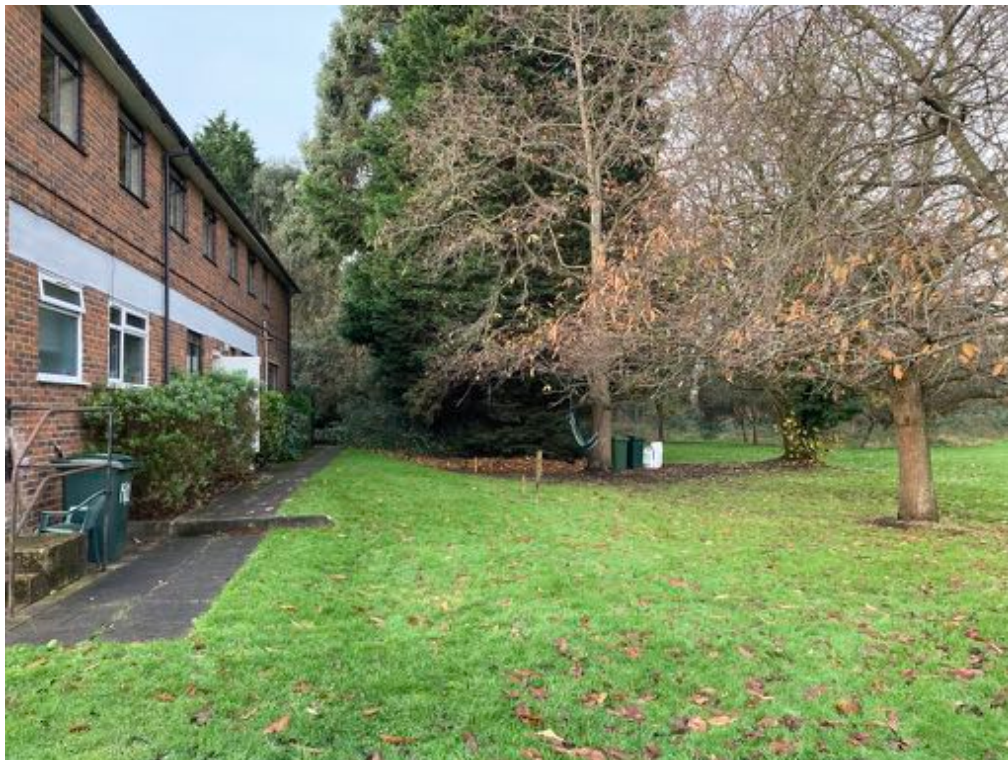
**Photograph 10**

**Description:** Grassed amenity space

**Location:** Land to the rear of The Molesey Venture accommodation; view to west

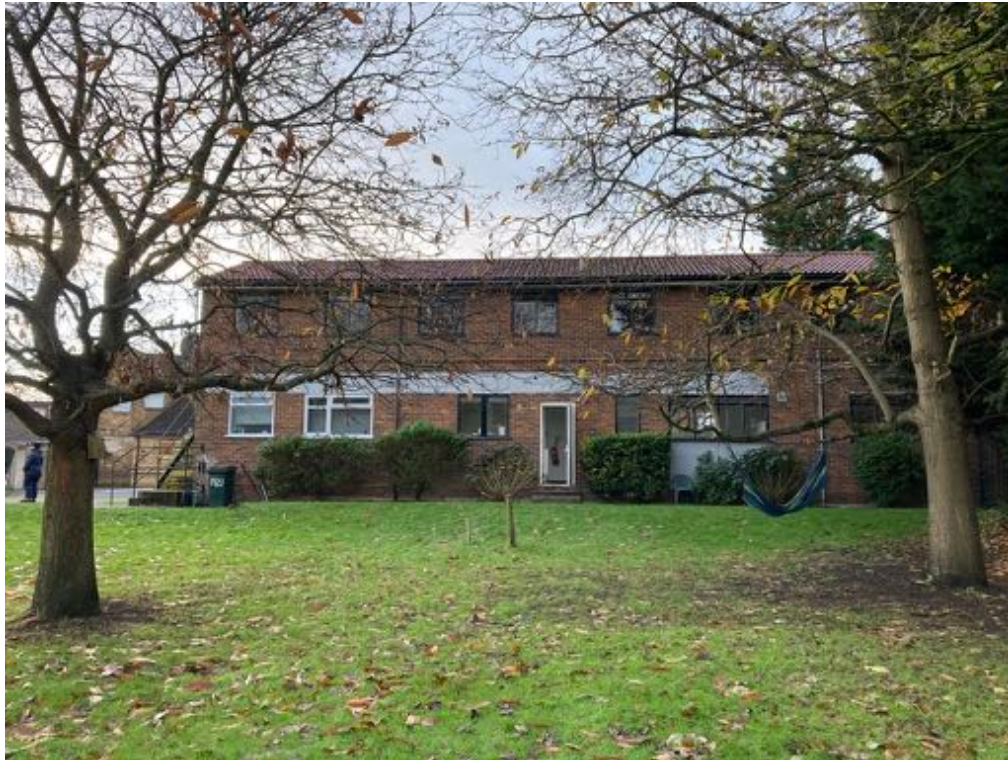
**Photograph 11**      **Description:** Rear (northern) elevation of The Molesey Venture accommodation  
**Date:** 08/12/2021  
**Location:** View from northern Site boundary; looking to the south

- Communal grassed areas were present in and around the Molesey Venture building in the north-west of the Site (see Photographs 11 to 13 in Appendix C). A large greenhouse and a vegetable garden were present in the north-east of the Site (see Photograph 24 in Appendix C), alongside a gravelled garden with multiple raised beds / planters (see Photograph 21 in Appendix C).

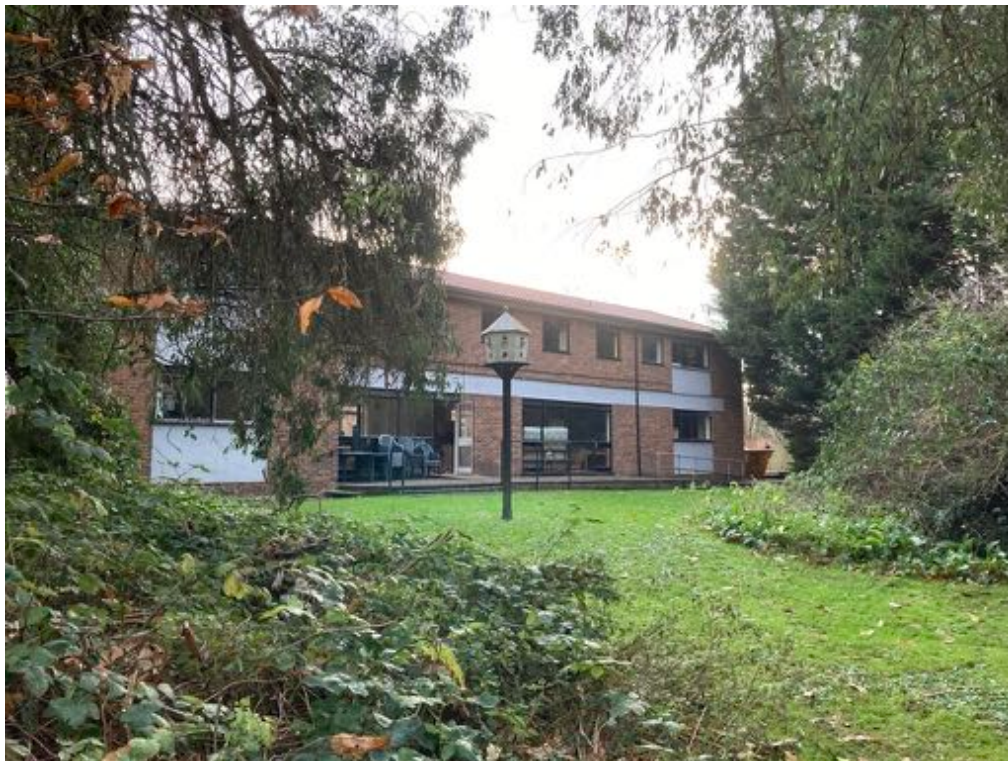
**Photograph 12**      **Description:** Western elevation of The Molesey Venture accommodation  
**Date:** 08/12/2021  
**Location:** View from north-western corner of Site; looking to the south-east

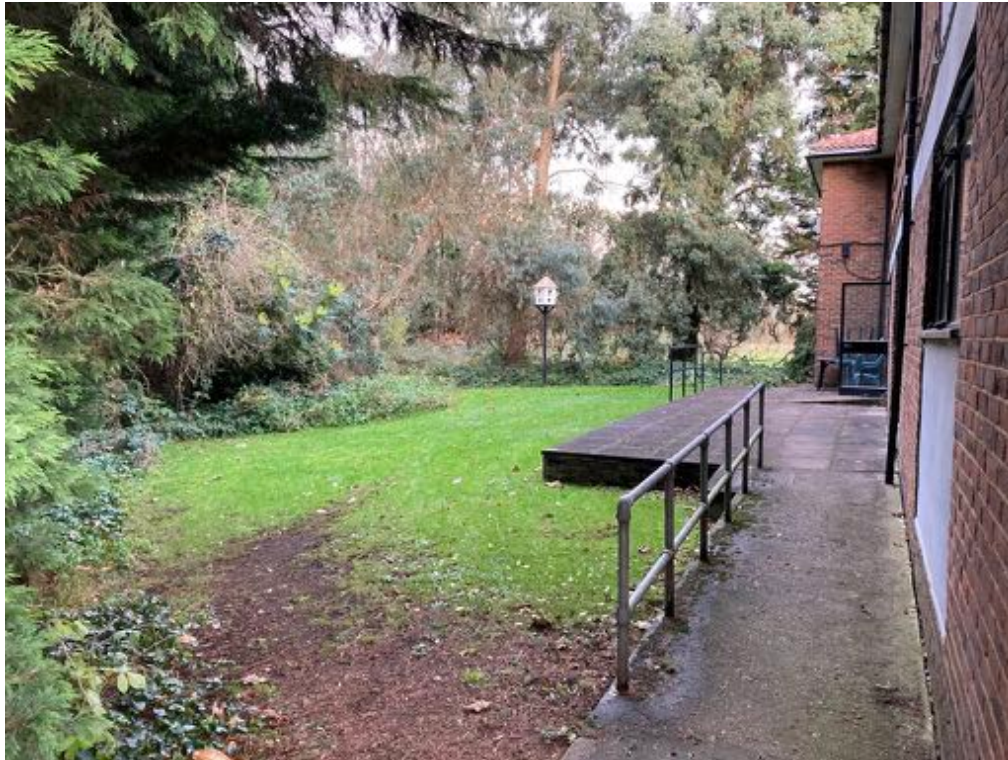
**Photograph 13**

**Description:** North-western corner of the Site

**Location:** View from south-western corner of The Molesey Venture: looking to north

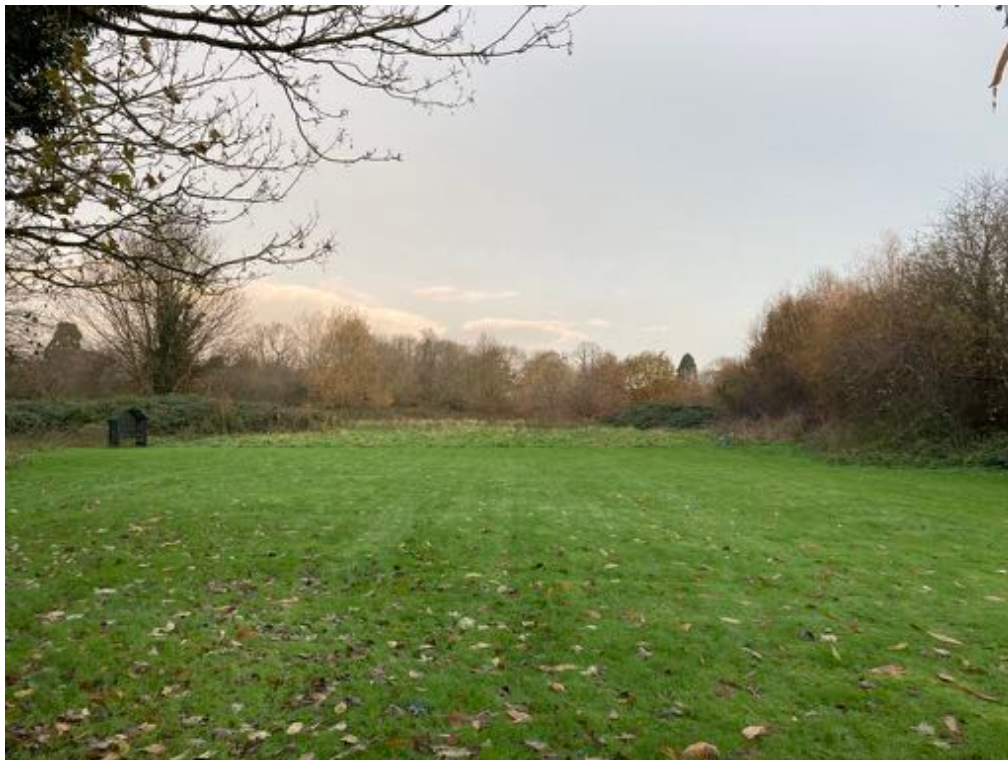
**Photograph 14**

**Description:** Grassed area directly to north of application Site

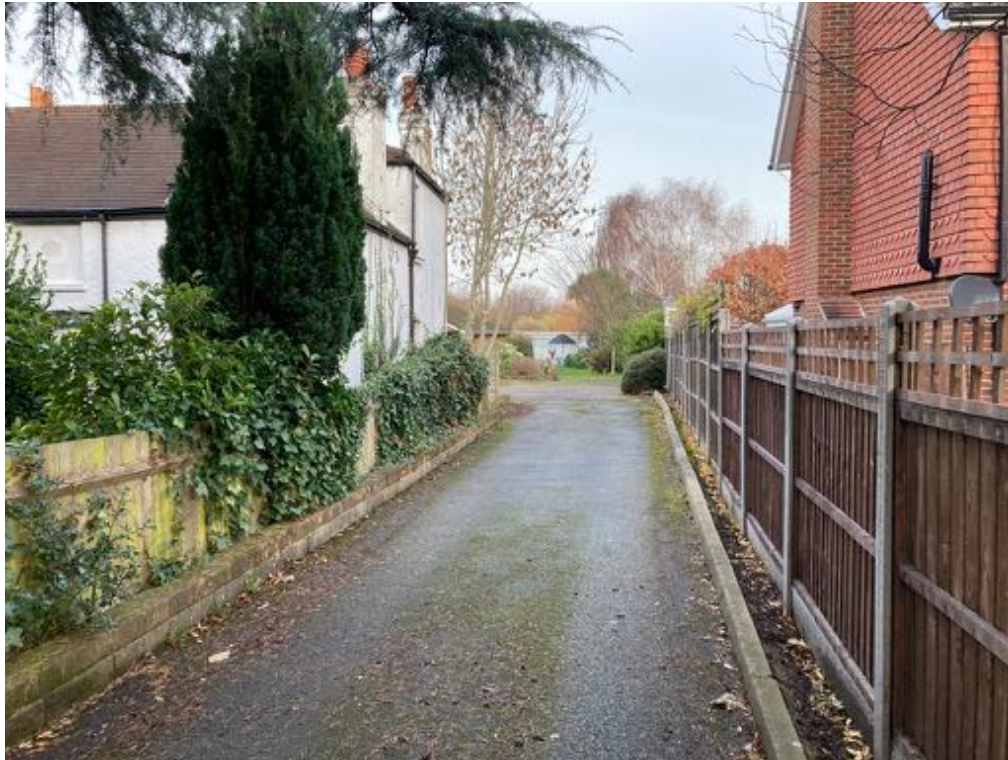
**Photograph 15**

**Description:** Secondary Site entrance (off Orchard Lan)

**Location:** View from south-eastern corner of the Site; looking to the north

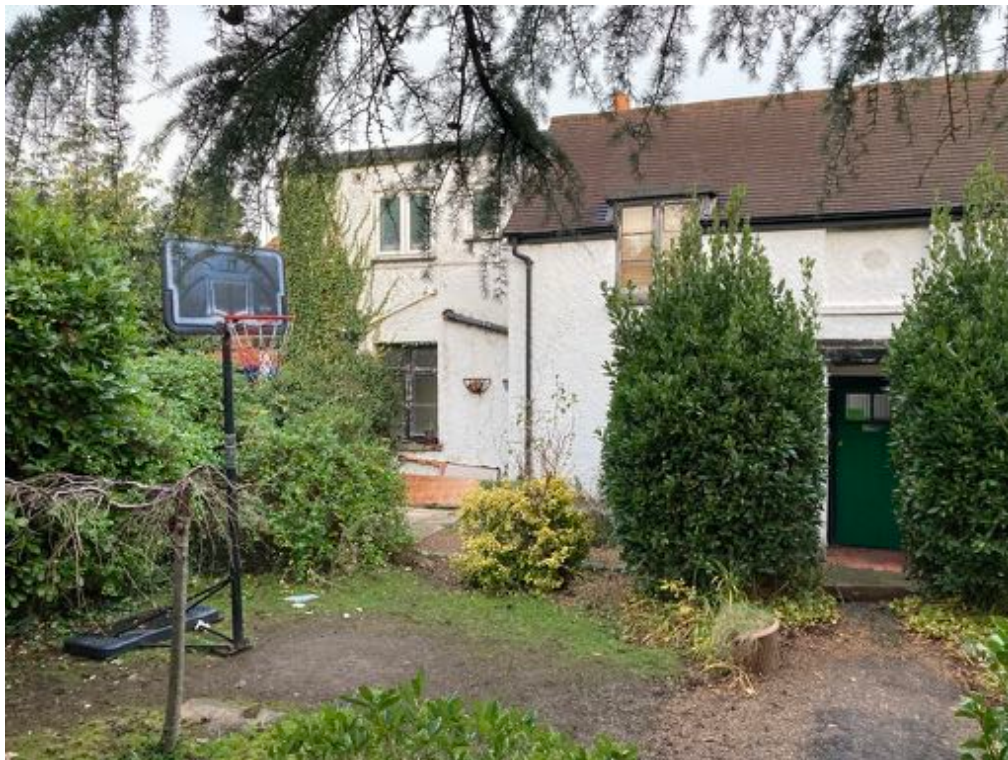
**Photograph 16**

**Description:** Lower Rivercroft property (residential use)

**Location:** Southern end of the Site; looking to the north

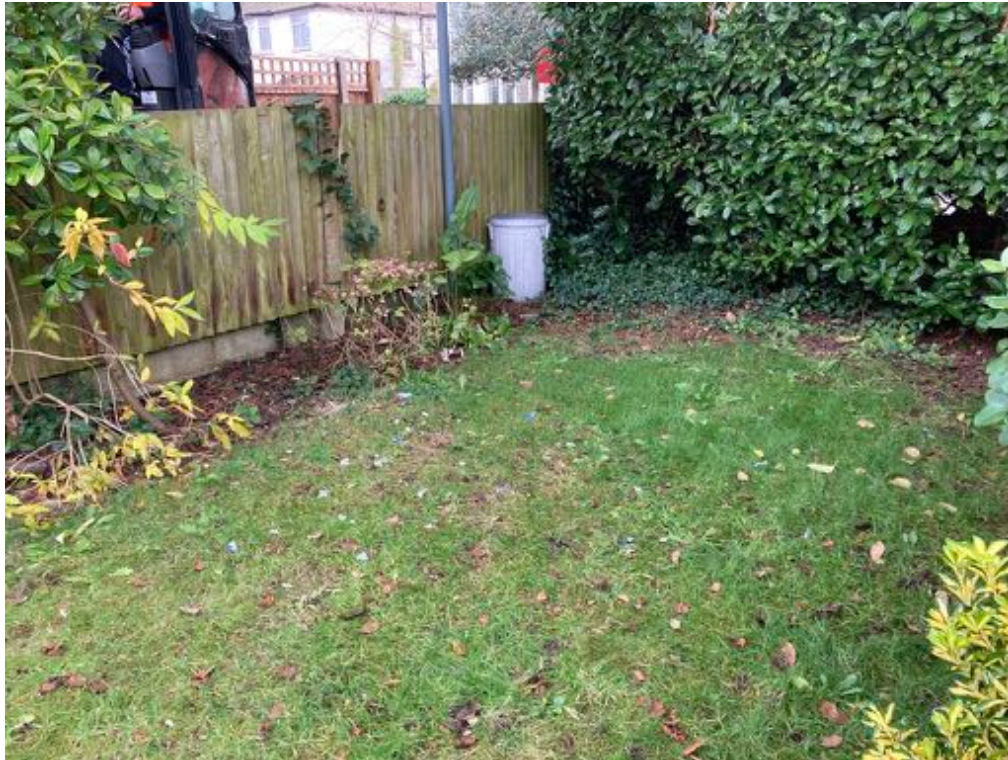
**Photograph 17**

**Description:** Front garden to the Lower Rivercroft property

**Location:** Southern end of the Site; looking to the south-east

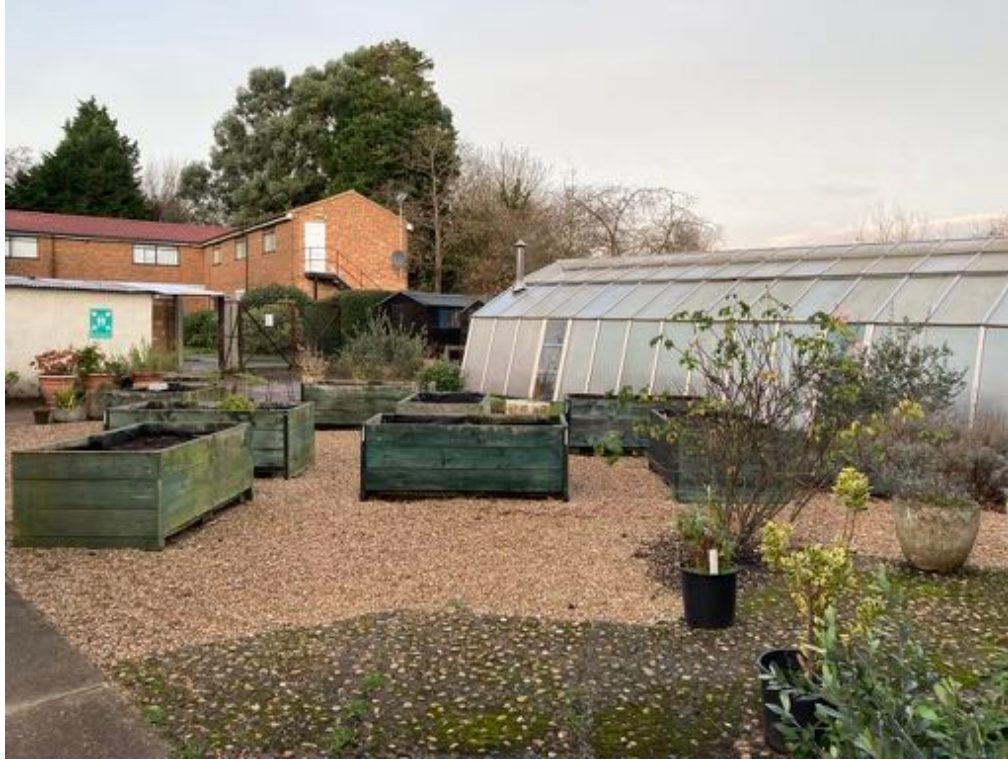
**Photograph 21**

**Description:** Former garden area and greenhouse

**Location:** Eastern part of the Site; looking to the north-west

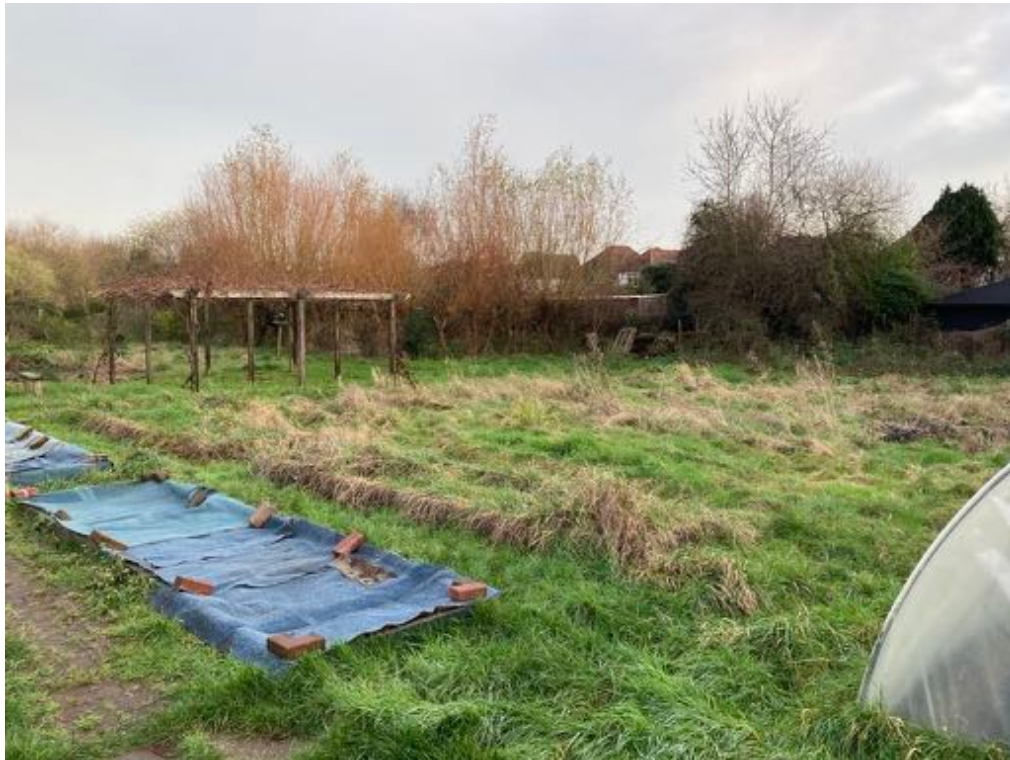
**Photograph 24**

**Description:** Former vegetable plot

**Location:** North-eastern part of the Site; looking to the north-east

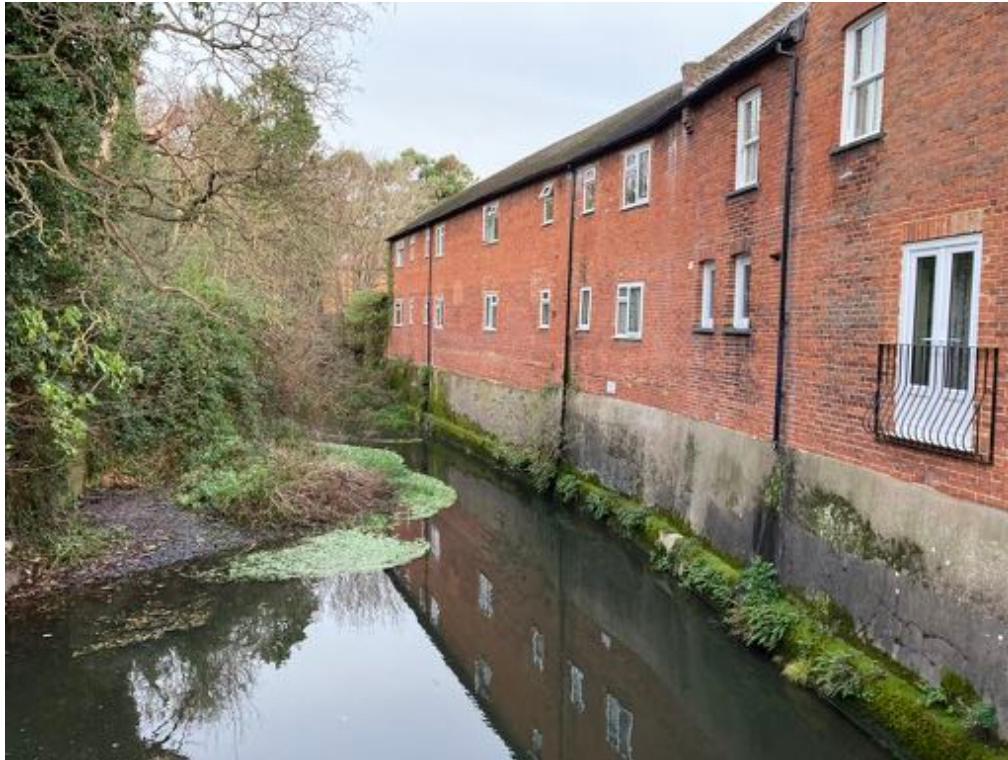
**Photograph 25**      **Description:** Rear of Newstead House and adjacent watercourse  
**Date:** 08/12/2021  
**Location:** South-western Site boundary; looking to the north

- A brick and concrete engineered wall was evident along the western Site boundary; see Photographs 25 to 27 in Appendix C. At the time of the site investigation the adjacent river stage was between 1.5 m and 2.0 m below the Site ground level.

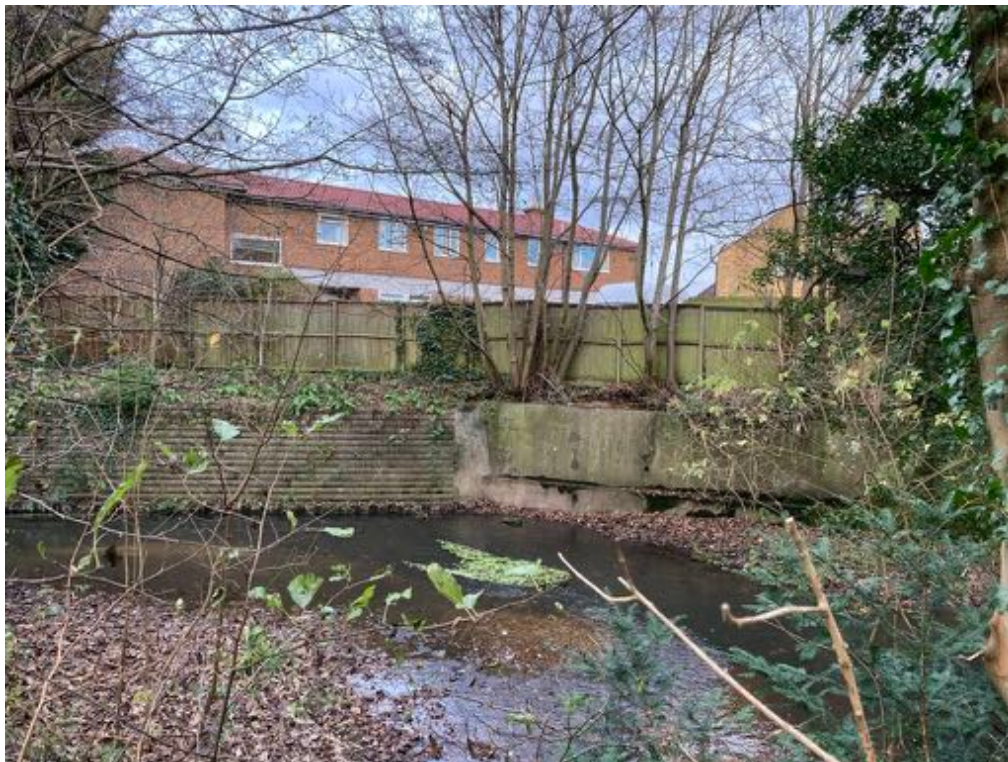
**Photograph 26**      **Description:** Central-western Site boundary and adjacent watercourse  
**Date:** 08/12/2021  
**Location:** View from third party land to the west of the stream; looking to the east

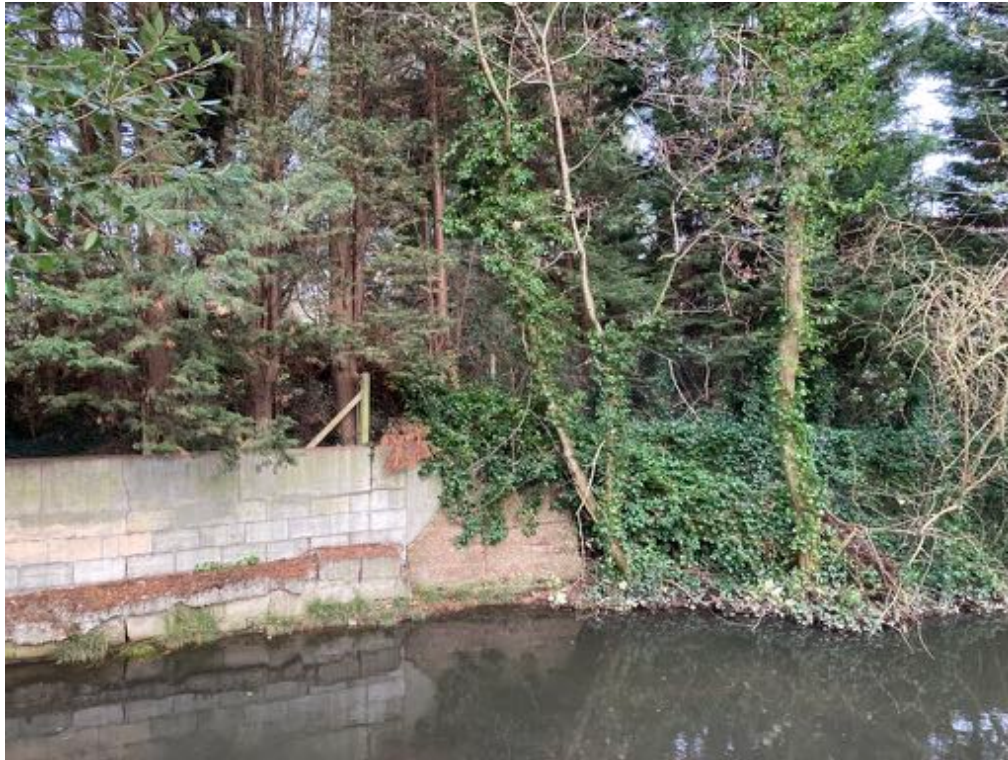
**Photograph 27**

**Description:** North-western Site boundary and adjacent watercourse

**Location:** View from third party land to the west of the stream; looking to the east

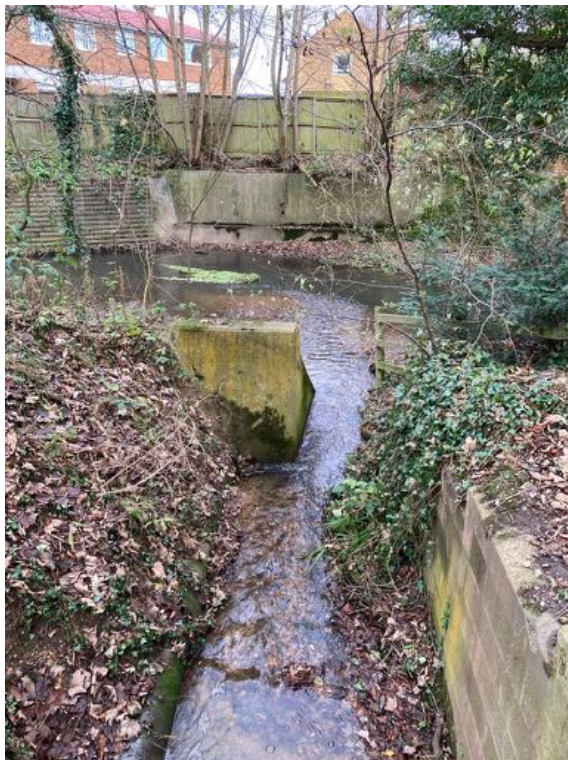
**Photograph 28**

**Description:** Drainage channel flowing into the neighbouring watercourse

**Location:** Area to the west of the Site; looking to the east

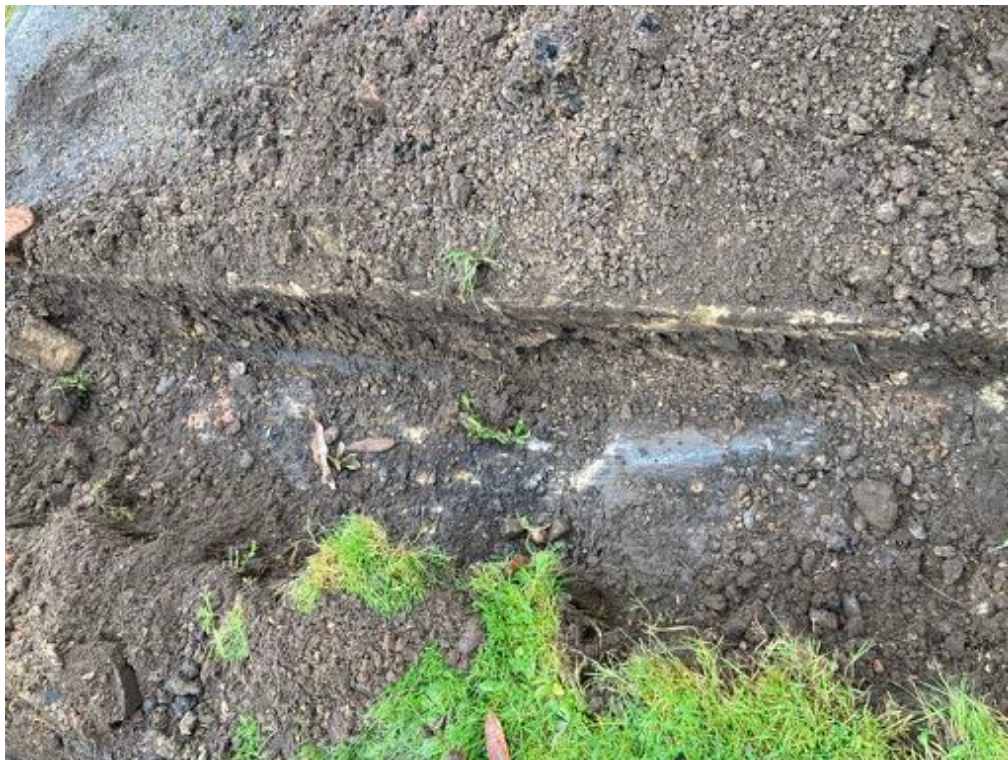
**Photograph 30**

**Description:** Trial pit TP01

**Location:** Excavation alongside former fuel tank (adjacent to The Molesey Venture)

0.12 - 0.2	Dark to mid-brown silty sand and gravel. Sand is fine; gravel is fine to coarse and sub rounded to sub angular including occasional brick and slate. <b>MADE GROUND</b>	Trial pit refused on concrete surfacing at 0.2 m bgl. No groundwater encountered. No discernible staining or odours recorded. Soil sample taken at 0.1 m.
<b>TP02</b>

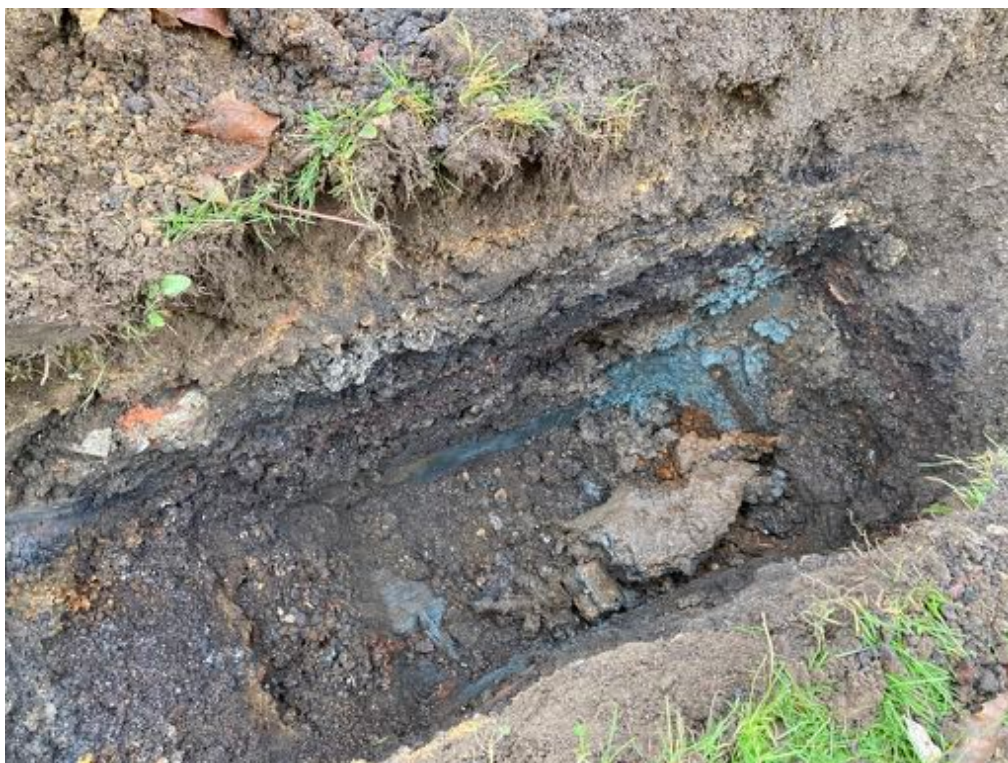
**Photograph 32**

- Chrysotile loose fibres were recorded within a sample taken from TP02 at a depth of 0.4 m.
- Chrysotile loose fibres were recorded within a sample taken from TP08 at a depth of 0.3 m.

**Description:** Trial pit TP02

**Location:** Excavation alongside former fuel tank (adjacent to The Molesey Venture)

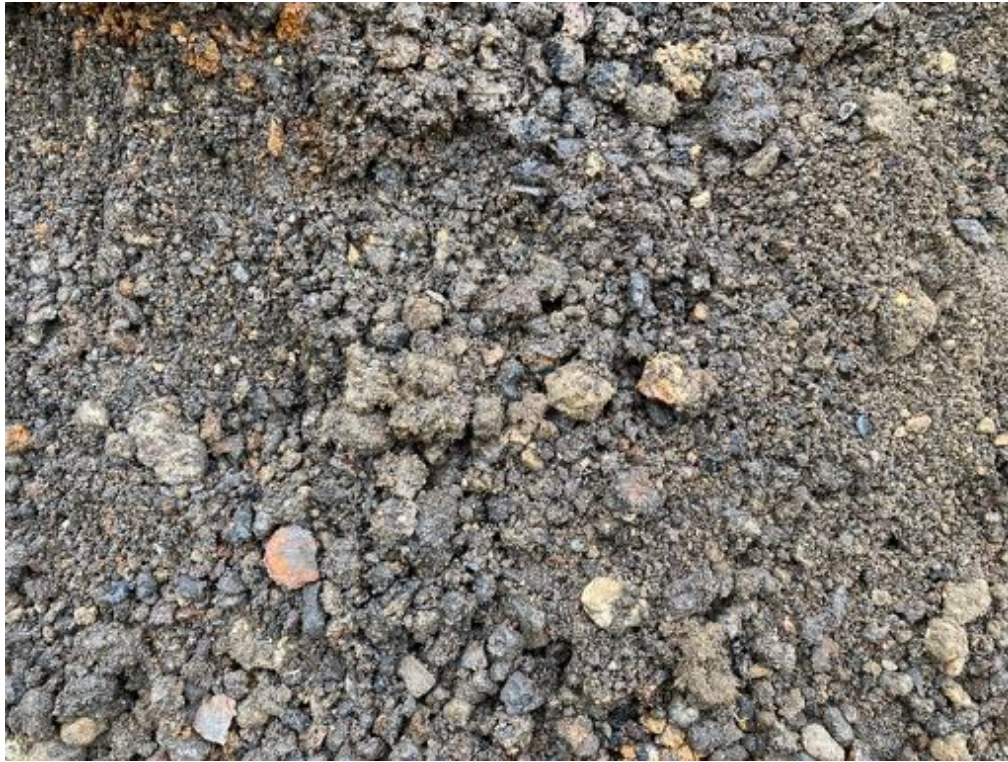
**Photograph 33**

**Description:** Made Ground recovered from trial pit TP02

**Location:** Excavation alongside former fuel tank
