# Orchard Lane / East Molesey

# Phase 2 land quality assessment: The Molesey Venture, East Molesey, Surrey

**Report reference:** 4224R1rev1

**Date of reporting:** 12<sup>th</sup> October 2022

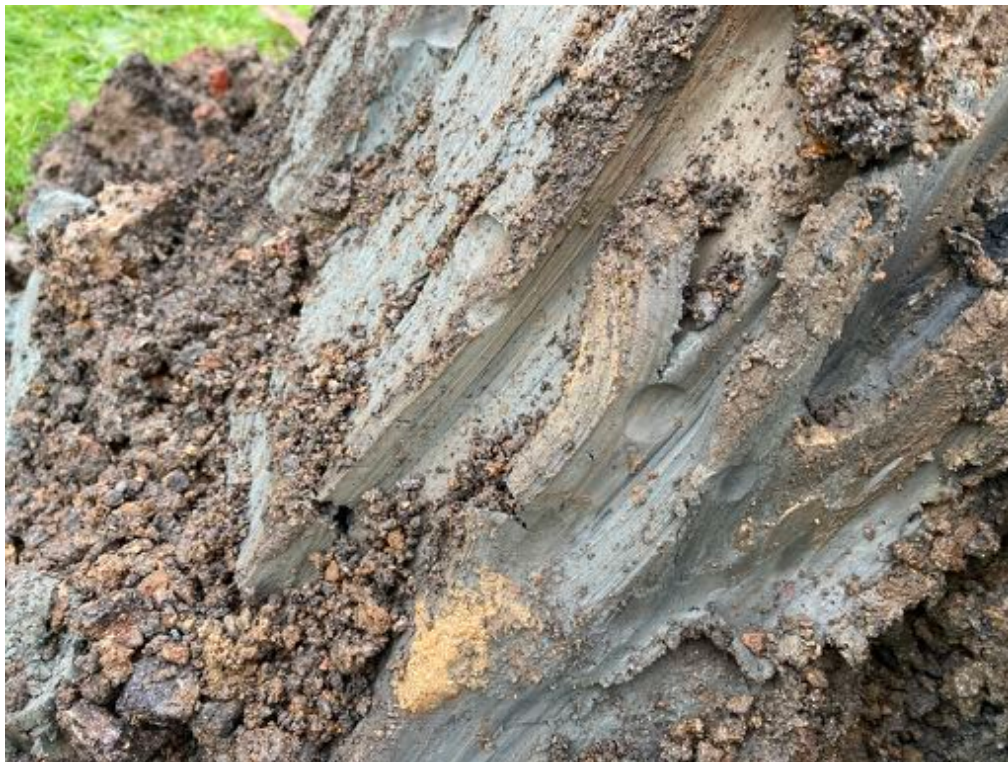
**Photograph 34**

**Description:** Clay deposits recovered from trial pit TP02

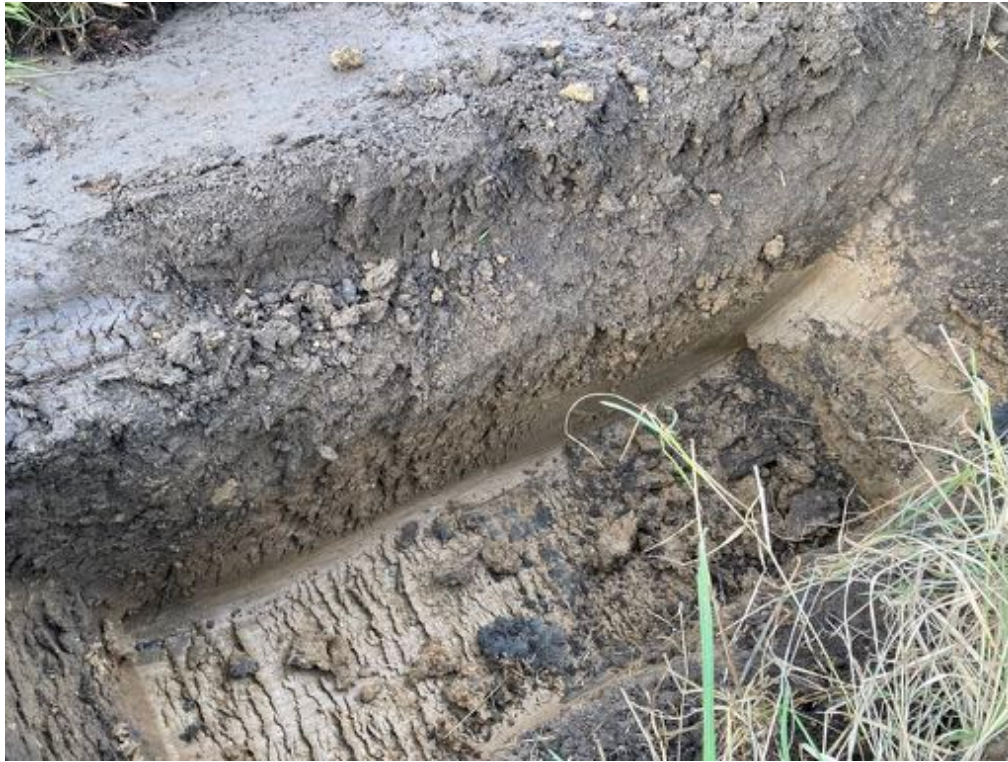
**Photograph 37**

No discernible man-made material was observed within the soils encountered across the former horticultural area in the north-east of the Site (TP03 and TP04), where the ground conditions comprised c. 0.3 m of mid to dark-brown silty gravelly sand with roots and rootlets, overlying soft to firm tan silty clay. Similarly, the raised bed present alongside the Site access route in the south-west of the Site (HP01) encountered 0.6 m of mid to dark brown silty gravelly sand with some roots and rootlets.

**Description:** Trial pit TP03

**Location:** Former vegetable plot – north-eastern part of the Site

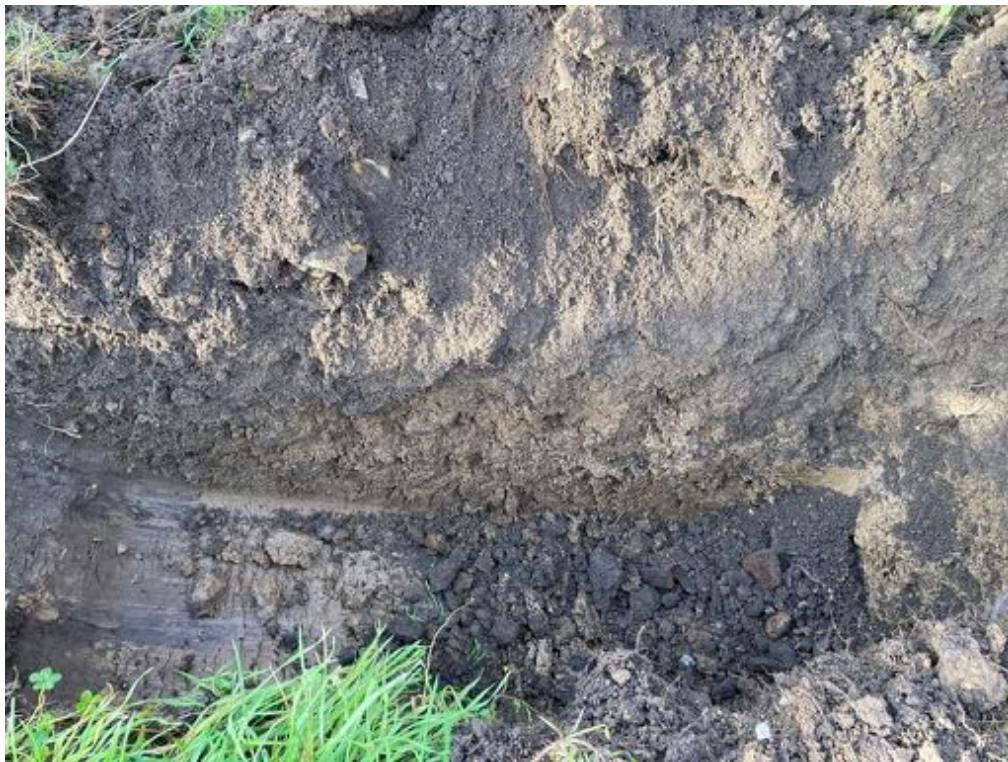
**Photograph 38**

**Description:** Trial pit TP04

**Location:** Former vegetable plot – north-eastern part of the Site

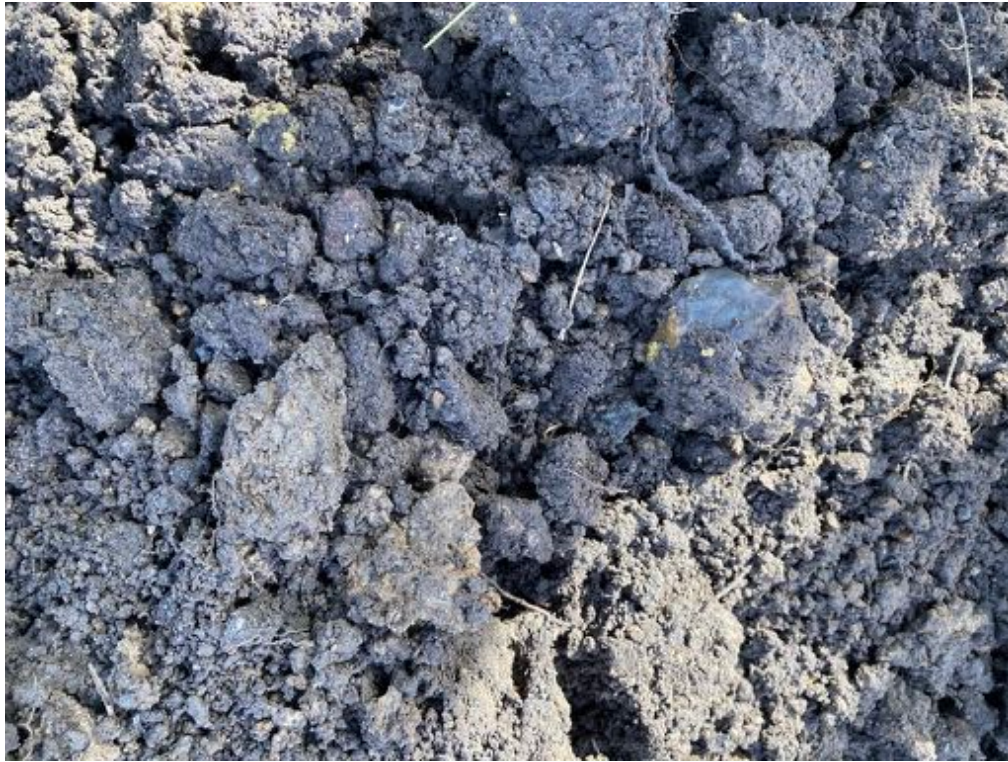
**Photograph 39**

**Description:** Top soil layer recovered from trial pit TP04

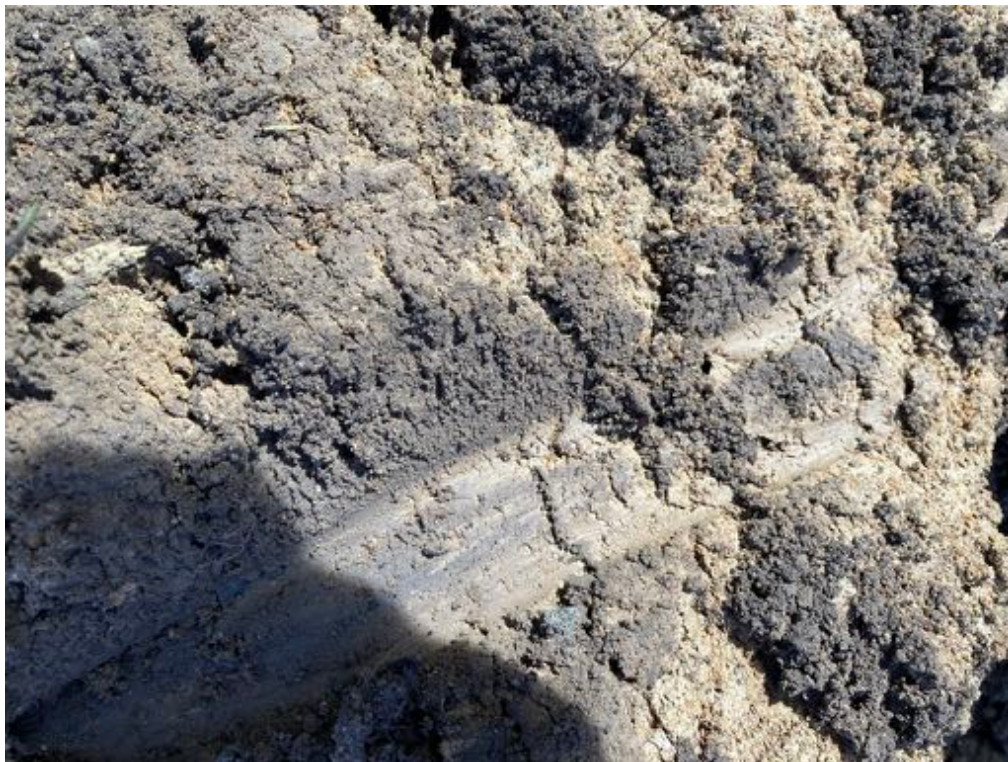
**Photograph 40**

**Description:** Silty clay layer recovered from trial pit TP04

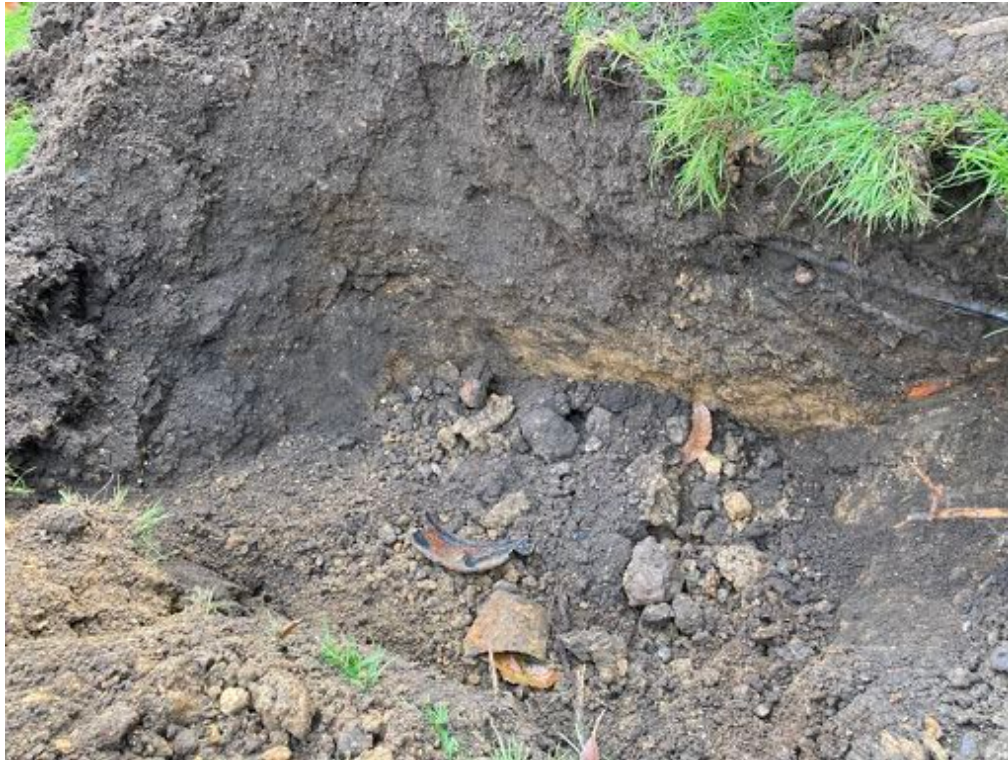
**Photograph 41**

**Description:** Trial pit TP05

**Location:** Grassed area to north of The Molesey Venture building

0.35 - 0.7+	Soft to firm tan silty clay.	No discernible staining or odours recorded. No soil sample taken (apparent natural soils).
<b>TP05</b>		
0.0 - 0.2	Brown sand and gravel with roots and rootlets. Sand is fine to medium; gravel is fine to coarse and sub rounded to sub angular. <b>MADE GROUND</b>	Trial pit targeted positioned on slightly raised land area surrounding existing residential building in north-west of the Site.

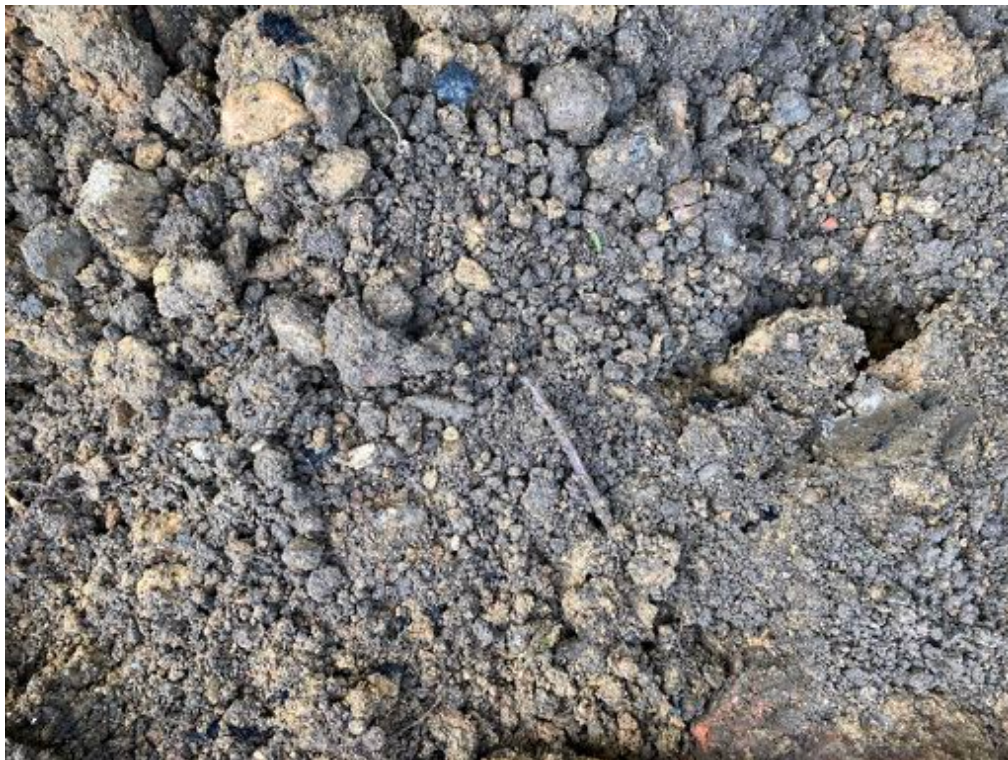
**Photograph 42**

**Description:** Made Ground recovered from trial pit TP05

**Location:** Grassed area to north of The Molesey Venture building

0.2 - 0.6	Brown to black silty sand and gravel. Sand is fine; gravel is fine to coarse and sub rounded to angular including some brick, coal, clinker and ceramic tile, plus occasional metal and half bricks. Concrete boulder at 0.4 m bgl. <b>MADE GROUND</b>	No groundwater encountered. No discernible staining or odours recorded. Soil sample taken at 0.15 m.

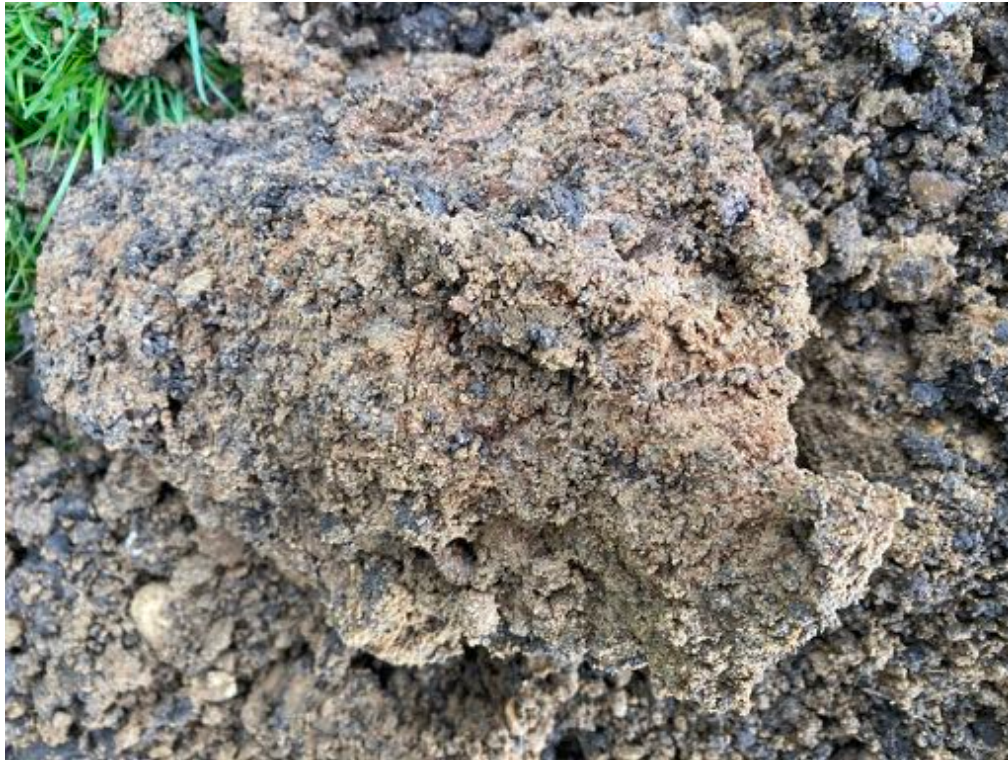
**Photograph 43**

**Description:** Silty clay recovered from trial pit TP05

**Location:** Grassed area to north of The Molesey Venture building

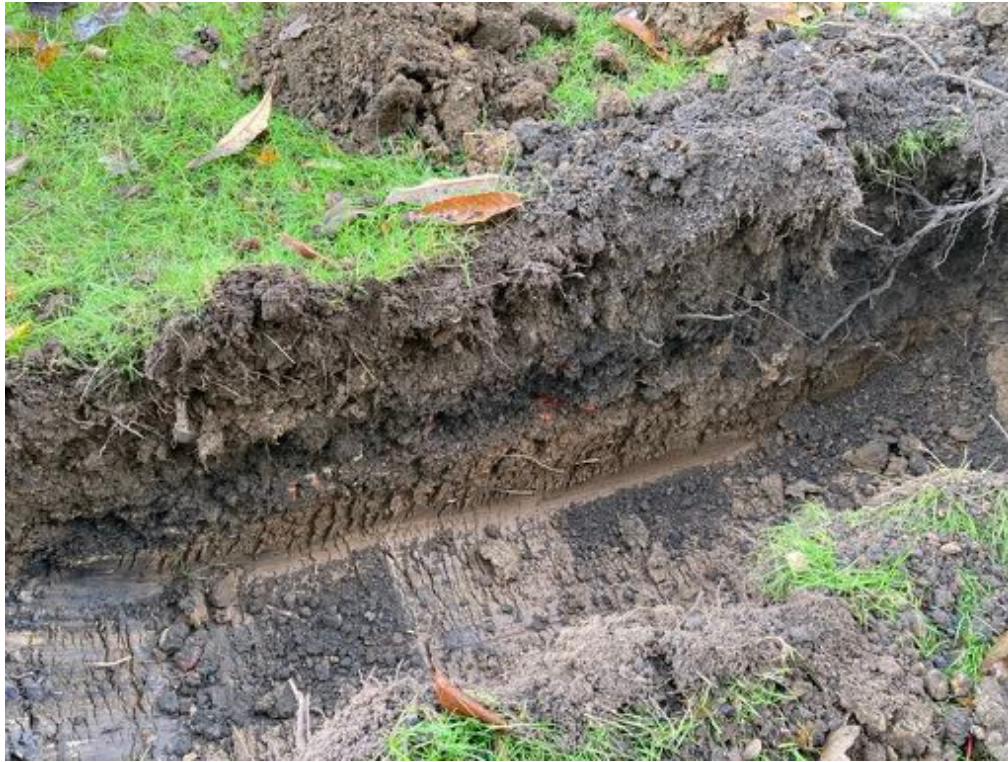
**Photograph 45**

**Description:** Trial pit TP06

**Location:** Grassed area to north of The Molesey Venture building

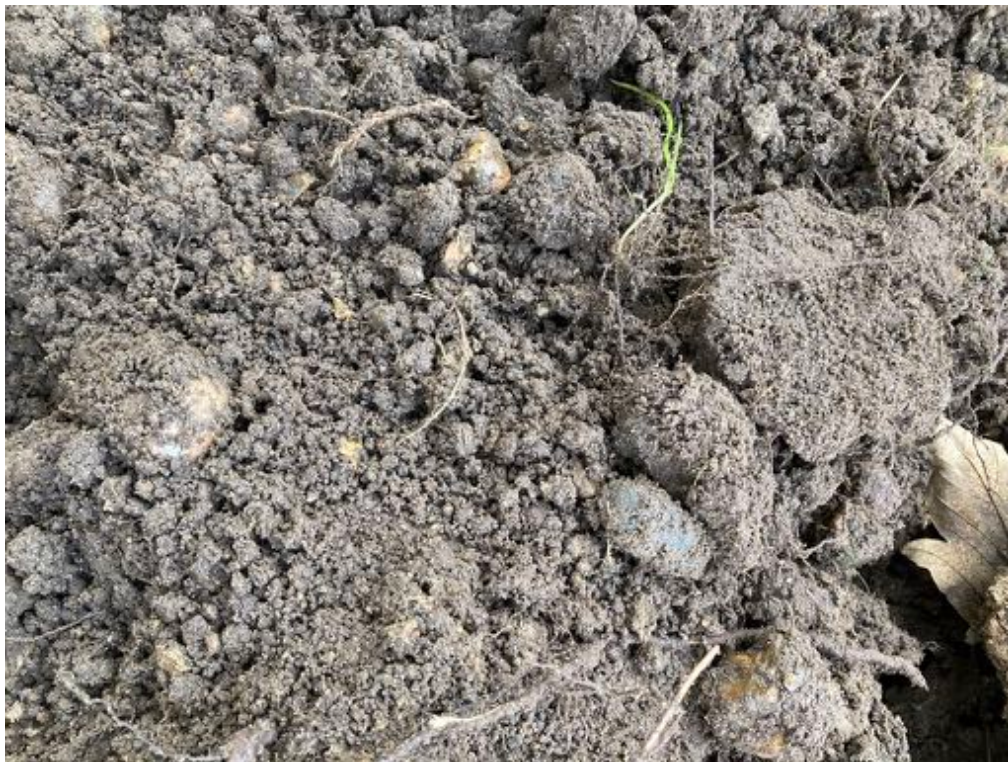
**Photograph 46**

**Description:** Upper Made Ground recovered from trial pit TP06

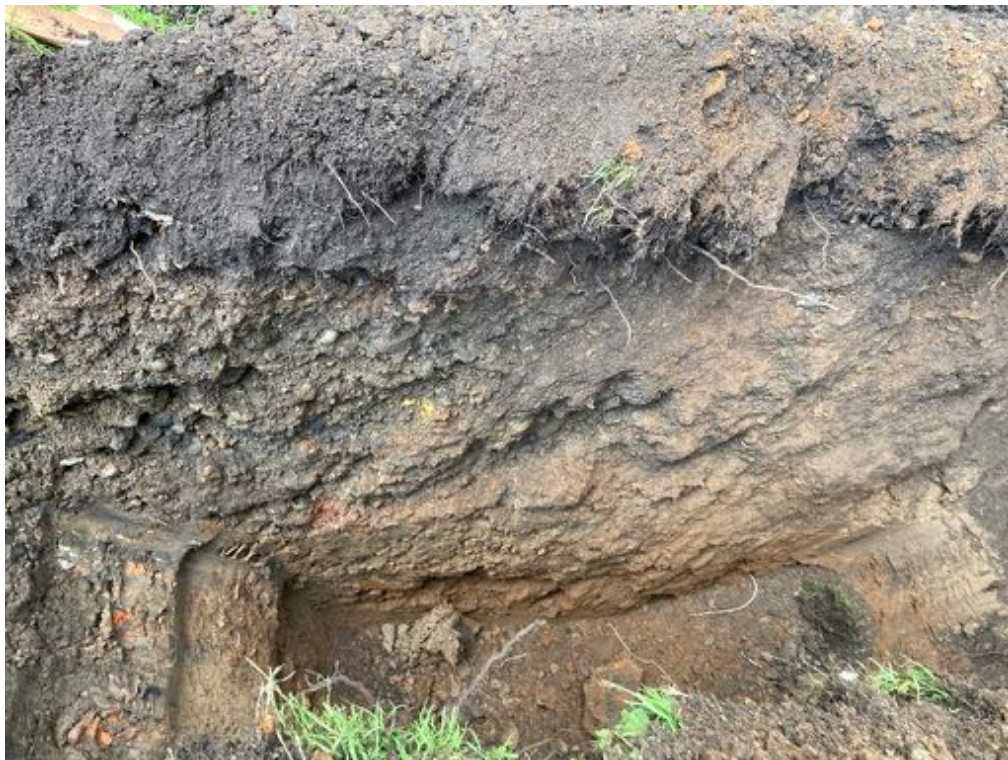
**Photograph 48**

**Description:** Trial pit TP07

**Location:** Grassed area to west of The Molesey Venture building

0.35 - 0.65+	Firm grey to blue clay.	
<b>TP07</b>		
0.0 - 0.1	Dark brown gravelly sand with roots and rootlets. Sand is fine to medium; gravel is fine to coarse and sub rounded to sub angular. <b>MADE GROUND</b>	No groundwater encountered. No discernible staining or odours recorded. Soil sample taken at 0.35 m.

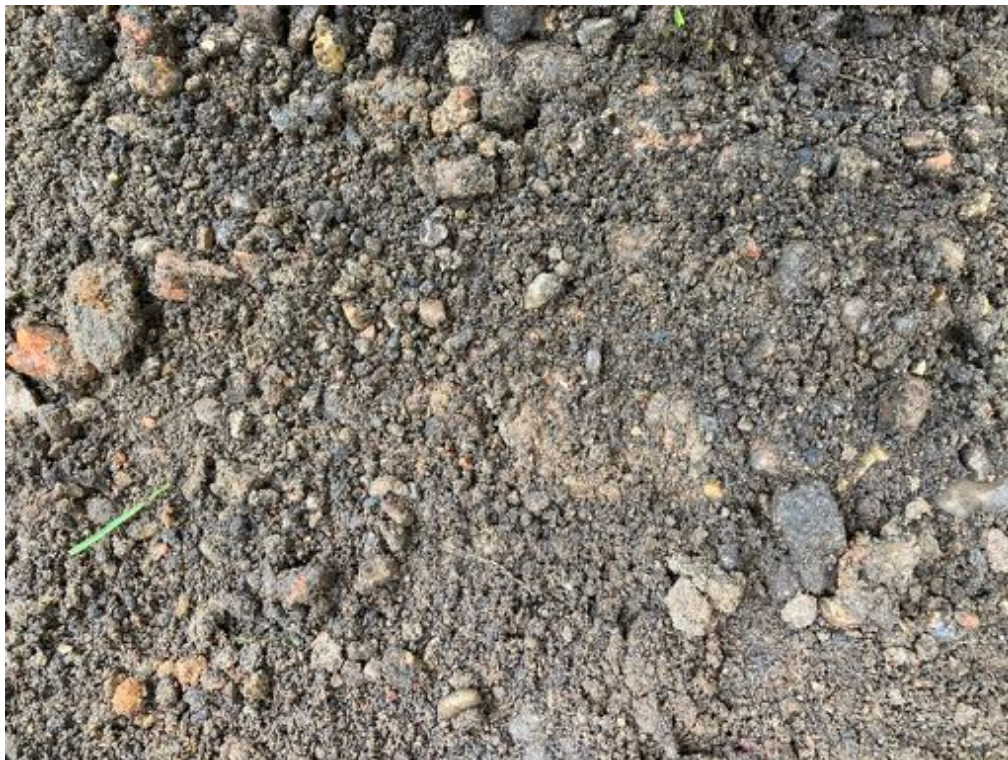
**Photograph 50**

**Description:** Made Ground recovered from TP07 between 0.1 m and 0.7 m

**Location:** Grassed area to west of The Molesey Venture building

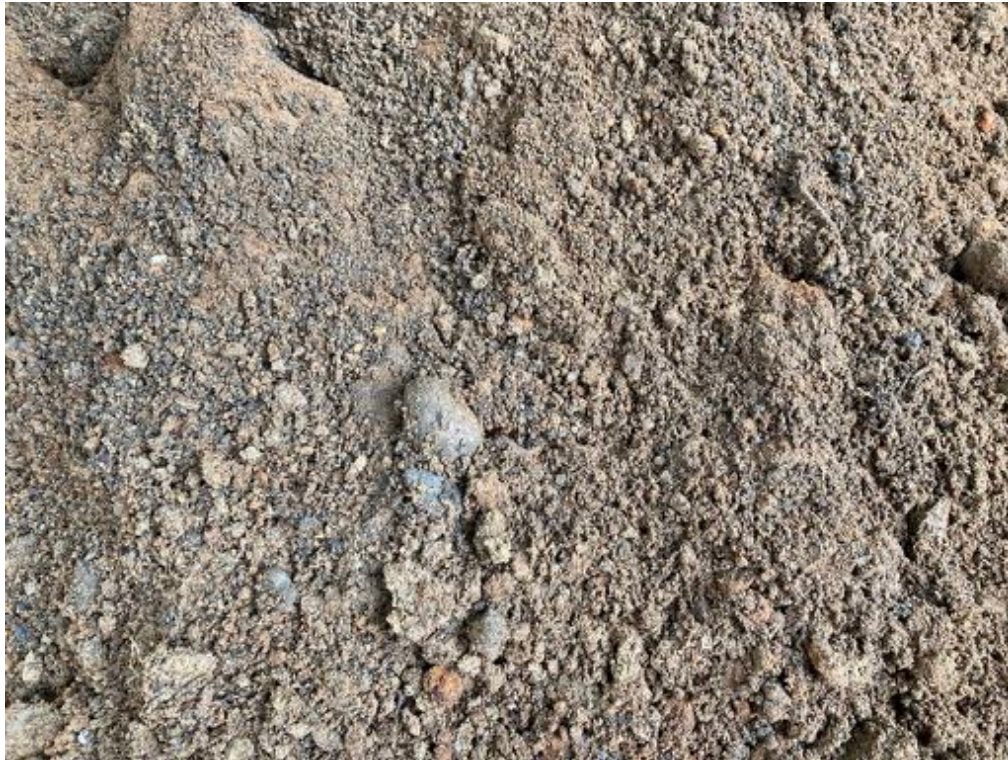
**Photograph 51**      **Description:** Made Ground recovered from TP07 between 0.7 m and 1.5 m  
                            **Date:** 08/12/2021  
                            **Location:** Grassed area to west of The Molesey Venture building

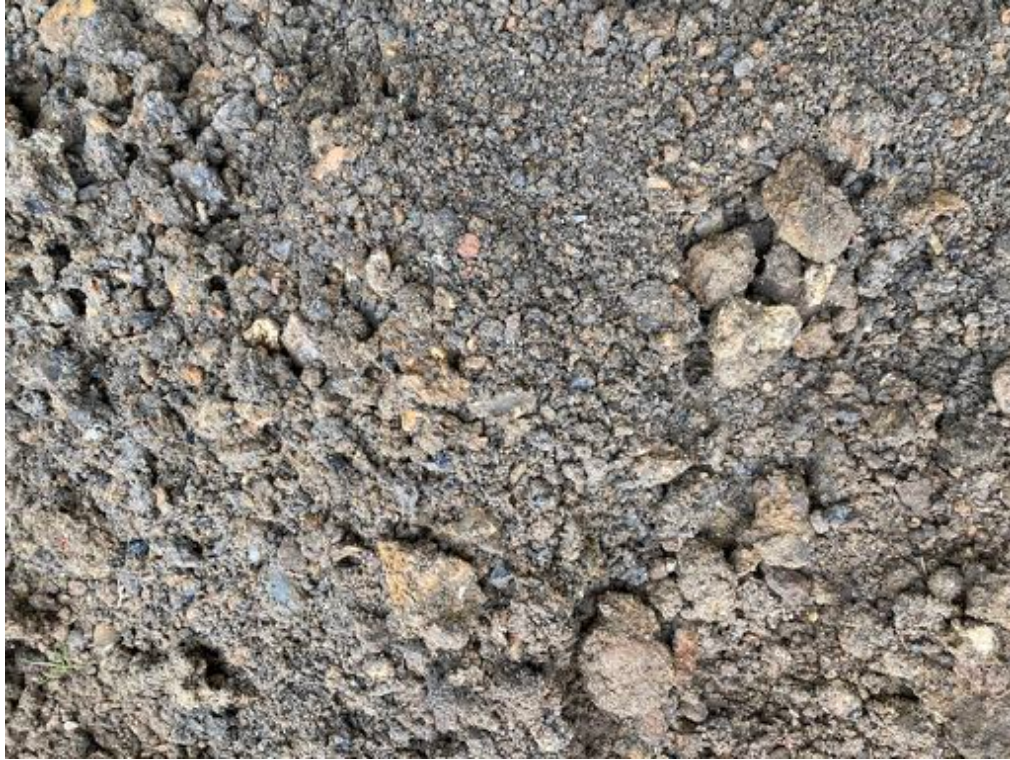
**Photograph 53**

**Description:** Made Ground recovered from TP07 between 0.05 m and 1.4 m

**Location:** Grassed area to west of The Molesey Venture building

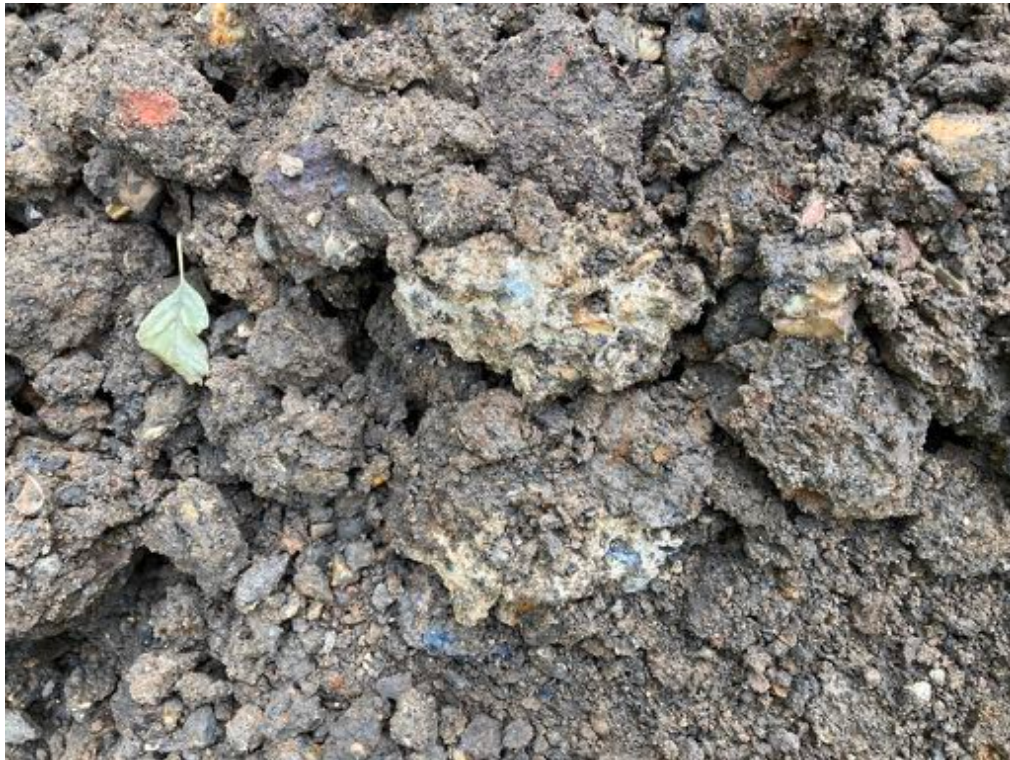
**Photograph 54**

**Description:** Gravelly clay recovered from trial pit TP08

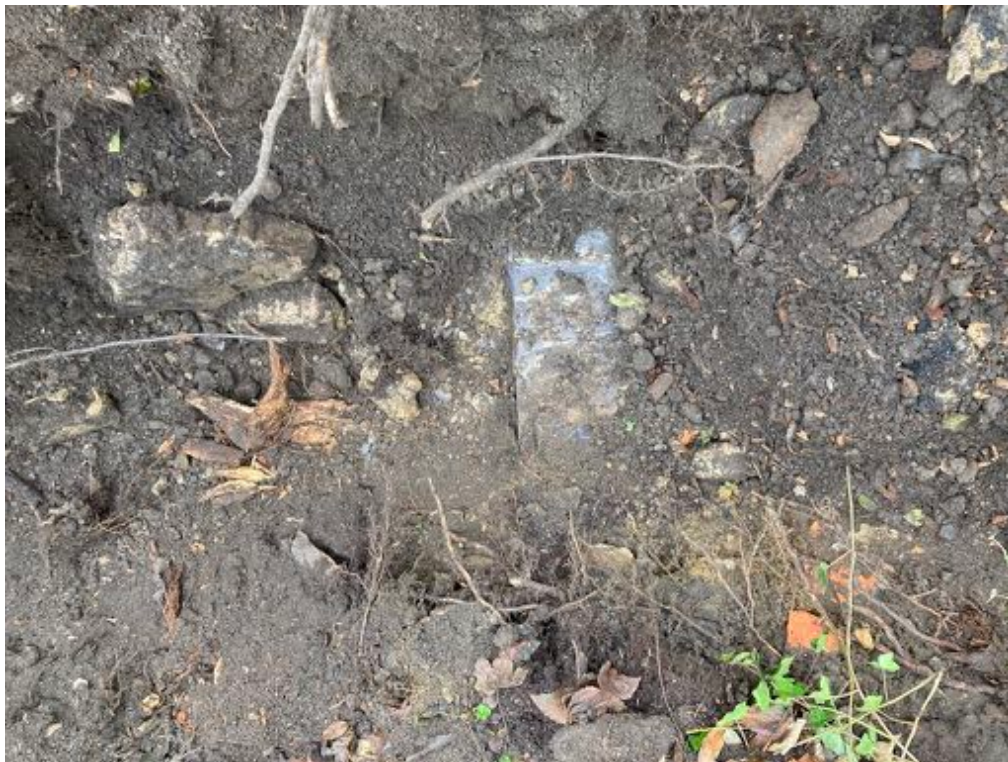
**Photograph 56**

**Description:** Brick structure encountered at the base of trial pit TP09

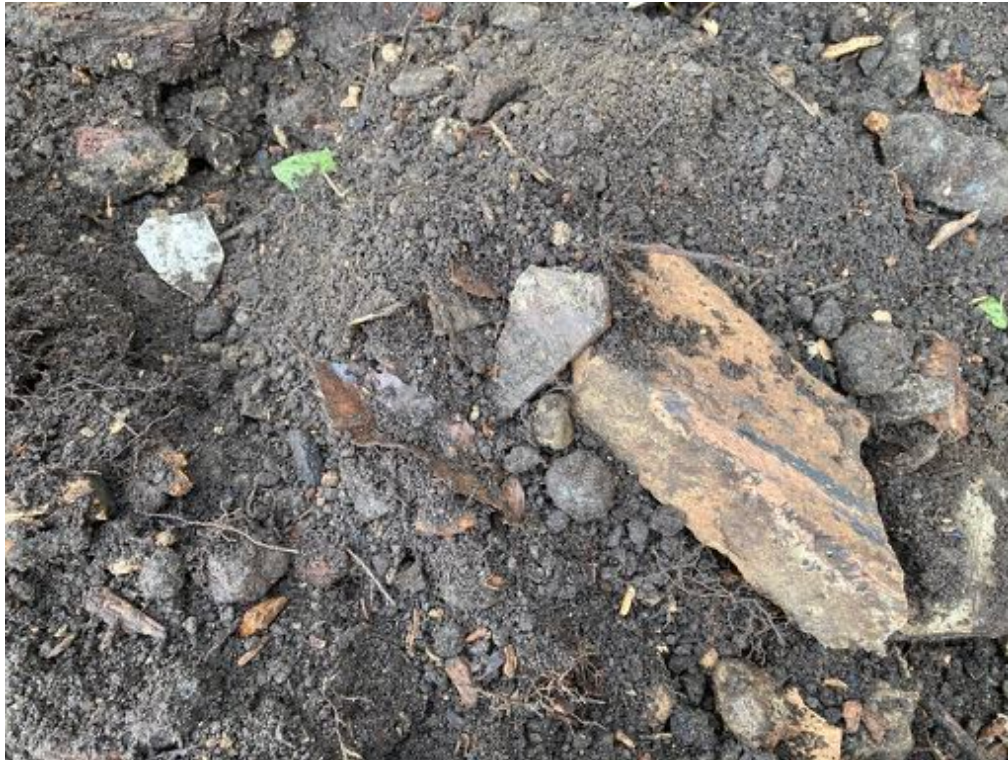
**Photograph 57**

**Description:** Made Ground recovered from trial pit TP09

**Location:** Western Site boundary to the south of The Molesey Venture building

1.4 - 1.45+	Soft to firm mid-brown silty clay.	
<b>TP09</b>		
0.0 - 0.8+	Mid to dark brown gravelly sand with some roots and rootlets. Sand is fine to medium; gravel is fine to coarse and sub rounded to sub angular including some brick, ceramic tile, concrete and slate remains. <b>MADE GROUND</b>	Tree stump removed prior to trial pitting. Trial pit refused on engineering brick (potentially associated with the neighbouring river / retaining wall). No groundwater encountered. No discernible staining or odours recorded. Soil sample taken at 0.35 m.

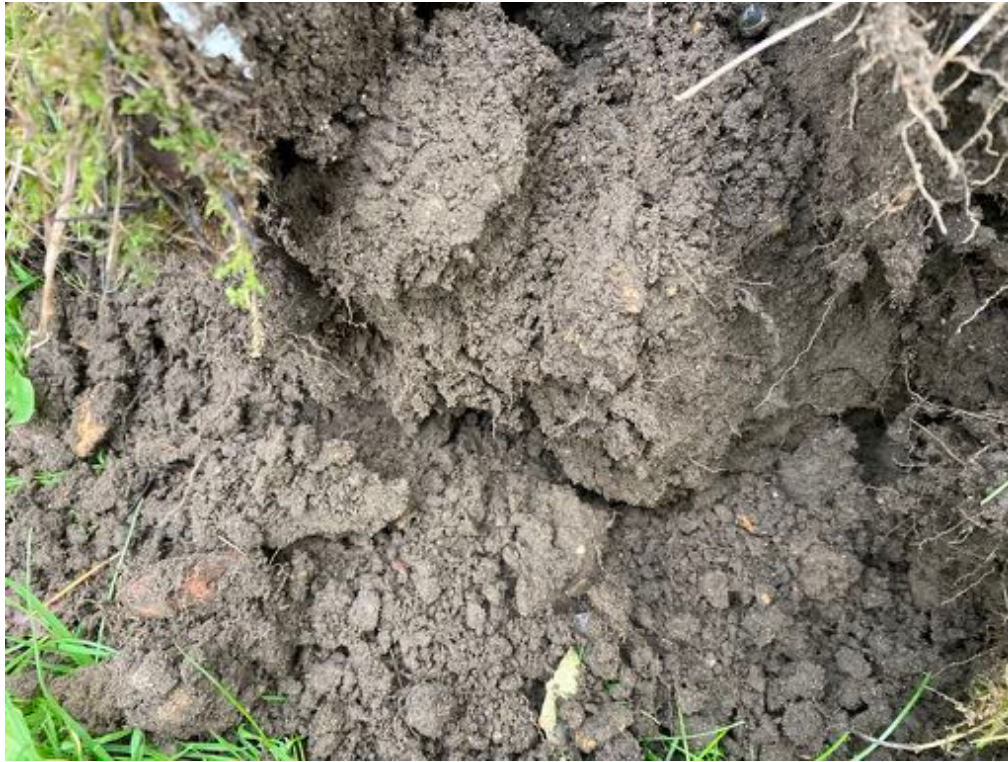
**Photograph 59**

- Only limited man-made material was observed beneath the garden areas present in the south-east (TP10) and eastern areas of the Site (TP11). The encountered soils at TP10 comprised an upper layer of mid to dark-brown silty slightly gravelly sand with roots and rootlets, overlying mid brown silty gravelly sand and gravelly silt with very occasional fine brick remains. The soil sequence observed at TP11 included 0.6 m of mid to dark-brown silty gravelly sand with roots and rootlets including very occasional glass and brick.

**Description:** Topsoil / upper Made Ground recovered from trial pit TP10

**Location:** Front garden of Lower Rivercroft property

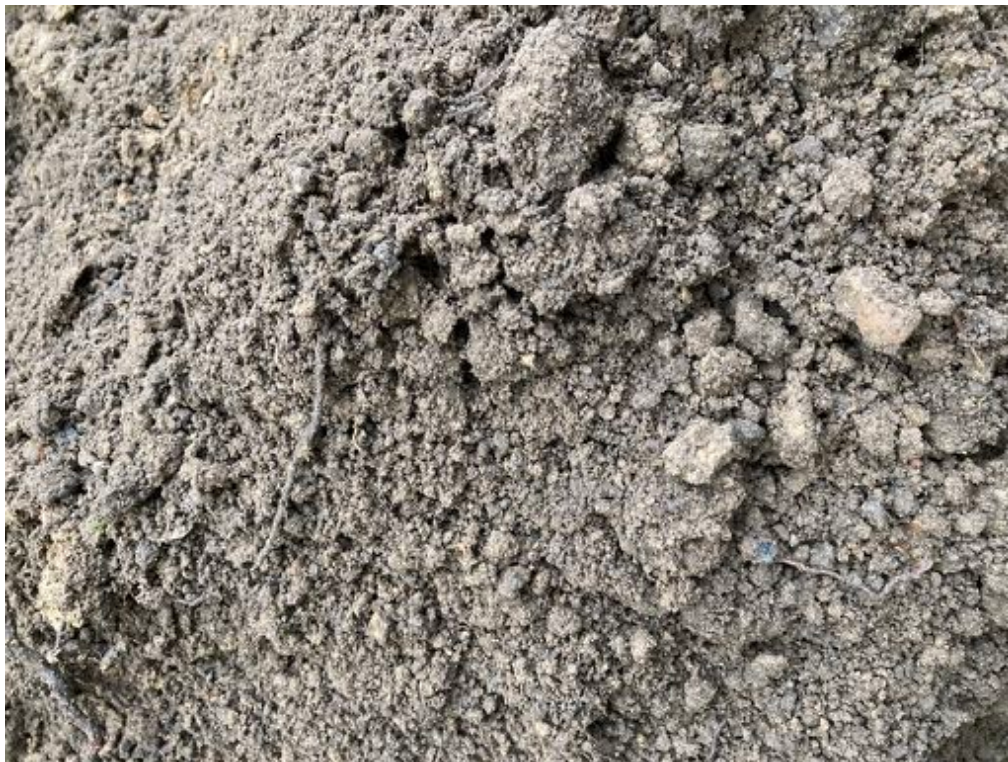
**Photograph 60**

**Description:** Sub soil / lower Made Ground recovered from trial pit TP10

**Location:** Front garden of Lower Rivercroft property

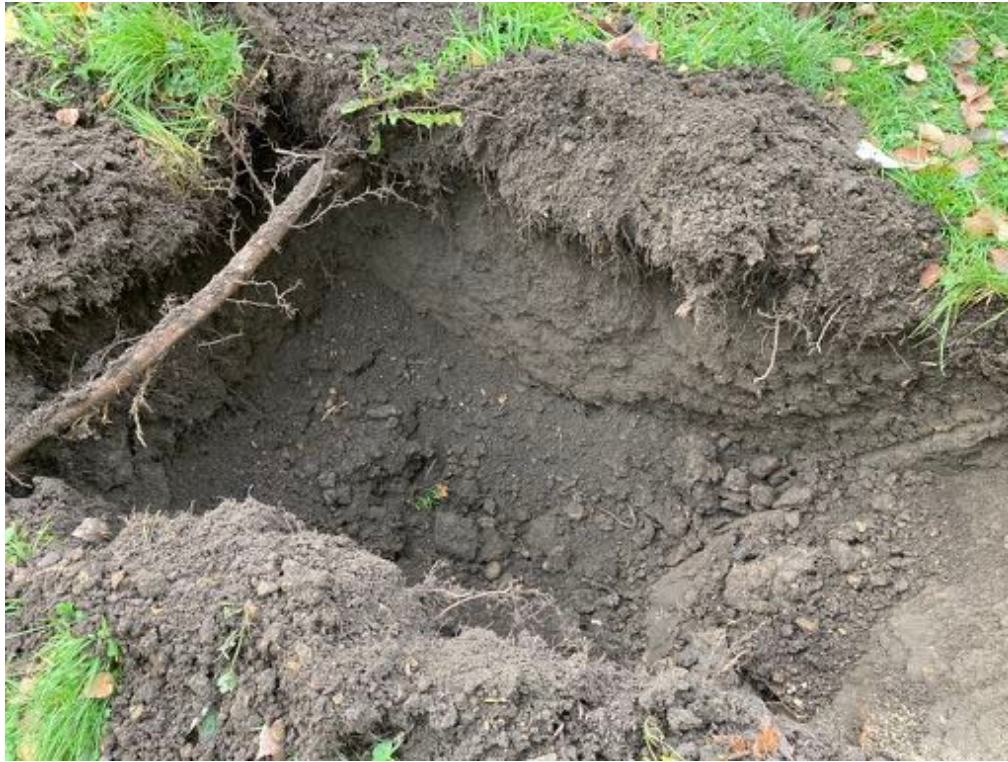
**Photograph 61**

**Description:** Trial pit TP11

**Location:** Landscaped area along the eastern Site boundary

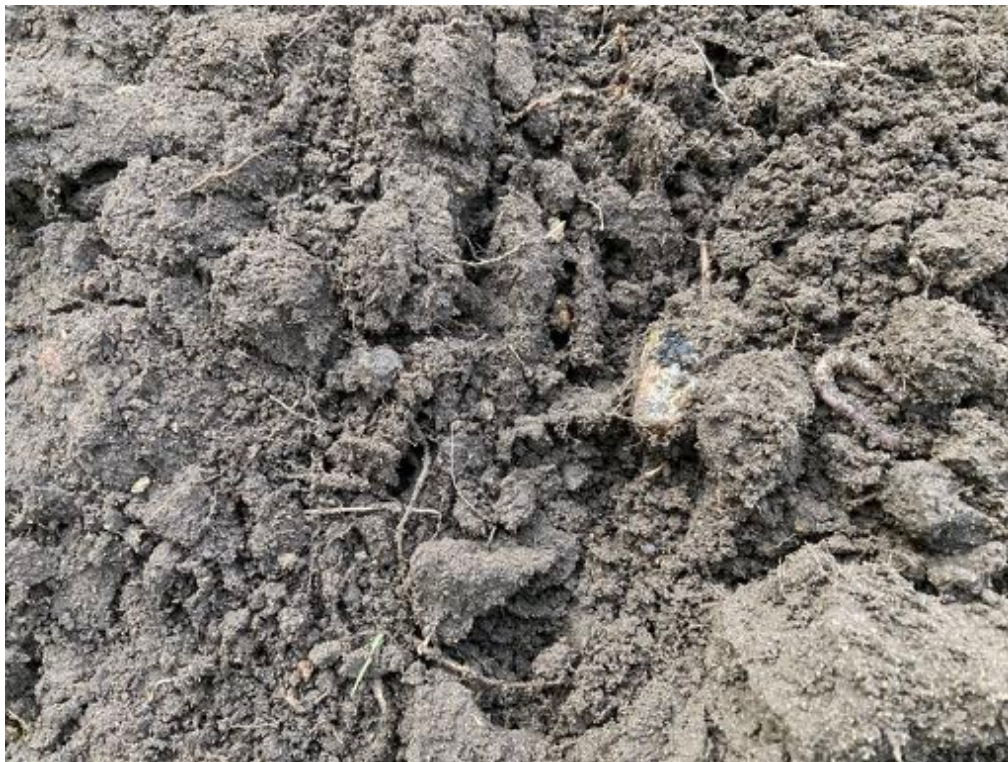
**Photograph 62**

**Description:** Topsoil / upper Made Ground recovered from trial pit TP11

**Location:** Landscaped area along the eastern Site boundary

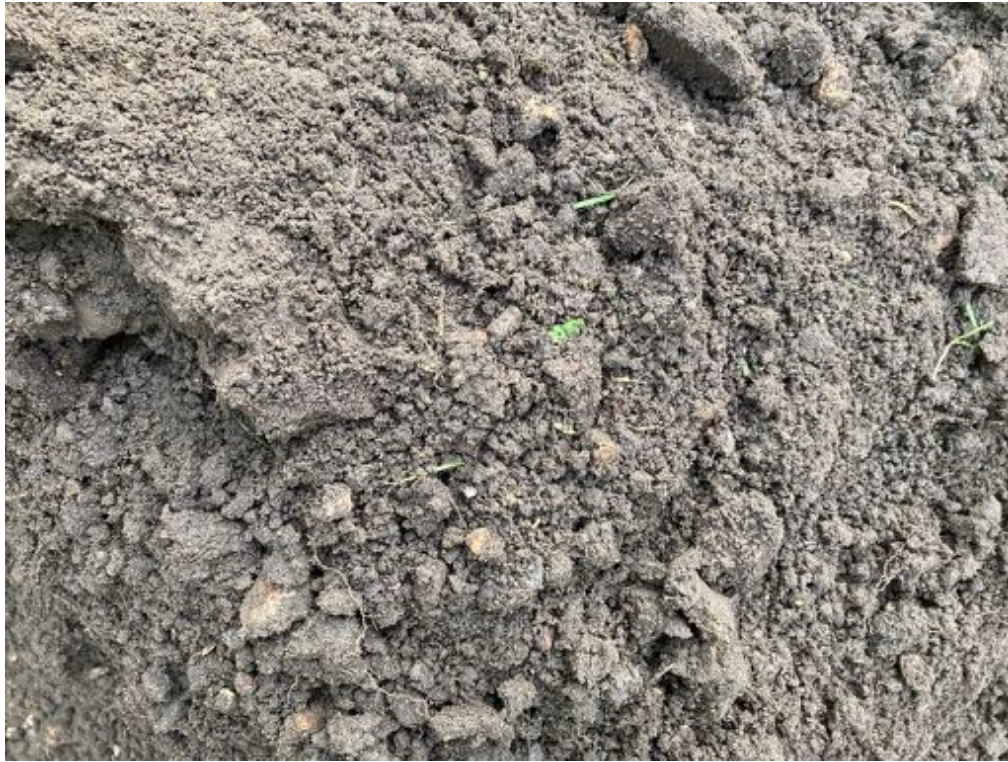
**Photograph 63**

**Description:** Topsoil / upper Made Ground recovered from trial pit TP11

**Location:** Landscaped area along the eastern Site boundary

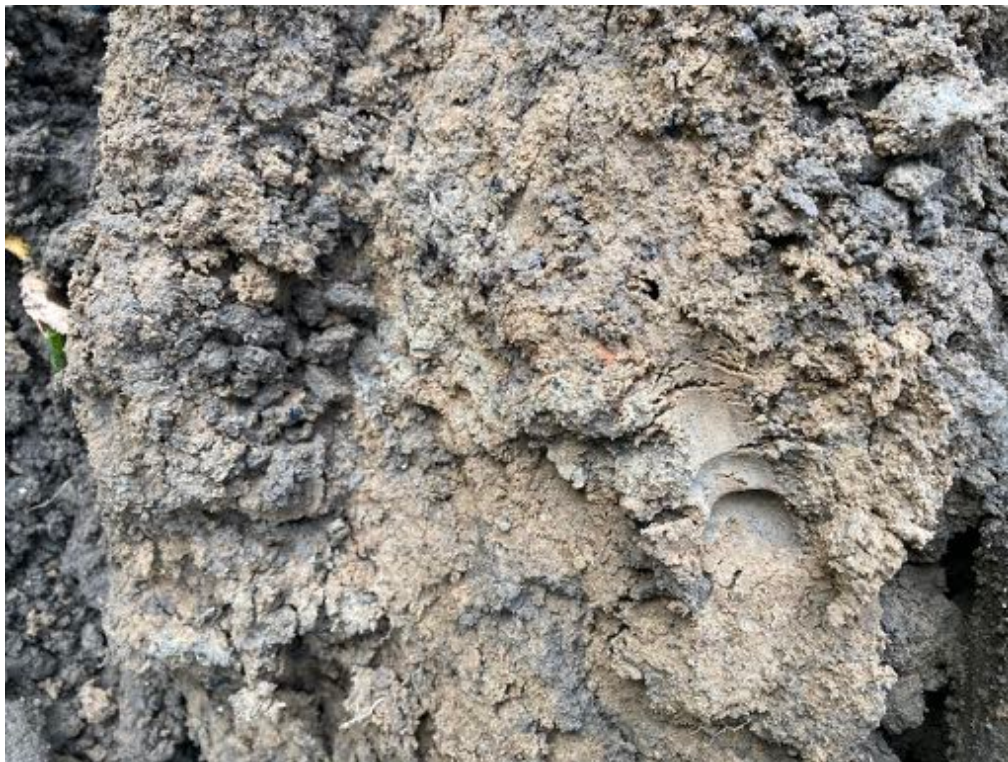
**Photograph 64**

**Description:** Gravelly clay recovered from trial pit TP11

**Location:** Landscaped area along the eastern Site boundary

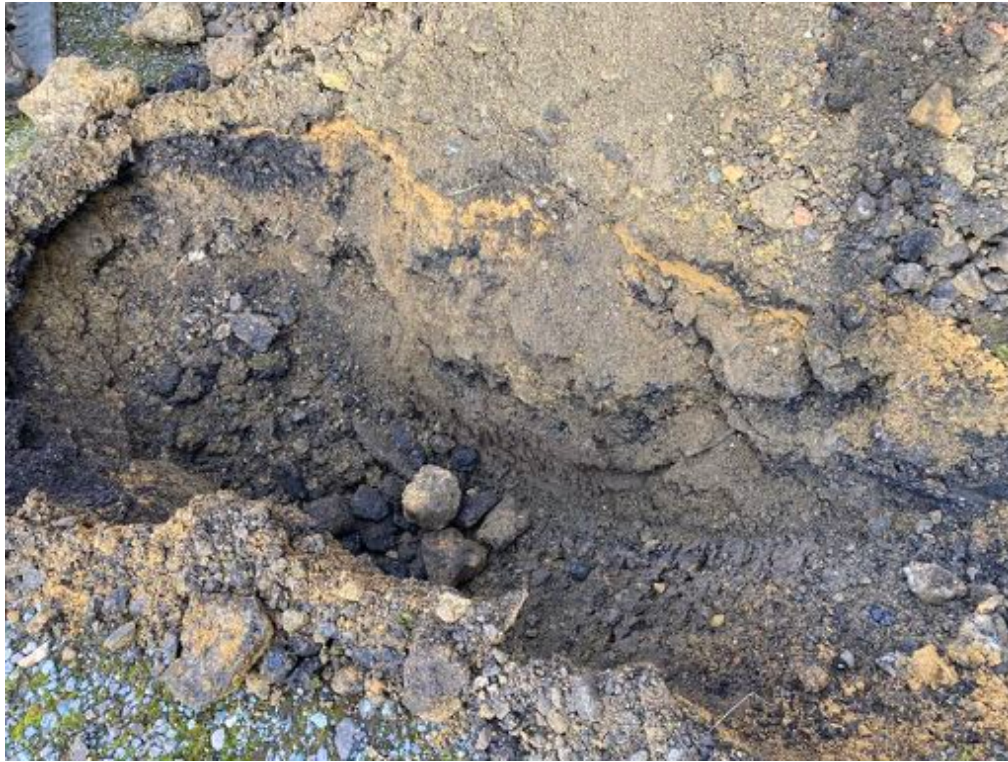
**Photograph 65**

**Description:** Trial pit TP12

**Location:** Former parking area in the east of the Site

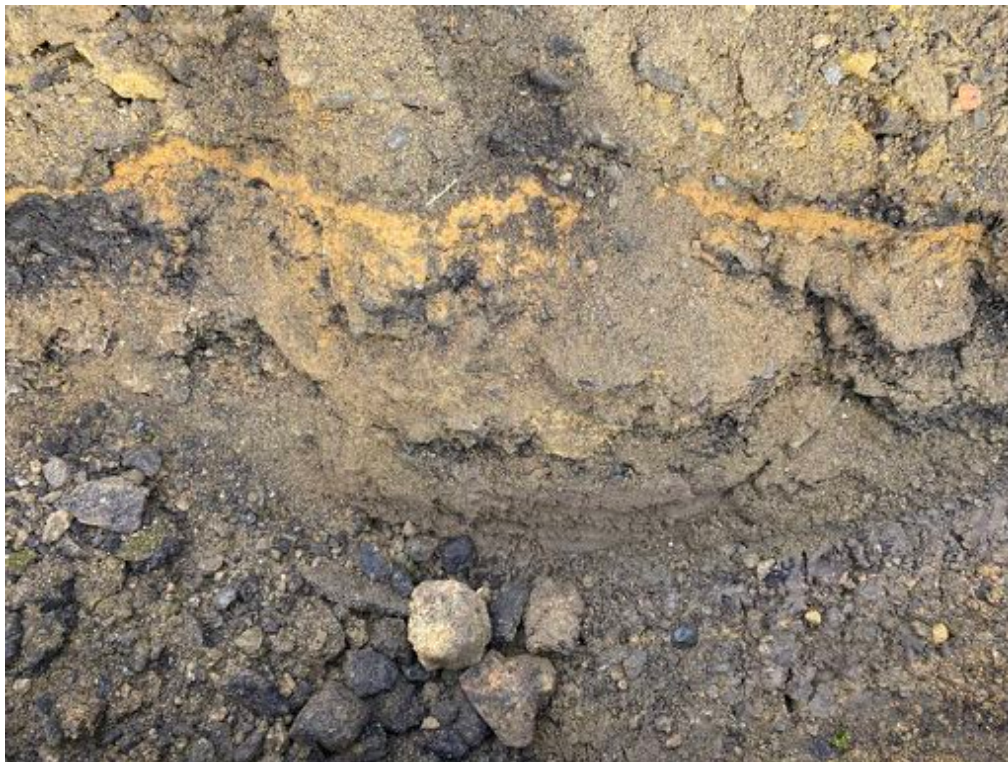
**Photograph 66**

**Description:** Trial pit TP12

**Location:** Former parking area in the east of the Site

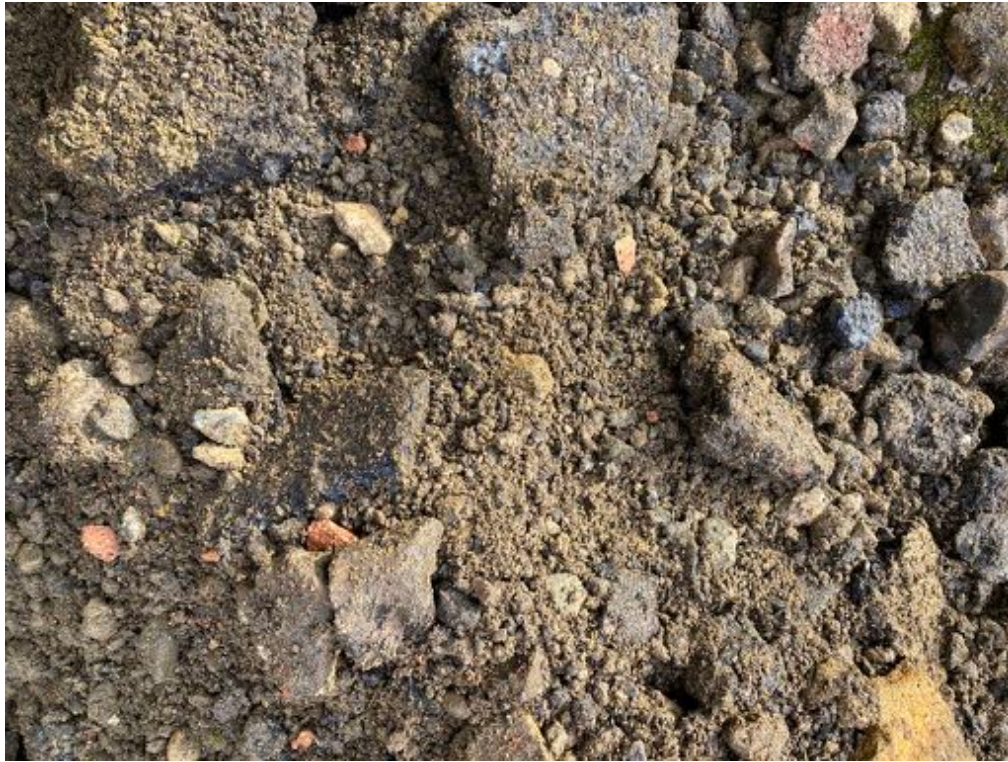
**Photograph 67**

**Description:** Made Ground recovered from trial pit TP12

**Location:** Former parking area in the east of the Site

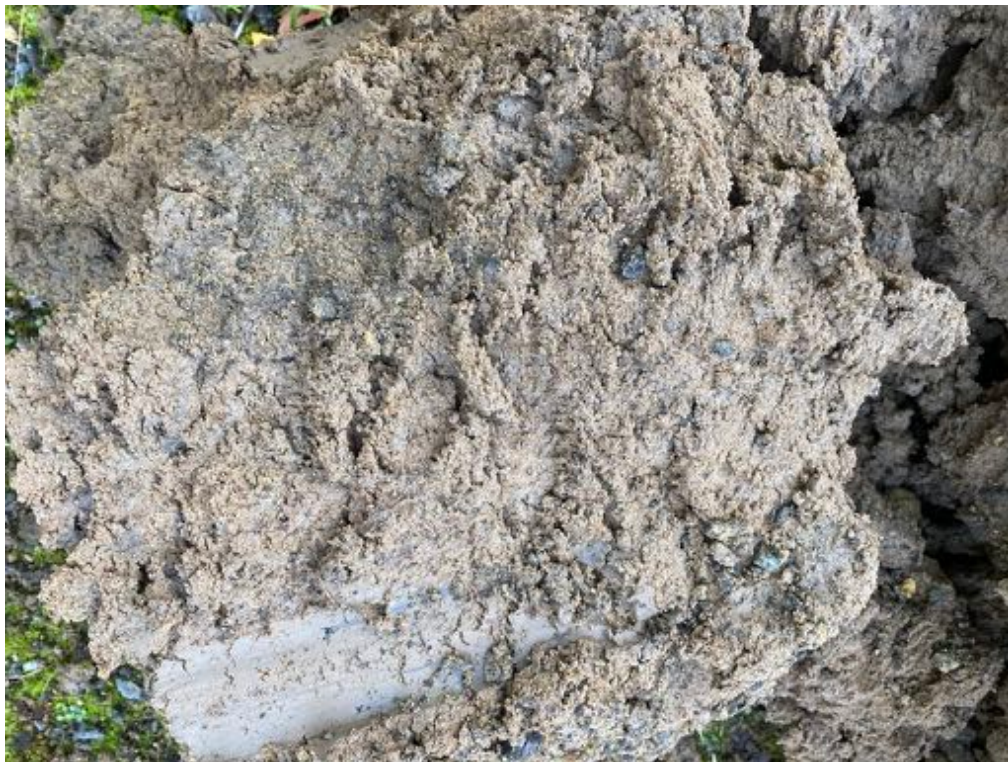
**Photograph 68**

**Description:** Silty clay recovered from trial pit TP12

**Location:** Former parking area in the east of the Site

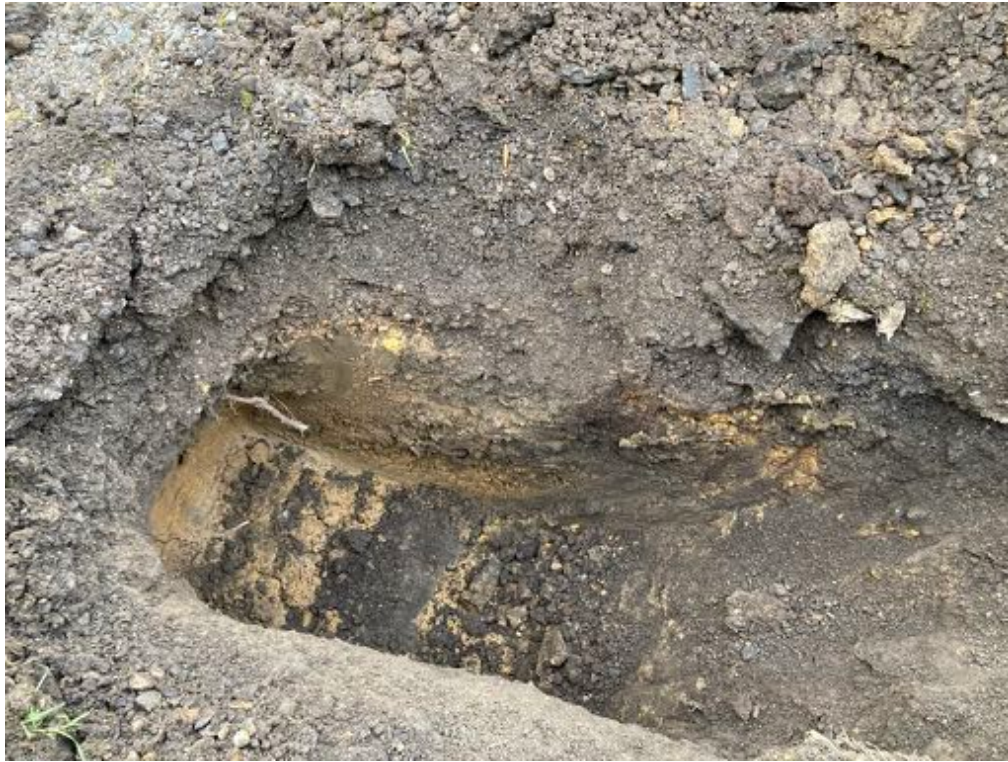
**Photograph 69**

**Description:** Trial pit TP13

**Location:** Former parking area in the south-east of the Site
