# Orchard Lane / East Molesey

# Phase 2 land quality assessment: The Molesey Venture, East Molesey, Surrey

**Report reference:** 4224R1rev1

**Date of reporting:** 12<sup>th</sup> October 2022

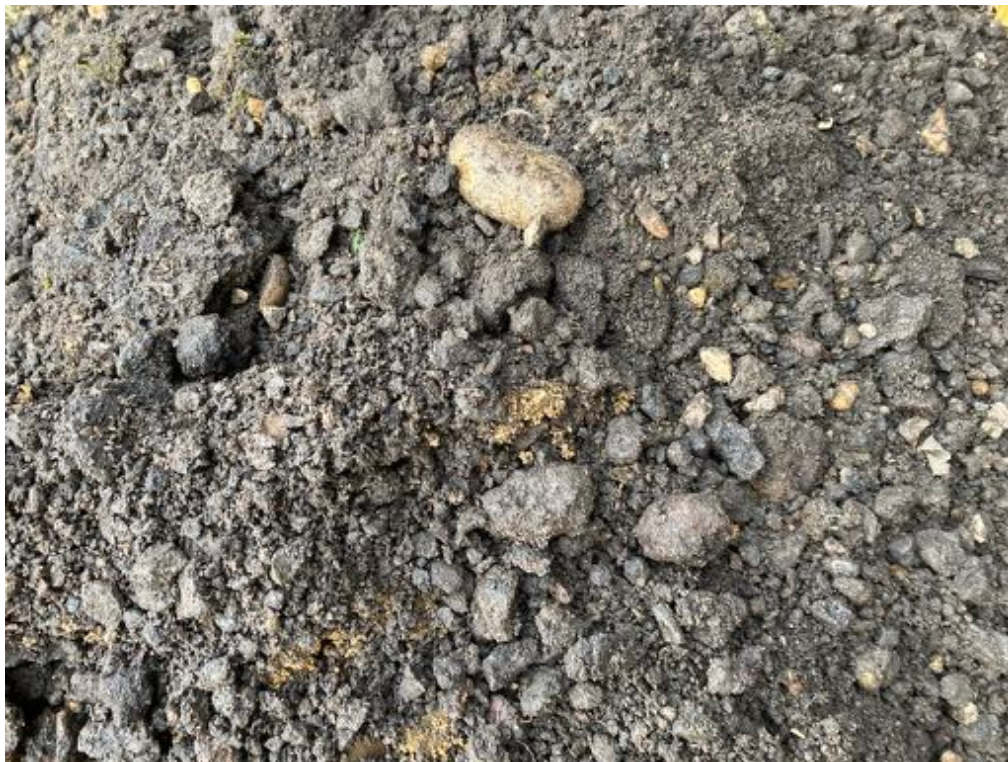
**Photograph 70**

**Description:** Made Ground recovered from trial pit TP13

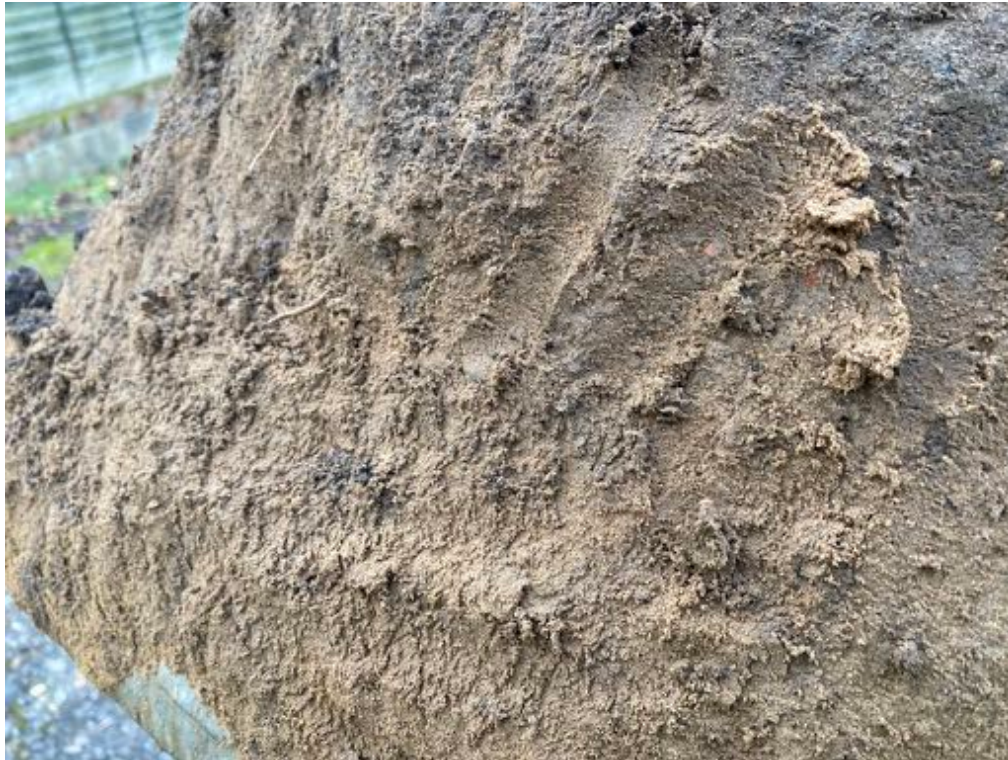
**Photograph 71**

**Description:** Sandy silt recovered from trial pit TP13

**Location:** Former parking area in the south-east of the Site

0.6 - 0.9+	Soft mid-brown silty clay to clayey silt.	
<b>TP13</b>		
0.0 - 0.05	Grey to black fine to medium sub angular gravel (road planings / weathered tarmac). <b>MADE GROUND</b>	No groundwater encountered. No discernible staining or odours recorded.
