## **BS5837:2012 Arboricultural Survey Impact Assessment & Arboricultural Method Statement**

**Site Address:  
Land at  
Burhill Golf Course  
Burwood Road  
Hersham  
KT12 4BX**

**Robert Toll  
HND Urban Forestry - ND Forestry - MArborA  
Ref: RMT931  
Site inspection date: 5<sup>th</sup> December 2023  
Date report published: 14<sup>th</sup> December 2023  
Prepared for Burhill Group Limited**

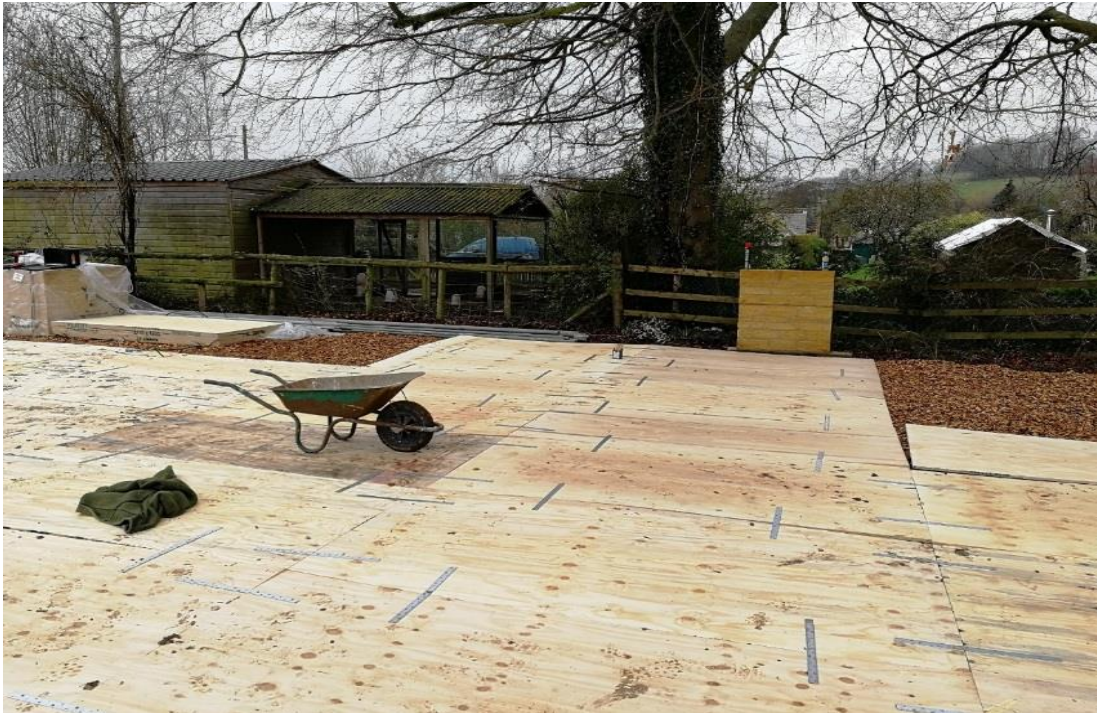
**Figure 6** – Plywood sheeting used as ground protection.

5.6 A permeable geotextile such as Terram will be laid and onto this will be placed treated timber (100 mm x 80 mm) at spacings of no more than 1m. The area between the timber bearers will be filled with a compressible material such as woodchips and will then be covered by 20 mm thick marine ply which will be screwed down onto the timber (Figures 5 and 6). The plywood may need to be coated with a non-slip paint.

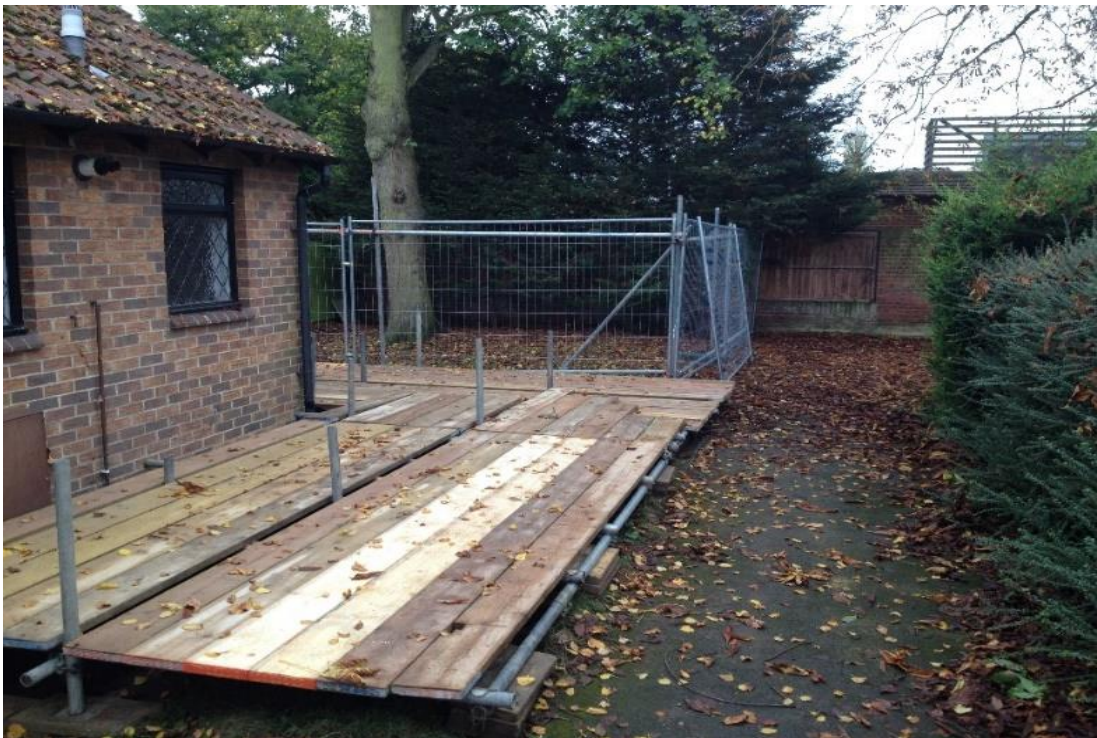
**Figure 7** – Specification for scaffold ground protection.

- 5.7** Single thickness of scaffold boards placed on top of driven scaffold frame to form a suspended walkway (Figure 7)
