**Heath Buildings
Oxshott**

INTRODUCTION

AA Environmental Limited (AAe) has been instructed by Heath Buildings Limited to carry out a follow-up ecological survey of the above site. Although an initial ecological survey was carried out on the site by AAe in June 2021, it was considered best practice to carry out a follow-up survey to update the previous findings and to record any changes that may have occurred during the intervening period. This information will serve to assess the ecological impact of the proposals and identify any ecological constraints and/or mitigation measures that may be required. A series of photographs has been attached for reference.

| Rev. | Details | Drawn Chkd. | Date |
|---|---|---|---|
| TITLE Photograph Record Sheet | | | |

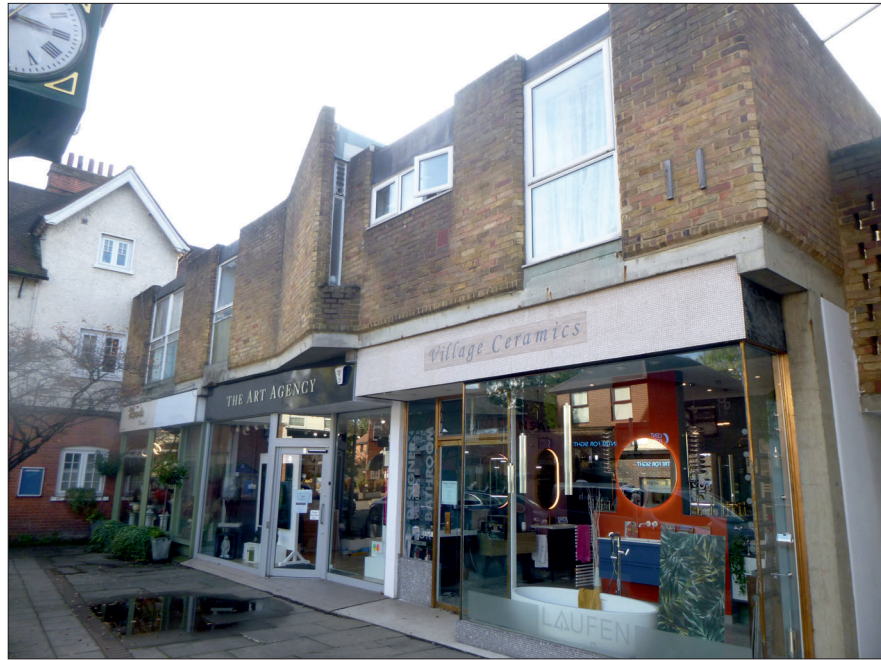
The buildings were of masonry and concrete construction, with flat, felted roofs. Both timber and plastic soffits/fascias were present. The high street shops had glass fronted windows/doors. There were no attic spaces/roof voids within the buildings but there were a few 'service units' housing boilers.

Photograph 1: Showing the front of the buildings.

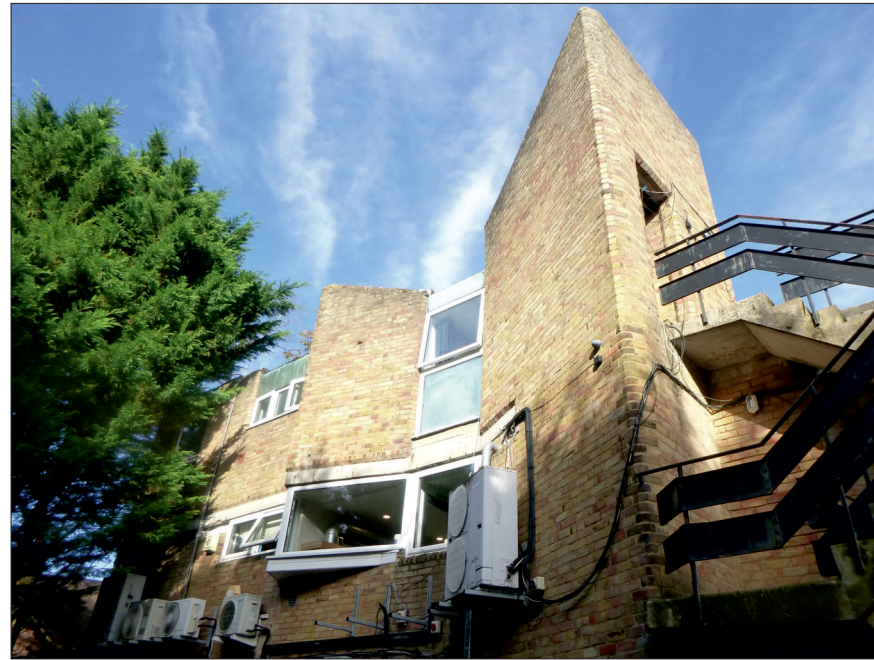
No evidence of bats was recorded during a careful internal and external re-inspection of the buildings. The buildings were well-maintained and sealed, with no obvious access points recorded. In addition, the soffits/fascias were well-maintained and tightly sealed lacking any access points. The service units were accessed and found to be well-sealed, with some light cobwebbing covering the timbers.

Photograph 2: Showing the rear of the buildings.

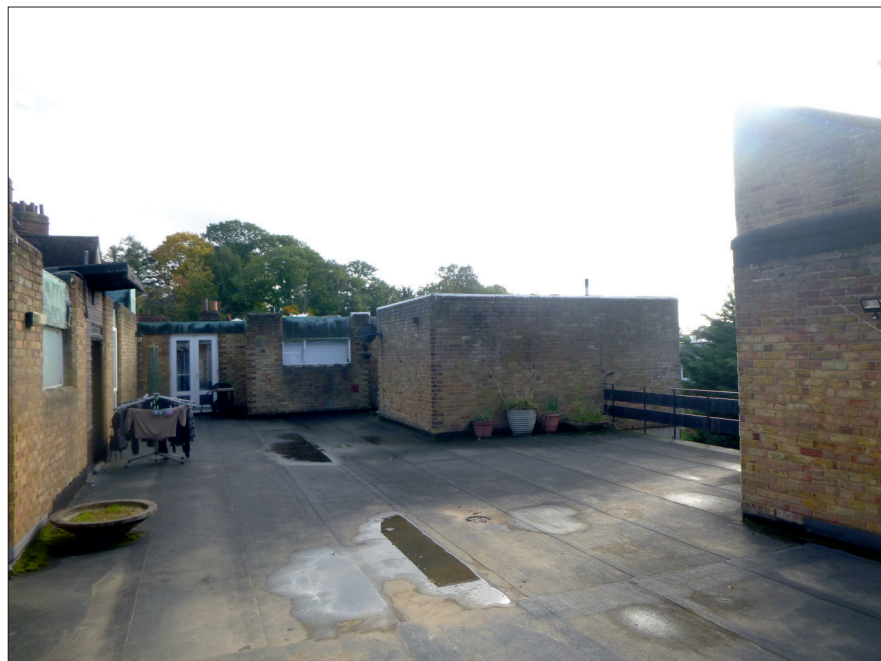
Photograph 3: Showing the flat, felted roof used by residents.

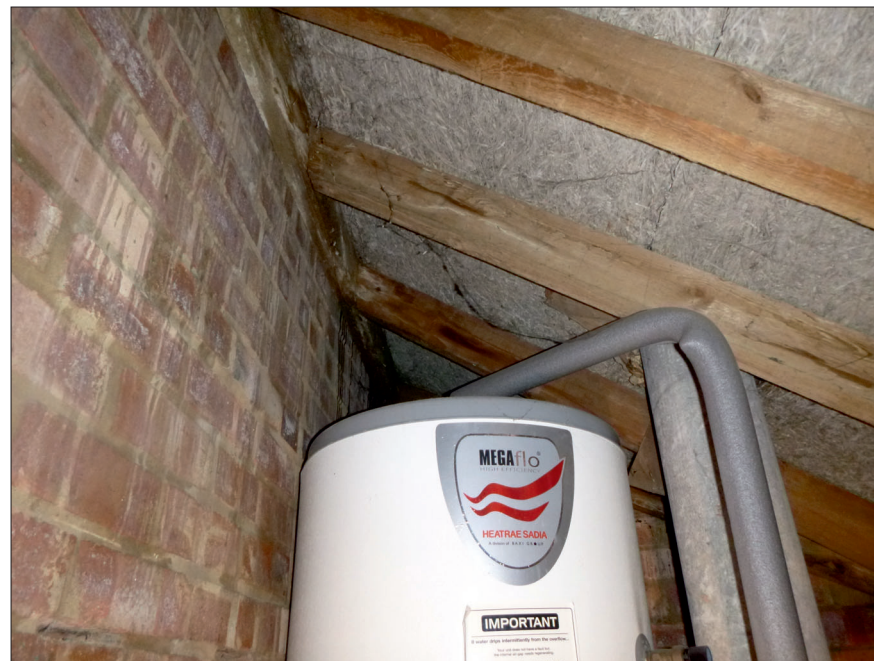
Photograph 4: Showing one of the service units' housing a boiler.

A thorough examination of the existing buildings was completed, with all potential access points and/or roosting opportunities fully inspected for evidence of bats on two occasions (recently and initially back in 2021). All service units were fully accessed and not complex allowing a thorough inspection and, therefore, there are considered to be no constraints to the survey findings. Although no evidence of bats was recorded and no further surveys are considered necessary, all site operatives should be made aware of current legislation protecting bats and their roosts. In the unlikely event of any bats being encountered on the site, then works should stop immediately and Natural England or AAe contacted so that appropriate advice can be provided.
