Bat Emergence Survey

Land at Glenelm and 160 Anyards Road, Surrey

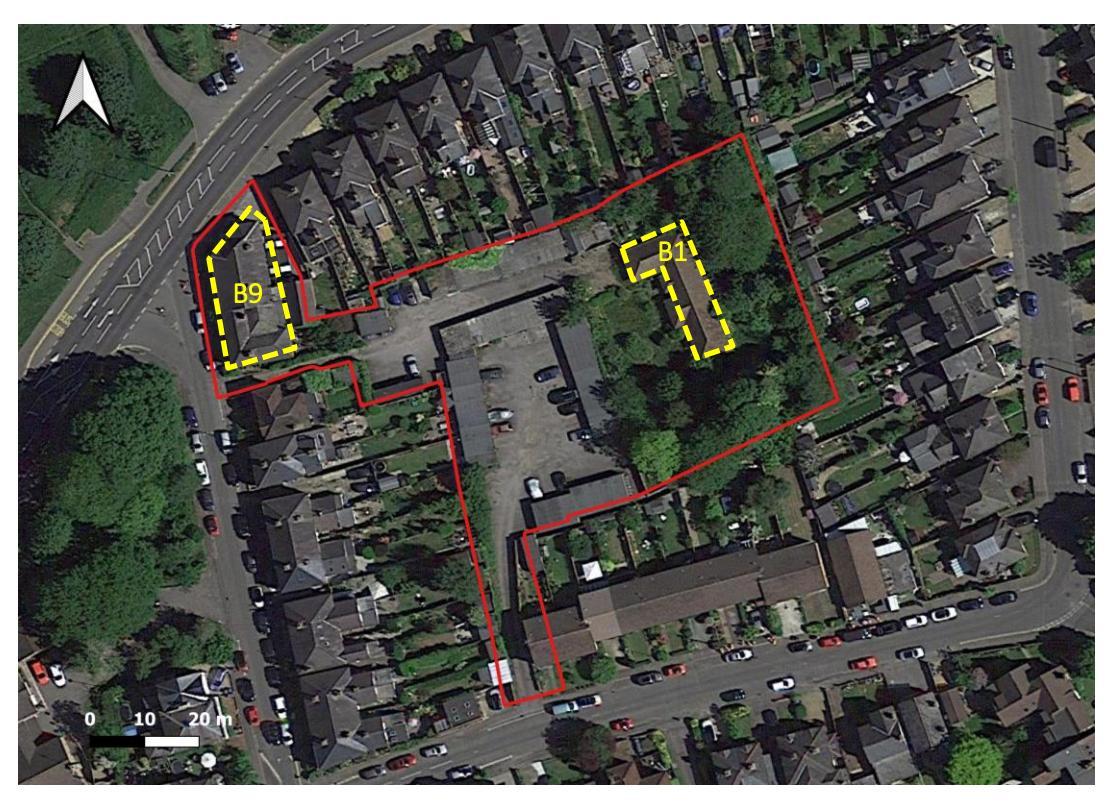
Figure 1: Approximate location of the surveyed buildings on site outlined in yellow

- 1.4 The site (TQ10776063) includes multiple buildings and hardstanding car parks. The site is surrounded by residential properties, with units of woodland and arable fields in the wider landscape.
- 1.5 The aerial photograph overleaf (Figure 1) shows the site and its immediate surroundings. The building surveyed is outlined in red.

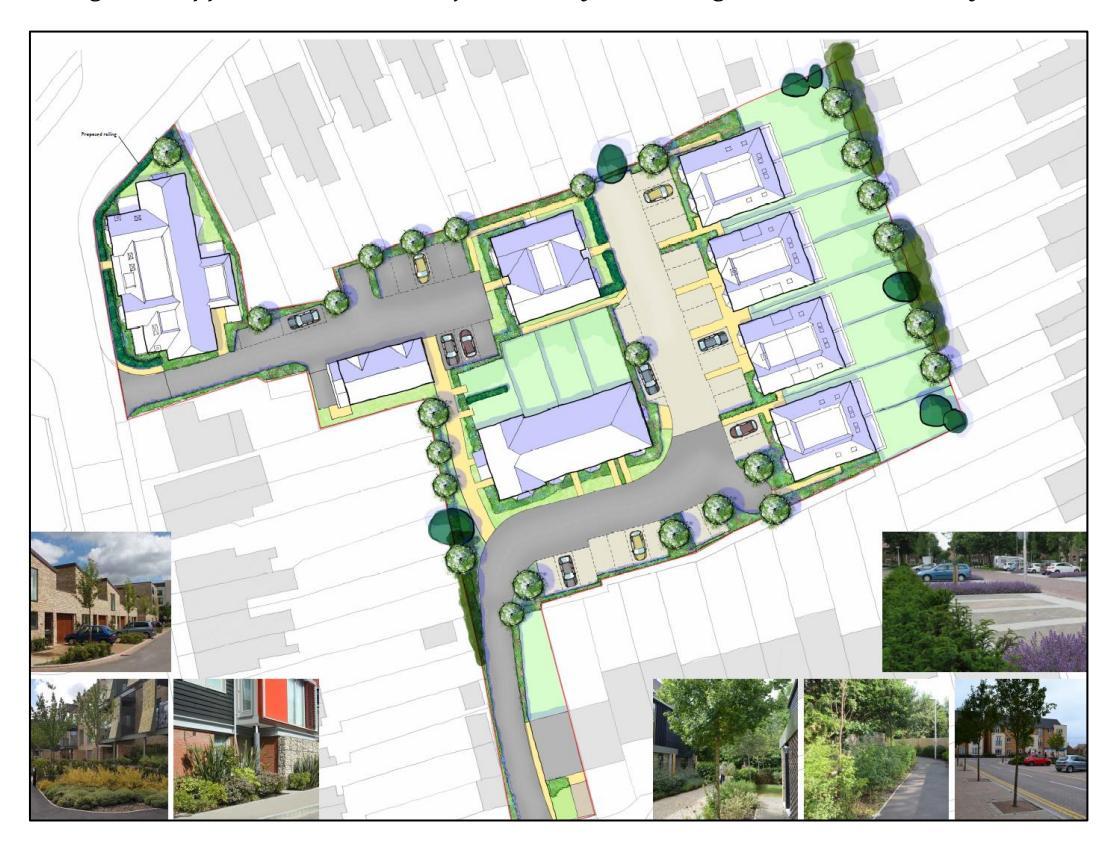
Figure 2: Proposals for the site.

1.6 The proposed development includes the Outline Application for the demolition of the existing buildings and erection of 26 residential dwellings, with layout, scale, access and appearance for consideration (Figure 2).

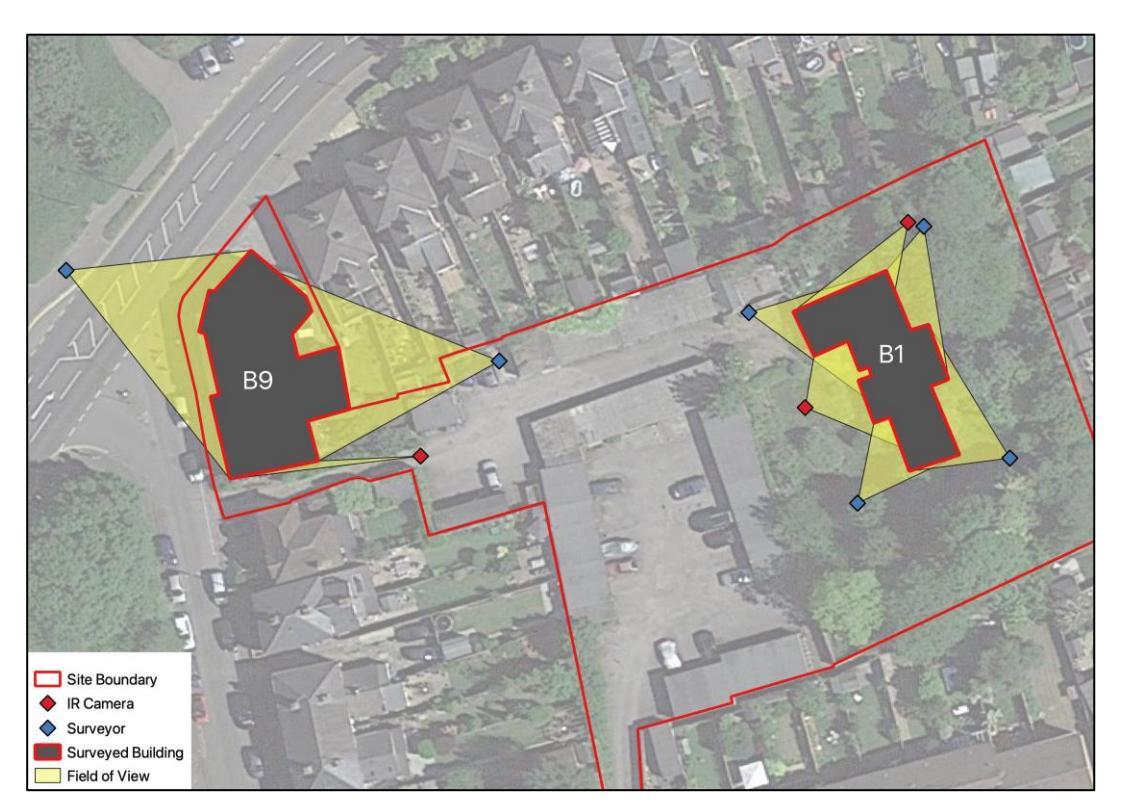
2.5 Figure 2: Location of surveyors on the building

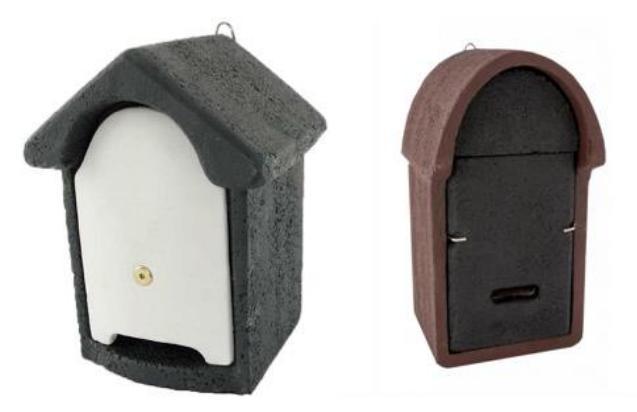
Figure 5: Vivara Pro WoodStone Bat Box (left) and Large Multi Chamber WoodStone Bat Box (right)

- Vivara Pro WoodStone Bat Box A general purpose bat box that supports a range of species (Figure 8). These can be hung on trees in a variety of heights and aspects in order to provide a variety of micro-climates.
- Large Multi Chamber WoodStone Bat Box This is a multipurpose box designed for larger colonies and a range of bat species including pipistrelles, noctules and brown long-eared bats. These should be hung on mature trees around the site (Figure 5).
