Project: Orchard Lane, East Molesey, Surrey, KT8 0BN

Drawing: Arboricultural Impact Assessment

Drawing No: Arbtech AIA 01 **Rev:**

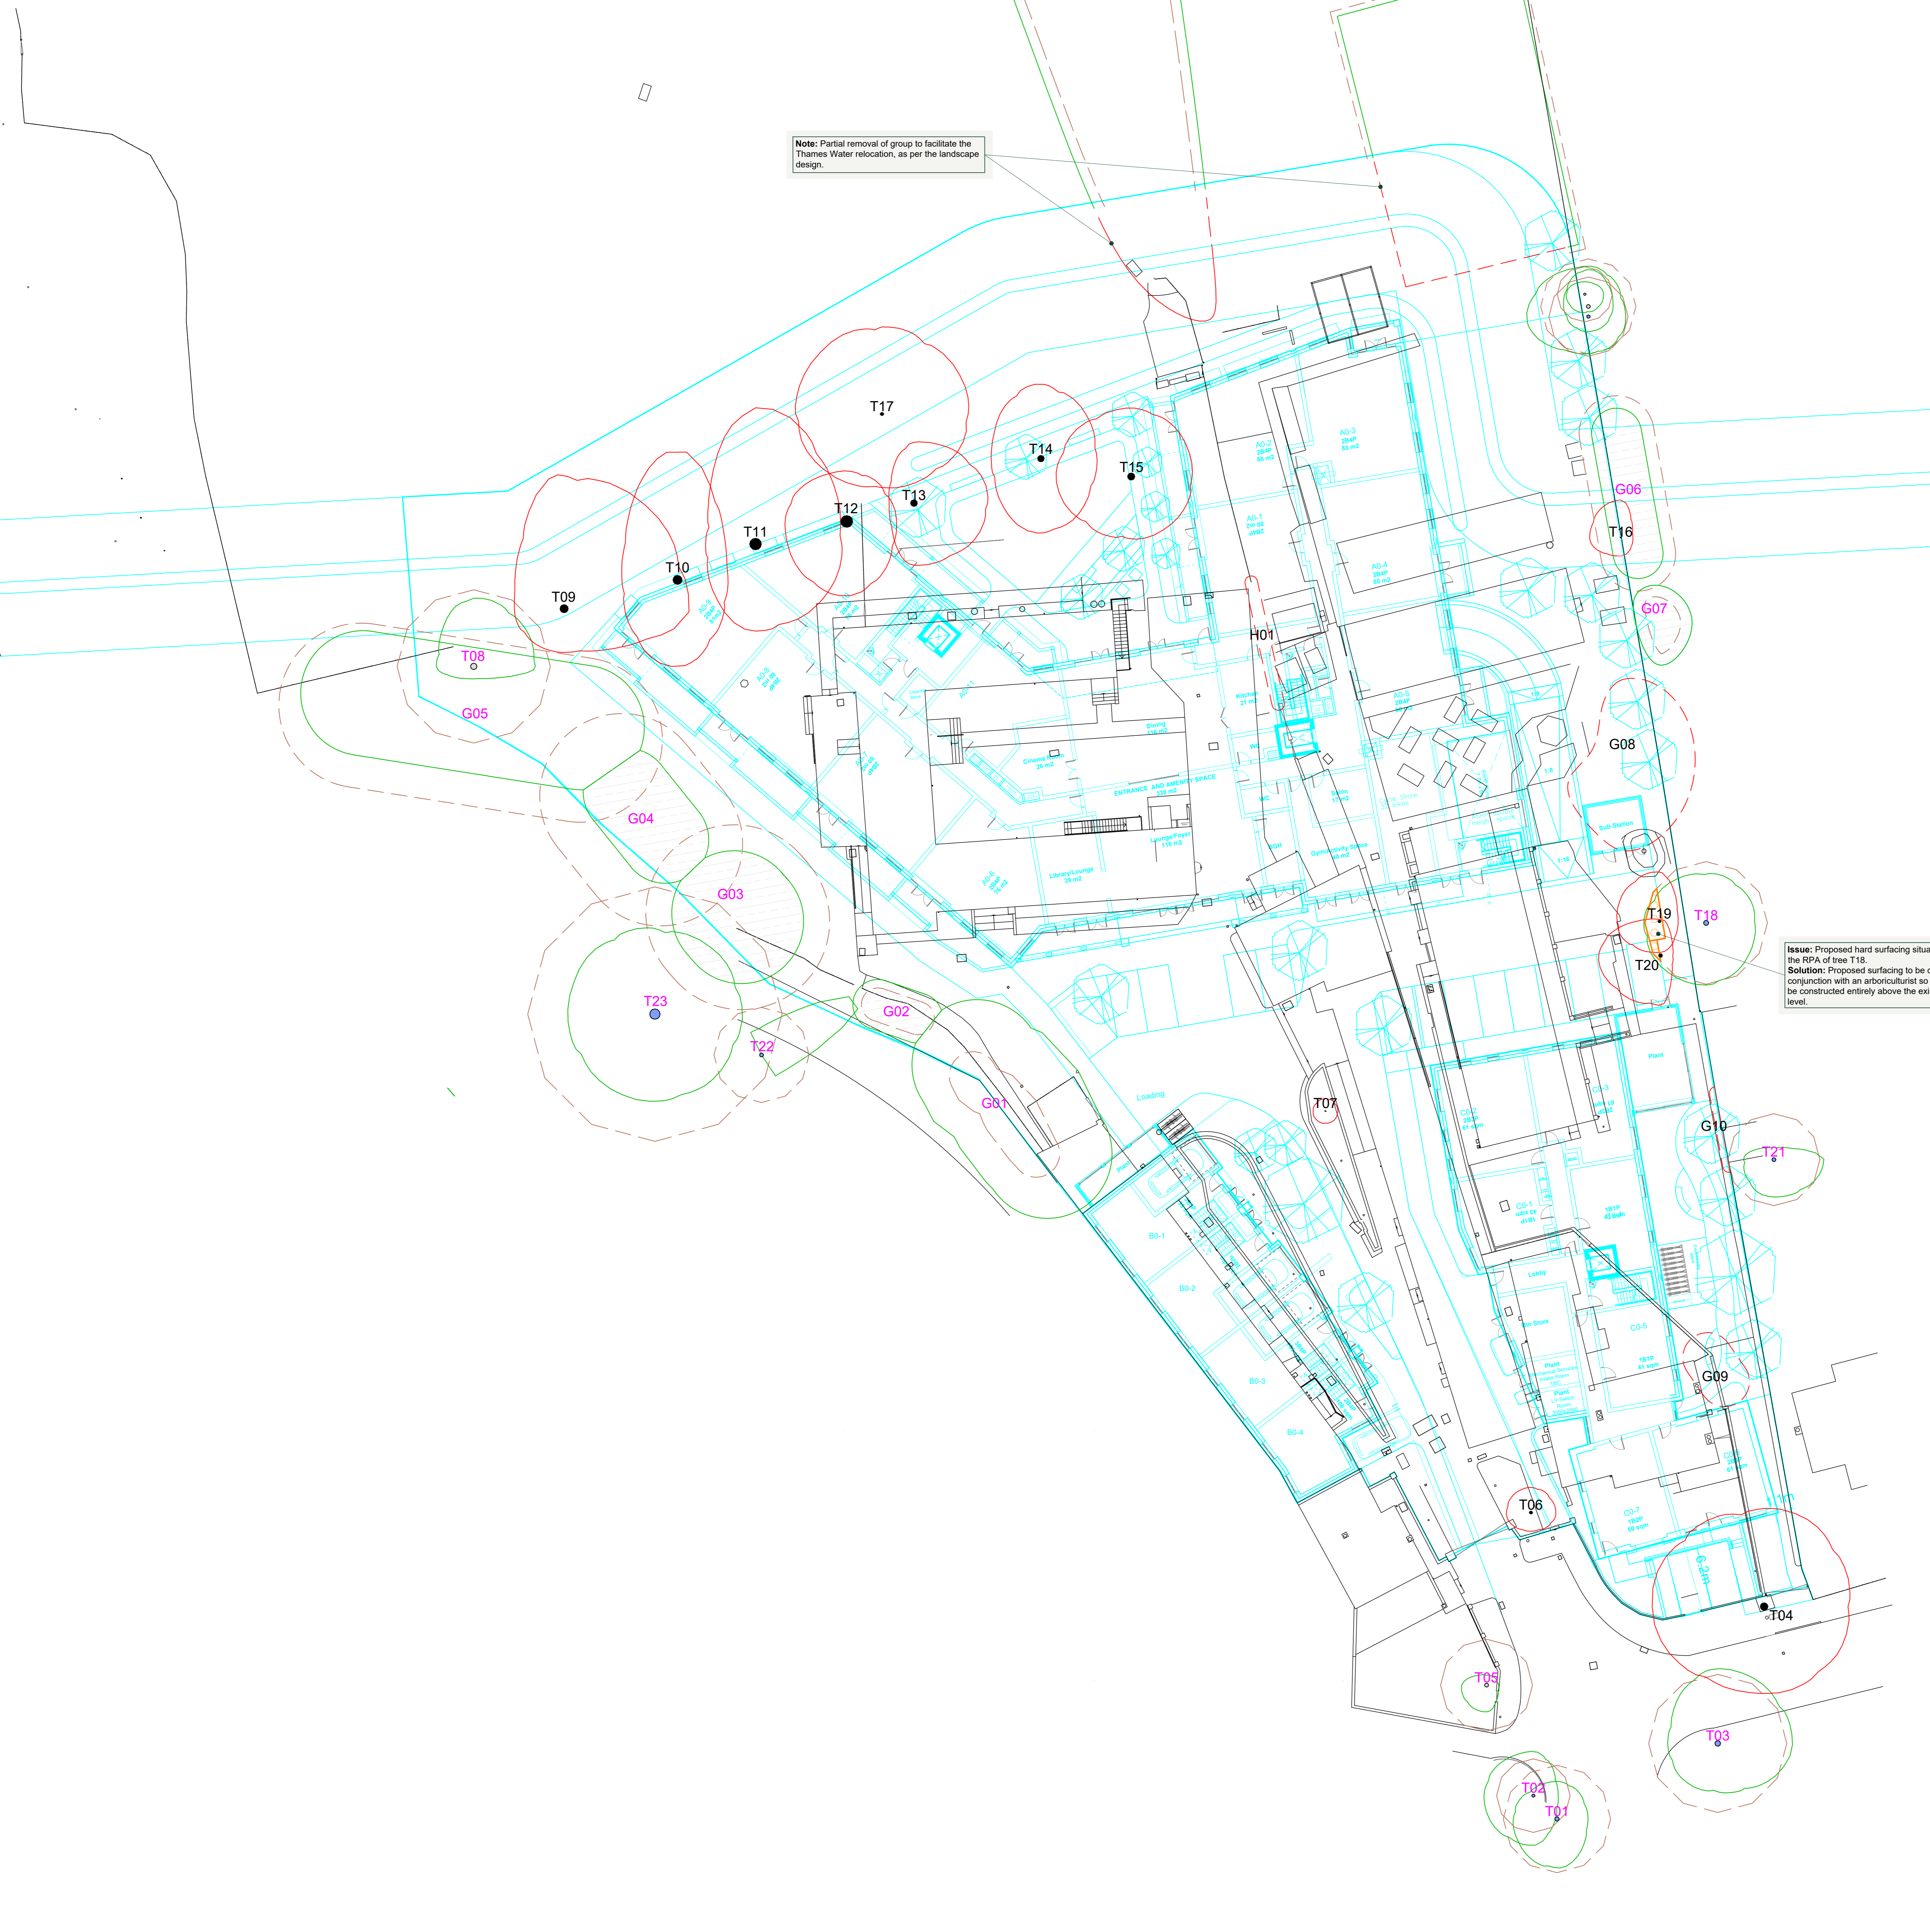
Arboricultural Impacts

Impacts	No. of trees
Trees to be removed	14
Groups / hedges to be removed	4
Trees with proposed measures into RPAs	1
Groups / hedges with proposed measures into RPAs	0
Trees that will require pruning	0
Groups / hedges that will require pruning	0
Trees to be translocated	0
Groups / hedges to be translocated	0

No.	Species	Proposed structure	Incursion
T18	Silver Birch	Hard Surfing	RPA

Arboricultural Impacts - RPAs (Area)

No.	Species	RPA Area (sqm)	Incursion (sqm)
T18	Silver Birch	724	47
